Technical Report Documentation Page

12. Sponsoring Agency Name and Address			13. Type of Report an	
Texas Department of Transportation			Technical Rep	
Research and Technology Implement	ntation Office)3 – August 2008

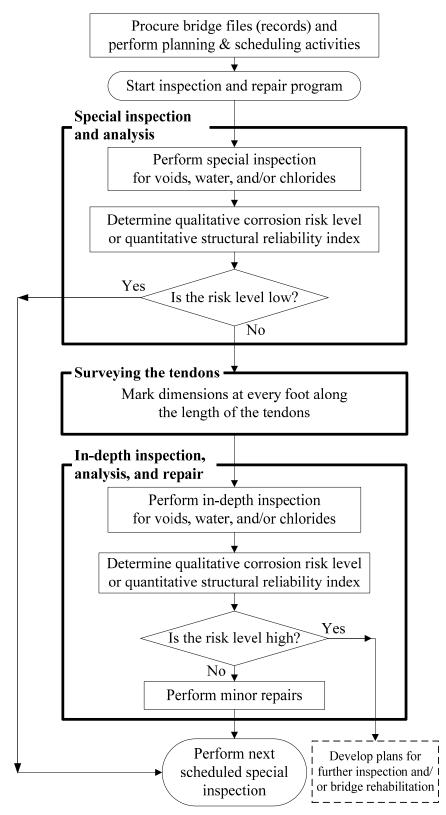
Figure 1-1. Overall Inspection, Analysis, and Repair Program for Post-Tensioned Bridges.

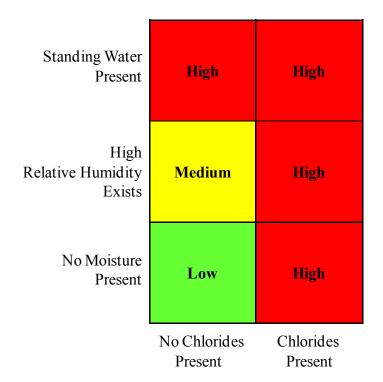
Figure 1-2. Qualitative Corrosion Risk Chart for PT Systems.

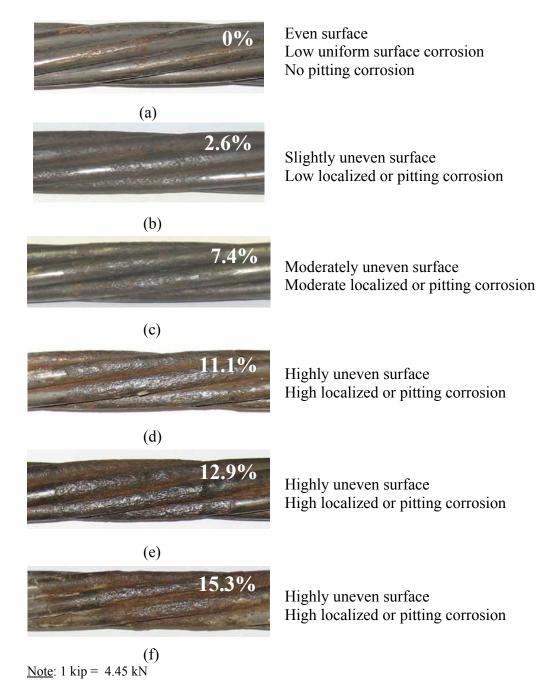
Figure 1-3. Photographs Showing the Typical Tensile Strength, Corrosion Level, and Surface Characteristics of Strands (Note: These photographs were taken after cleaning the strand surface using a synthetic cleaning pad and/or a steel wire brush).

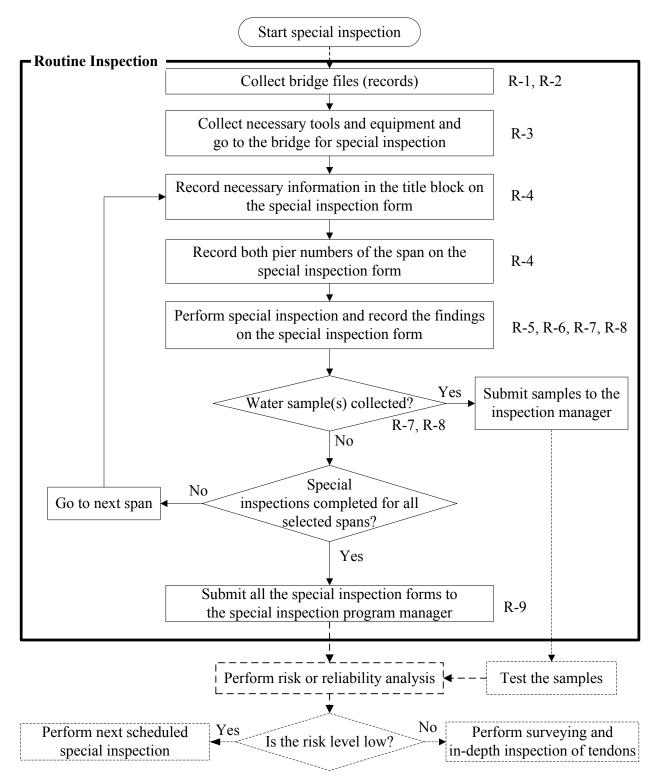
Figure 2-2. Flowchart of Special Inspection and Analysis.

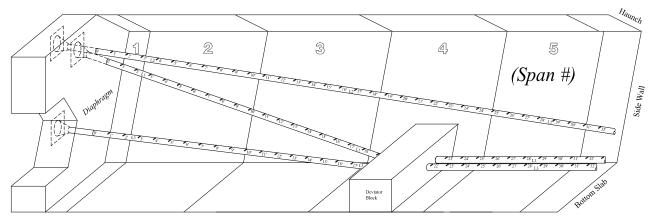
Figure 3-6. An Isometric Interior View of a Bridge Girder (after Surveying).

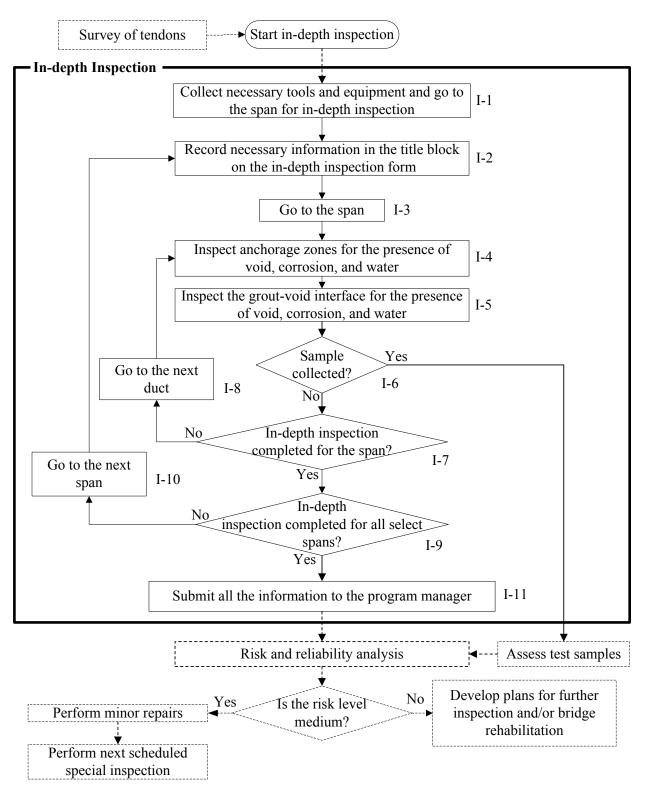
Figure 4-2. Flowchart of the In-Depth Inspection and Analysis.

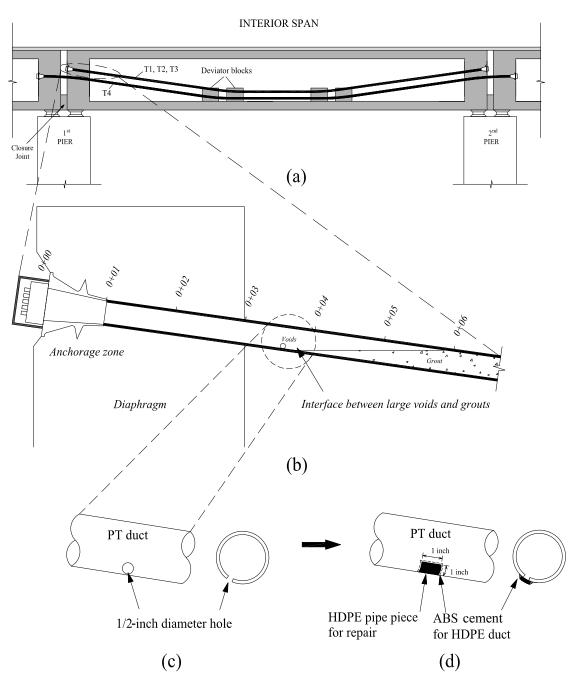
Note: 1 inch = 25.4 mm

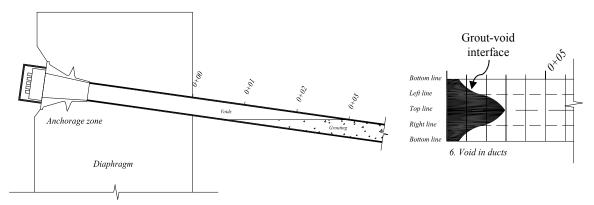
Figure 4-5. Marking Voids on the In-Depth Inspection Form.

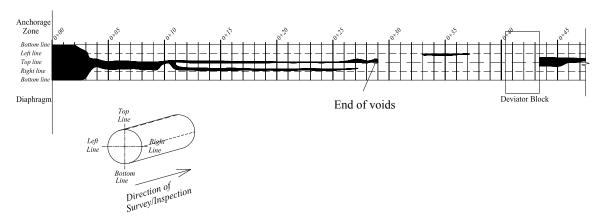
Figure A-2. Location of the End of Voids on the Detailed Inspection Sheets.

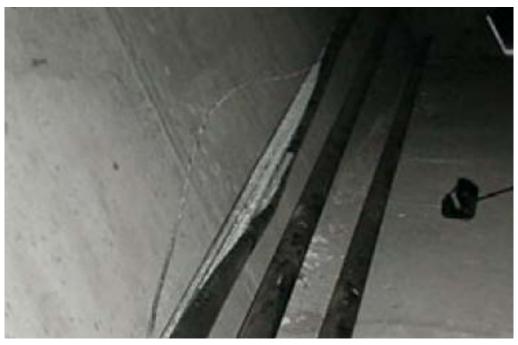
Figure A. Broken strands and broken ducts.

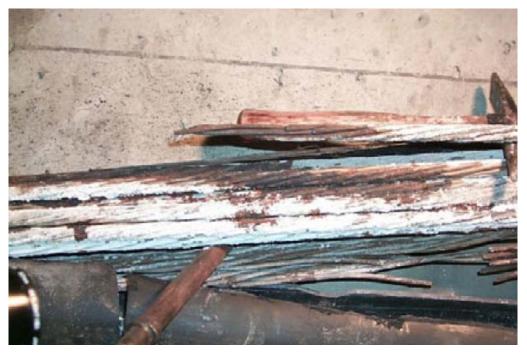
Figure B. Corroded and broken strands and broken ducts.

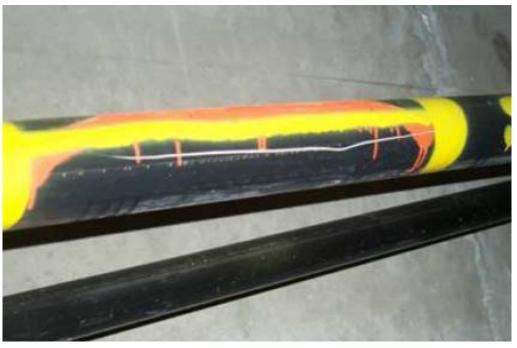
Figure C. Cracked ducts.

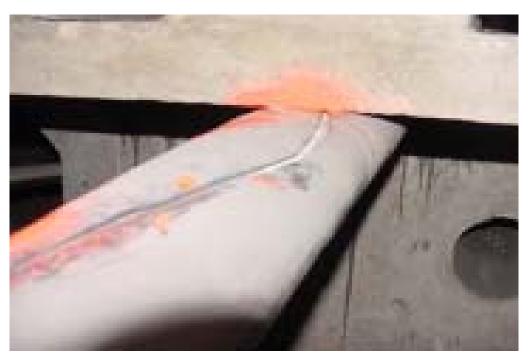
Figure D. Cracked ducts.

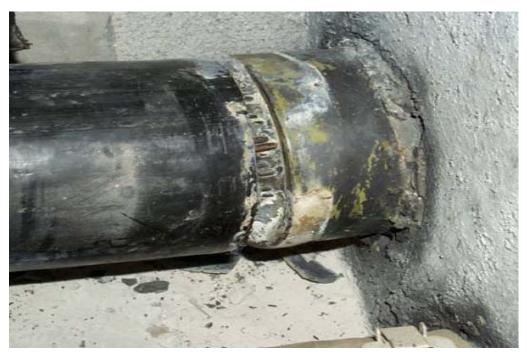
Figure E. Broken ducts and exposed strands.

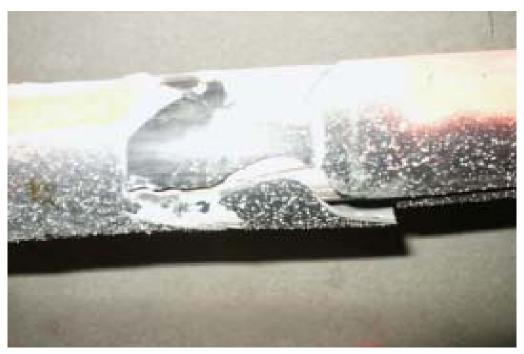
Figure F. Broken ducts and exposed strands.

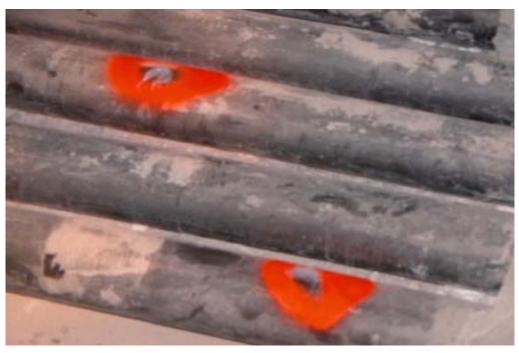
Figure G. Ducts with holes.

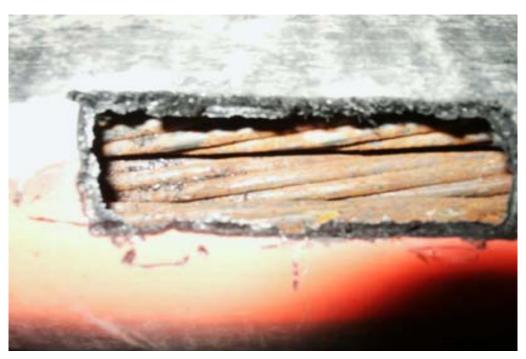
Figure H. Voids in tendons and corroded strands.

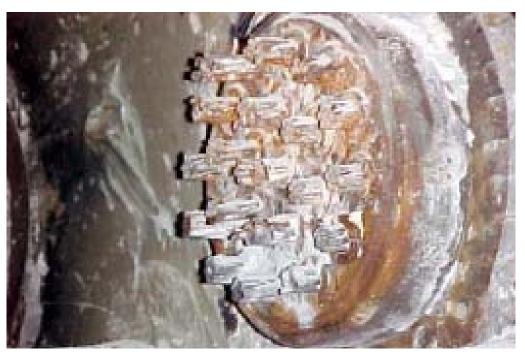
Figure I. Missing anchorage cap, exposed anchor head, and corroded strands.

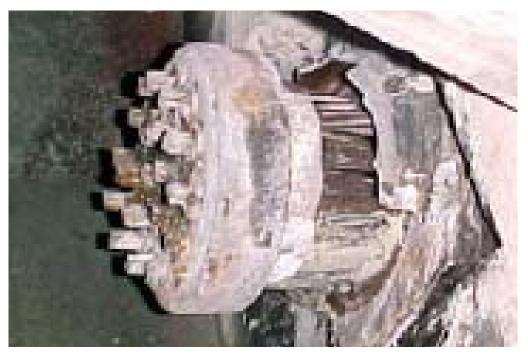
Figure J. Loose anchorage (indicating broken strands).

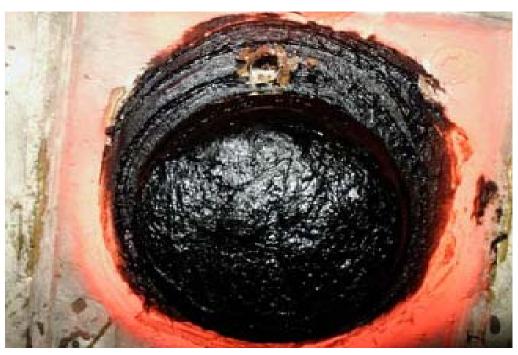
Figure K. Opened grout port.

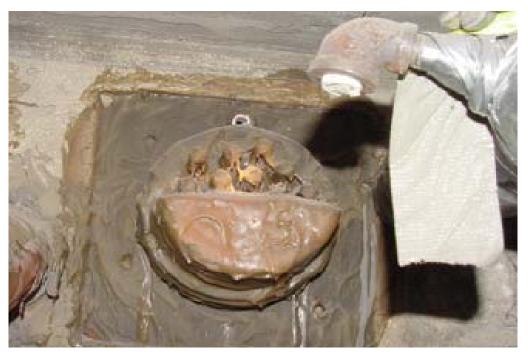
Figure L. Opened grout port, broken anchorage cap, and exposed anchorage zone.

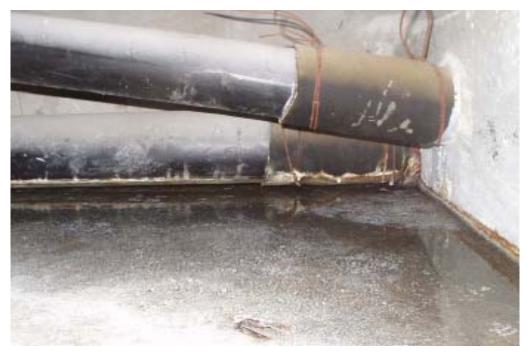
Figure M. Standing water in the concrete box girder.

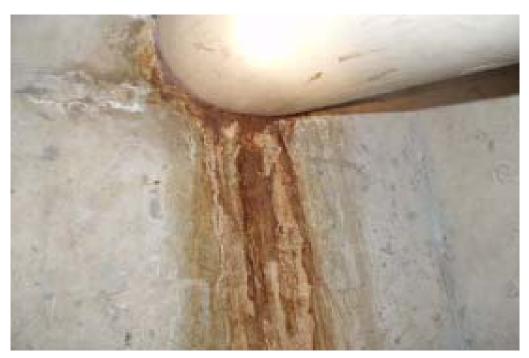
Figure O. Sign of past moisture infiltration in the concrete girder, broken drainage pipe.

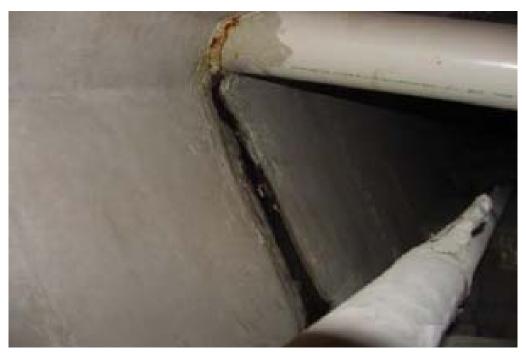
Figure P. Sign of past moisture infiltration in the concrete girder, broken drainage pipe.

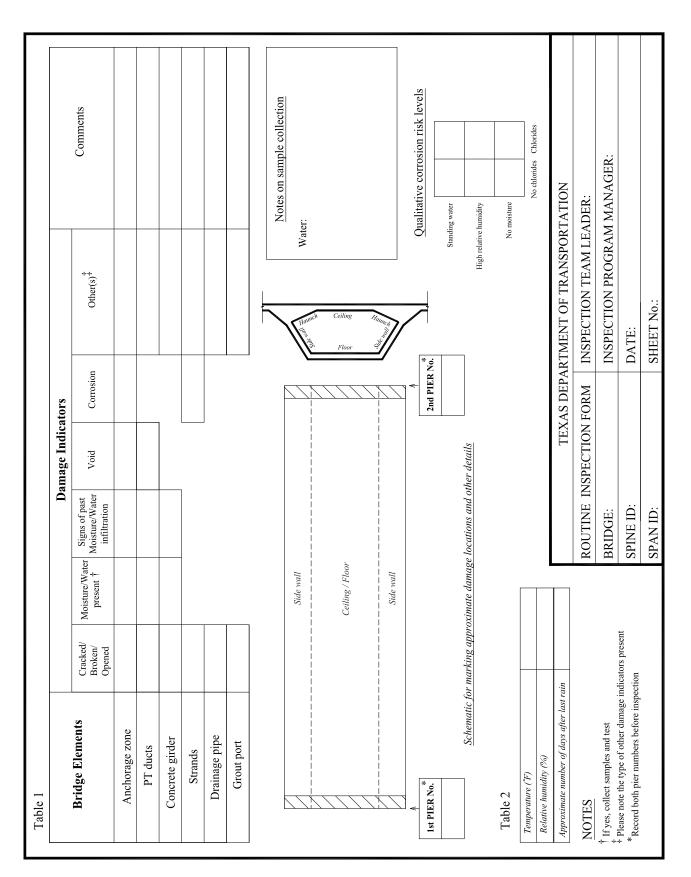
APPENDIX C. INSPECTION FORMS
