**A STUDY ON CHARACTERISATION, DETERIORATION
MECHANISMS AND PROTECTION OF BRICKS AND STONES IN
HISTORIC STRUCTURES**

A THESIS

**DEPARTMENT OF CIVIL ENGINEERING
INDIAN INSTITUTE OF TECHNOLOGY MADRAS
CHENNAI, INDIA**

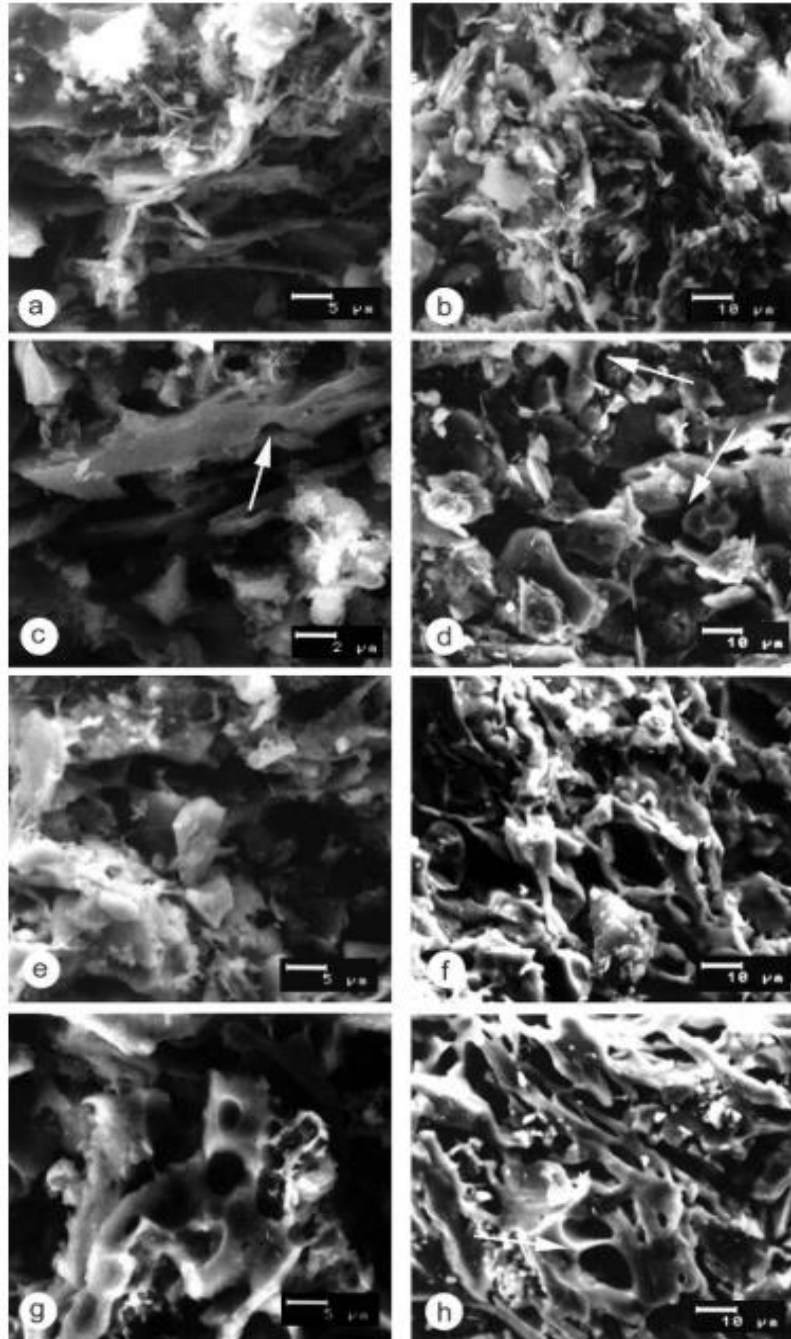
Figure 2.3. SEM images of calcareous (left column) and non-calcareous (right column) bricks fired at 800 °C (a and b), 900 °C (c and d), 1000 °C (e and f) and 1100 °C (g and h) (Elert et al., 2003)

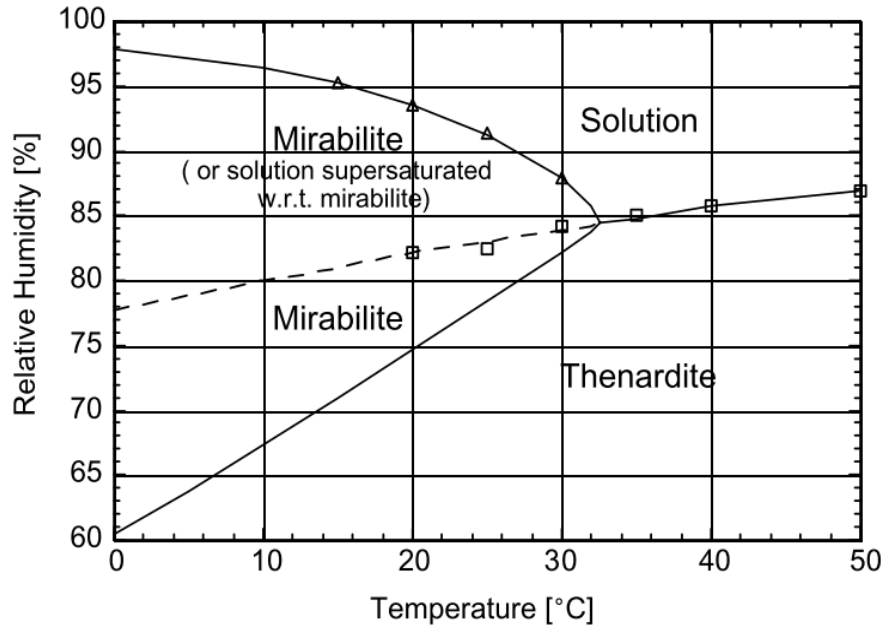
Figure 2.8. Phase diagram of sodium sulphate (Robert J. Flatt 2002)

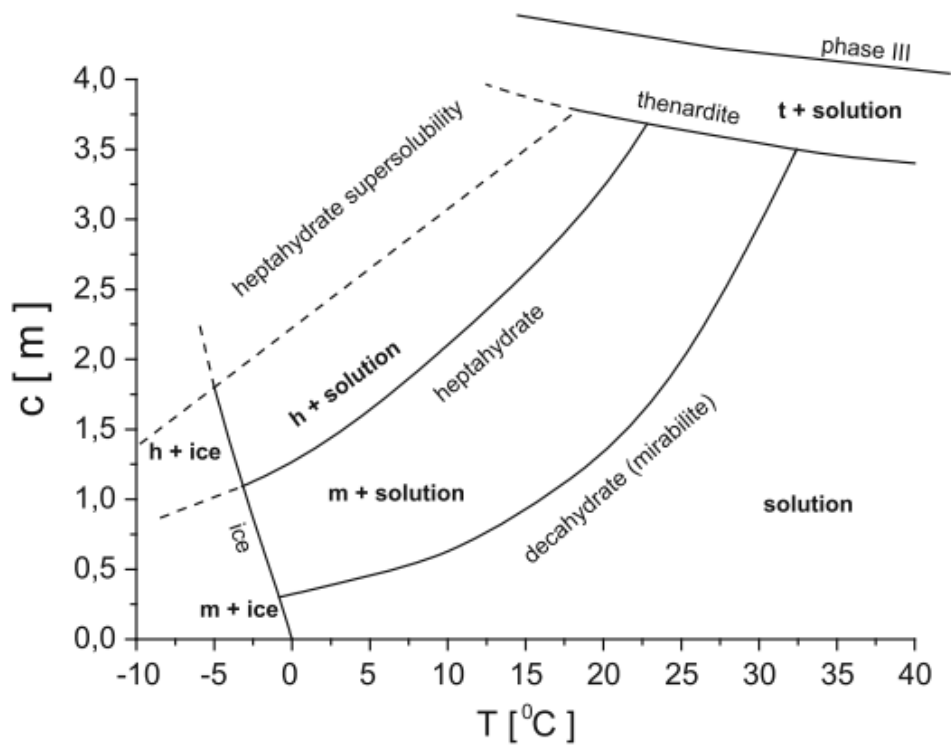
Figure 2.9. Phase diagram of sodium sulfate showing the equilibrium solubilities of various phases (h, t, m for heptahydrate, thenardite and mirabilite respectively) (Saidov et al. 2017)

Sodium sulphate can crystallize in at least eight different crystalline phases. The two stable phases are mirabilite (or Glauber's salt) and thenardite (phase V). The metastable phases are a heptahydrate, $\text{Na}_2\text{SO}_4 \cdot 7\text{H}_2\text{O}$, and two other anhydrous ones (phases III and IV), Na_2SO_4 . Anhydrous phases I and II exist only at higher temperatures (4270 and 4225 °C, respectively), whereas the octahydrate, $\text{Na}_2\text{SO}_4 \cdot 8\text{H}_2\text{O}$, is formed under high-pressure conditions. The phase diagram is shown in Figure 2.8, which illustrates the conditions for different crystallization states. According to Saidov et al. (2017), the instantaneous transformation of thenardite-to-decahydrate by rewetting is the major reason for damage by sodium sulphate weathering within the temperature range between 22 and 25 °C. The authors presented the equilibrium solubilities of various phases in a phase diagram, as shown in Figure 2.9.

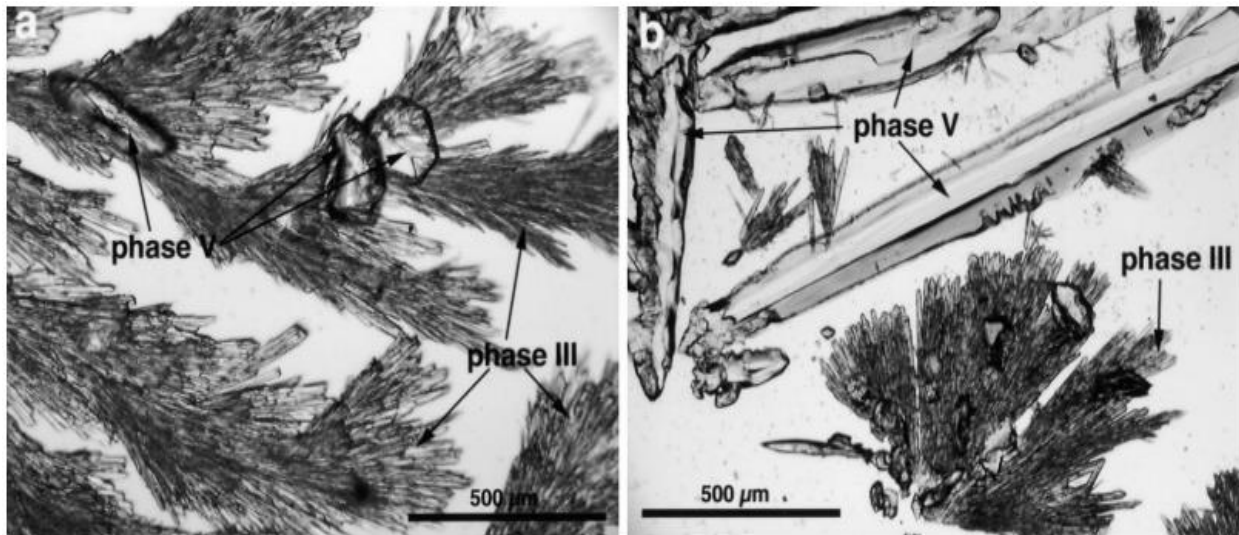
Figure 2.10. Micrograph of precipitated thenardite crystals (a) at 20°C, RH > 40%- needles are phase III of sodium sulphate and prisms are phase V (b) Phase V bipyramidal prisms at 20°C, 13% RH, with minor amounts of phase III needles (Rodriguez-Navarro et al. 2000)

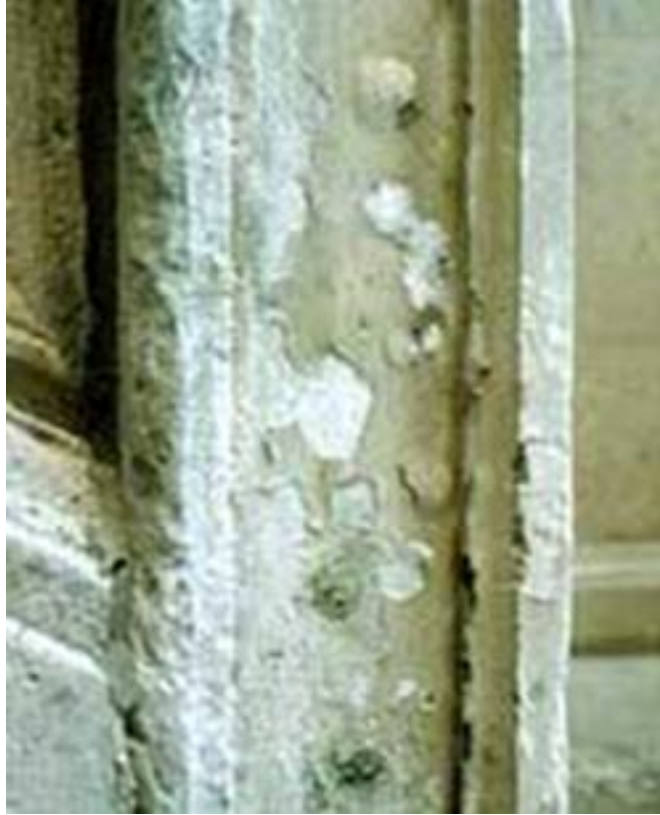
Figure 2.11. Protective coating damaging the stone substrate upon peeling (Mack and Grimmer 2000)

The treatments to historic structures are often applied without proper scientific study, and without identifying the actual requirement and the properties of the chemicals being applied. If not selected and appropriately applied, the coatings can cause deleterious actions, and it is difficult to remove them from the surface properly if they fail. Figure 2.11 shows a case where a clear coating has failed and has pulled off some of the stone substrates upon peeling (Mack and Grimmer 2000). Cleopatra’s Needle, the Egyptian obelisk in New York City, was once treated with wax as a protective sealant, but the process sealed in saline moisture. The treatment provoked an already deleterious action of moving the monument from an arid to a humid environment (Winkler 1997). Binders derived from mortars or cements may exert new pressure on masonry when they solidify or crystallize, such that the substances used to repair the stone end up actually causing greater destruction (Pope et al. 2002).

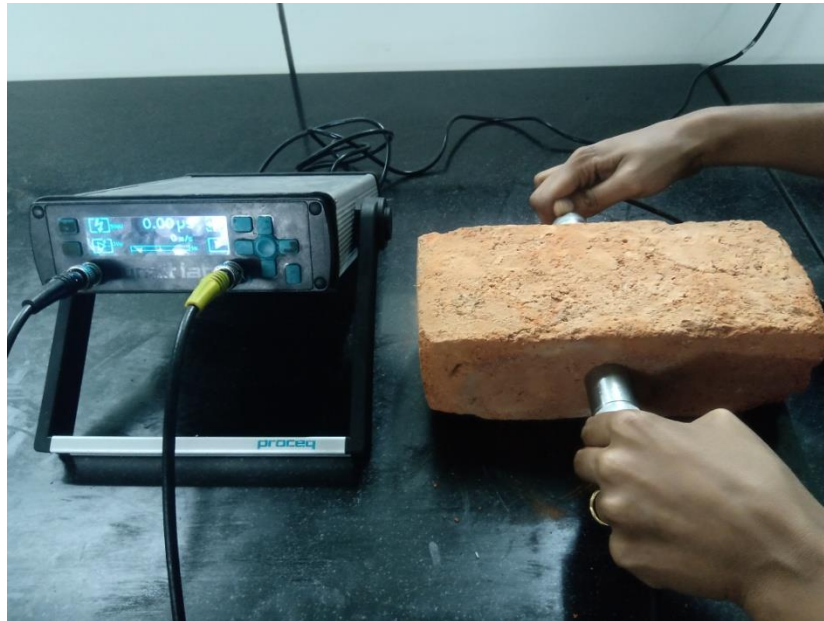
Figure 3.5. Illustration of UPV test on a brick sample

(i.e., the thickness of cross-section) and the measured time taken by the pulse to travel through the material. Ultrasonic sound waves are used in the test to get an idea of cracks, voids, vaults, and in general, about the overall soundness of materials. Transducers of frequency 55 kHz were used as per the standard ASTM C597-2016 (ASTM Standard C597 2016).

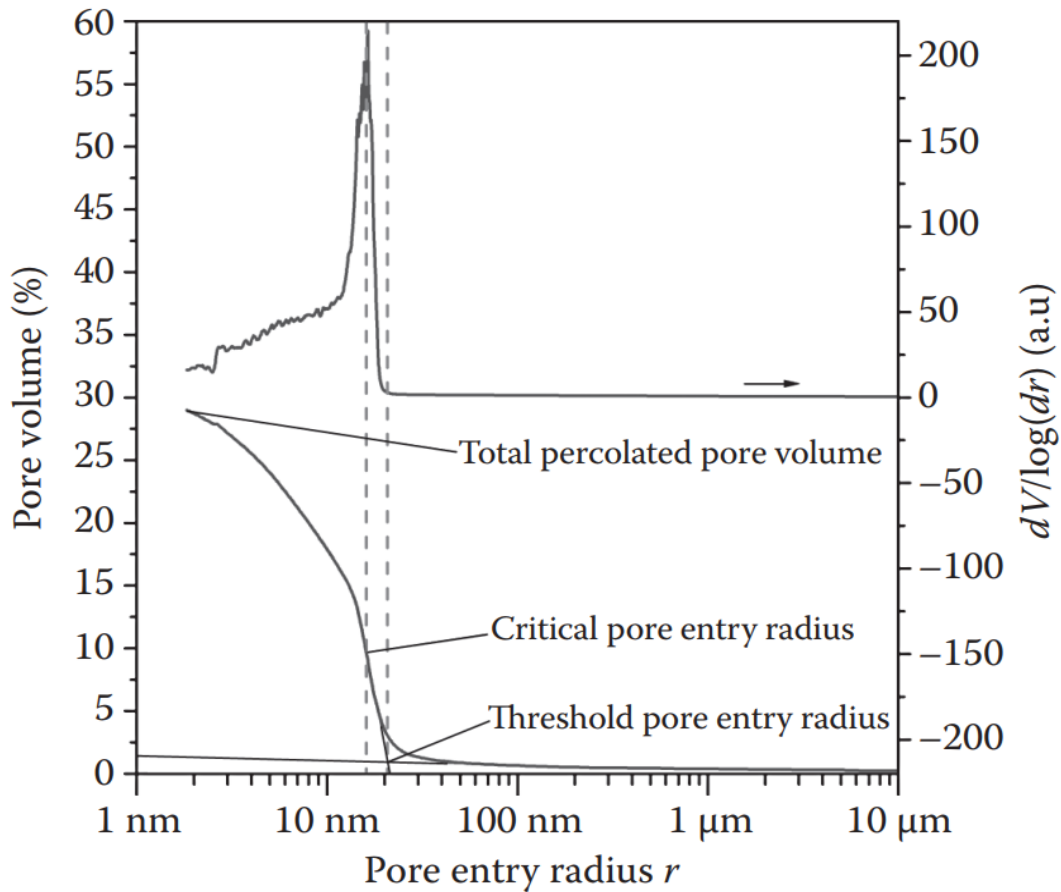
Figure 3.9. A typical example of MIP cumulative and derivative curves for Portland Cement, showing the pore parameters (Scrivener, Snellings 2016)

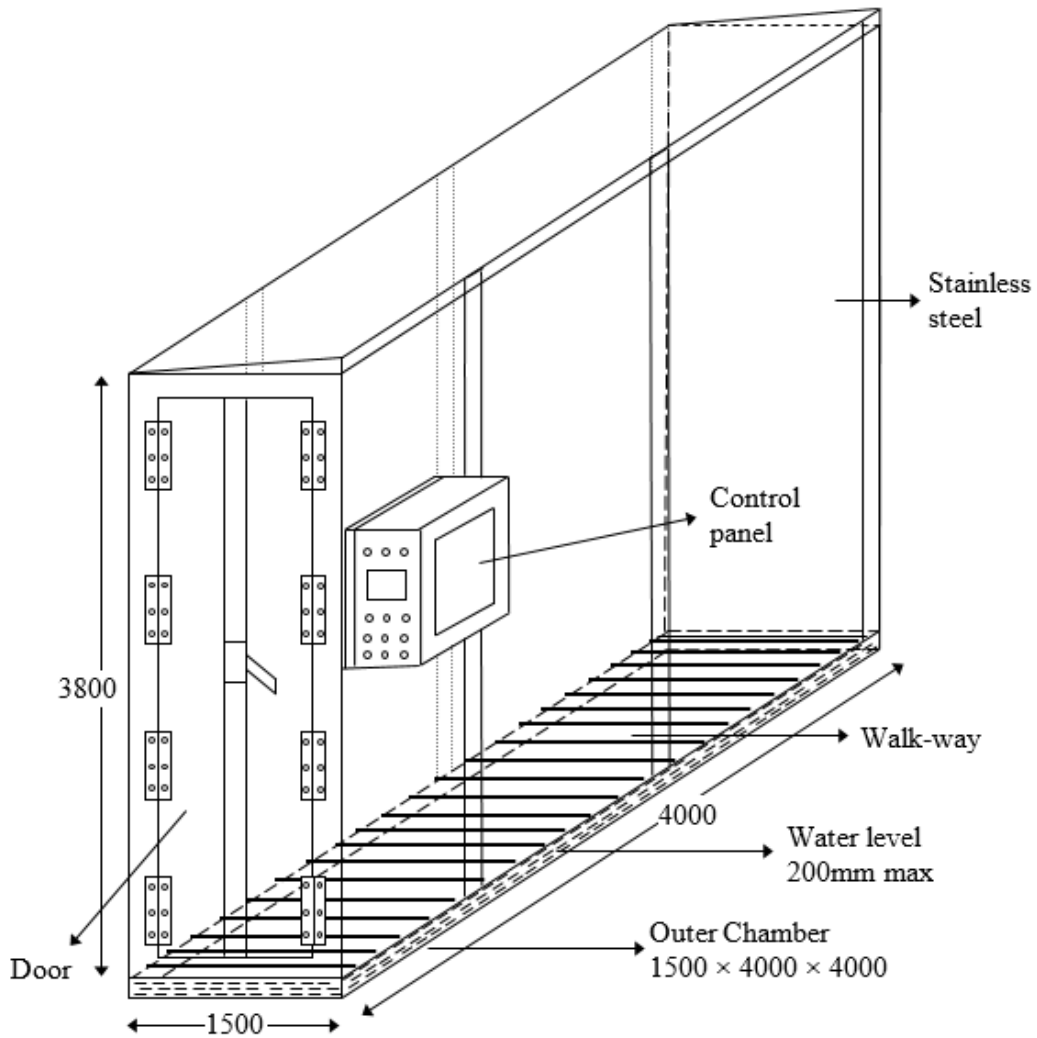
Figure 3.13. Schematic diagram of the salt spray chamber used for the study

5% NaCl solution was prepared and filled into the reservoir provided in the backside of the chamber. The reservoir with the salt solution is connected to four atomizer nozzles for spraying the humidified salt solution. The air compressor supplies air at a pressure of 12 kg/cm² used for both the humidifier and closing and opening of the chamber door.

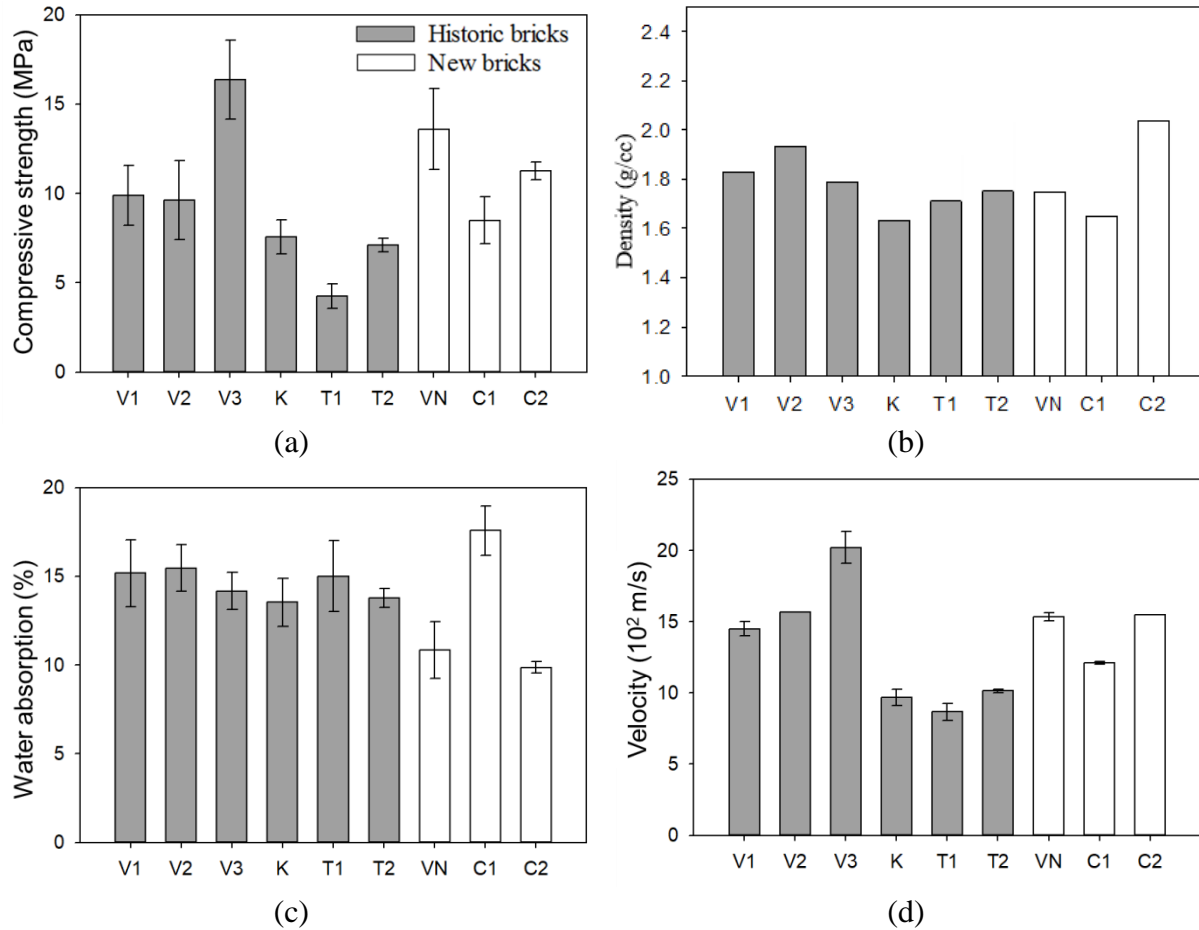
Figure 4.1 (a) Compressive strength (b) Bulk density (c) water absorption (d) UPV

Ultrasonic pulse velocities (UPV) through the different bricks are shown in Figure 4.1 (d). The wave velocities were found to be lower in samples K, T1 and T2, which were observed with visual weathering traces like fissures and cracks.

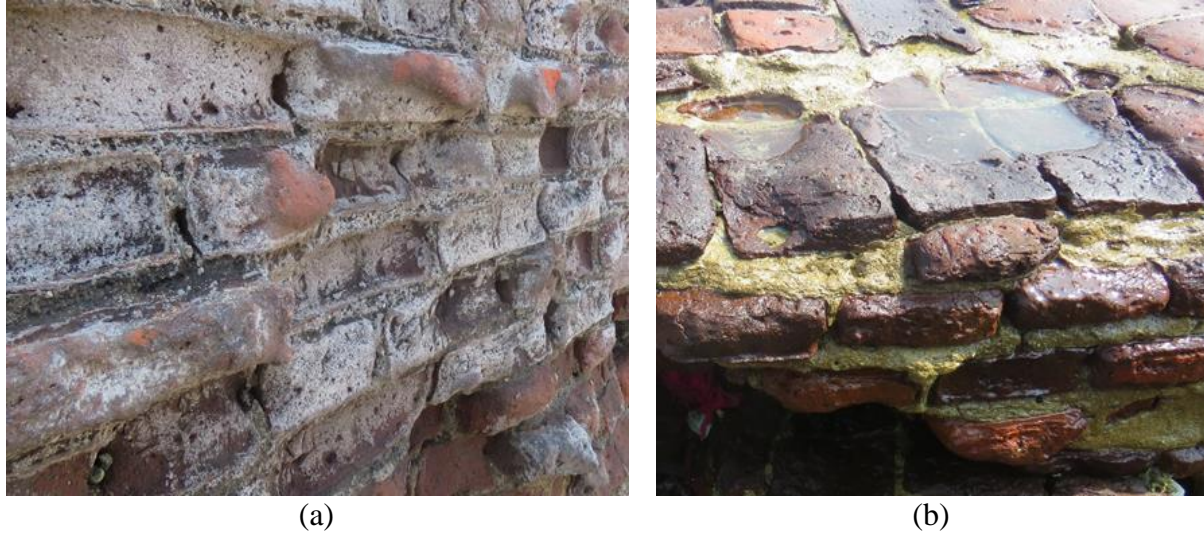
Figure 4.5. (a) Brick wall showing T1 bricks (b) T2 sample bricks which were partially immersed in seawater

The T1 bricks were collected from dry walls at a lower level, close to the ground where it is more exposed to both moisture and salts (both sulphates and chlorides). The selected walls were facing the sea but had no direct contact with the sea. Sample T2 was from wet bricks, which were partially or fully immersed in the sea and under continuous erosive forces of the splashing waves. The bricks in the wall where T1 was collected showed heavy efflorescence and blistering. The T2 bricks did not show any efflorescence but were softened and eroded from the sides progressively. Even though no efflorescence was found, crystallization happened beneath the surface, which is termed as sub-florescence. Full bricks which are representative were removed carefully using a chisel and hammer. A few specimens which got damaged during the process were discarded. Figure 4.5 shows the locations where the samples were collected.

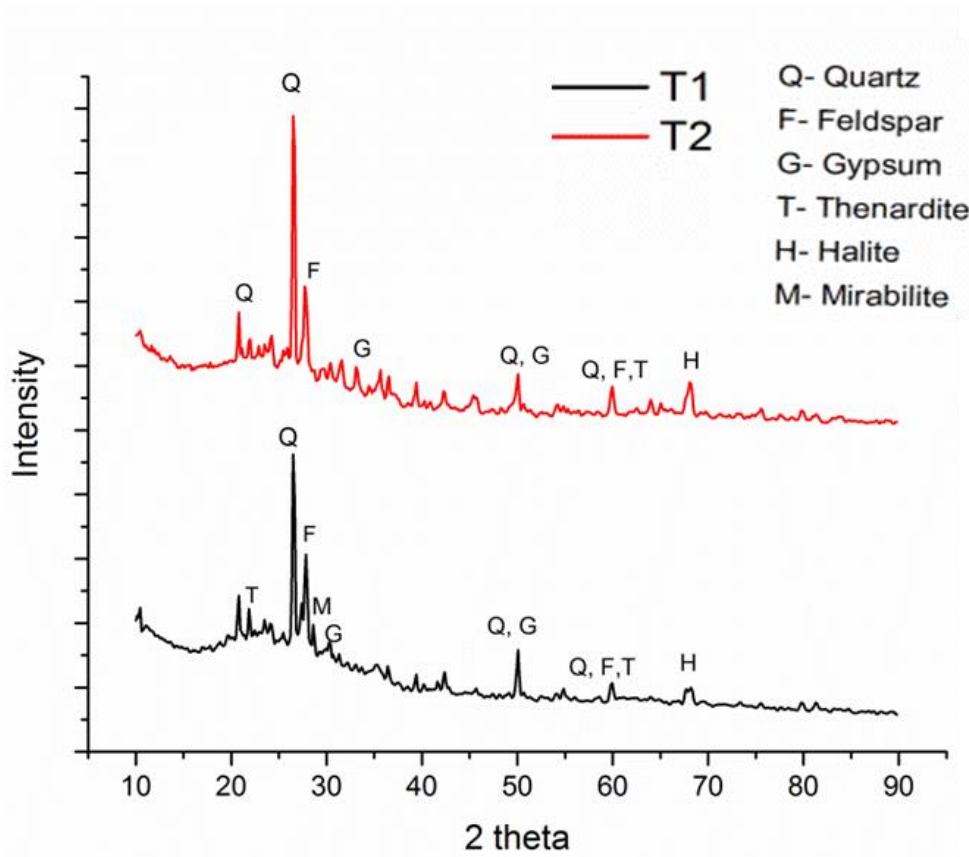
Figure 4.6. Diffractograms showing the peaks of major mineral phases of T1 and T2 samples

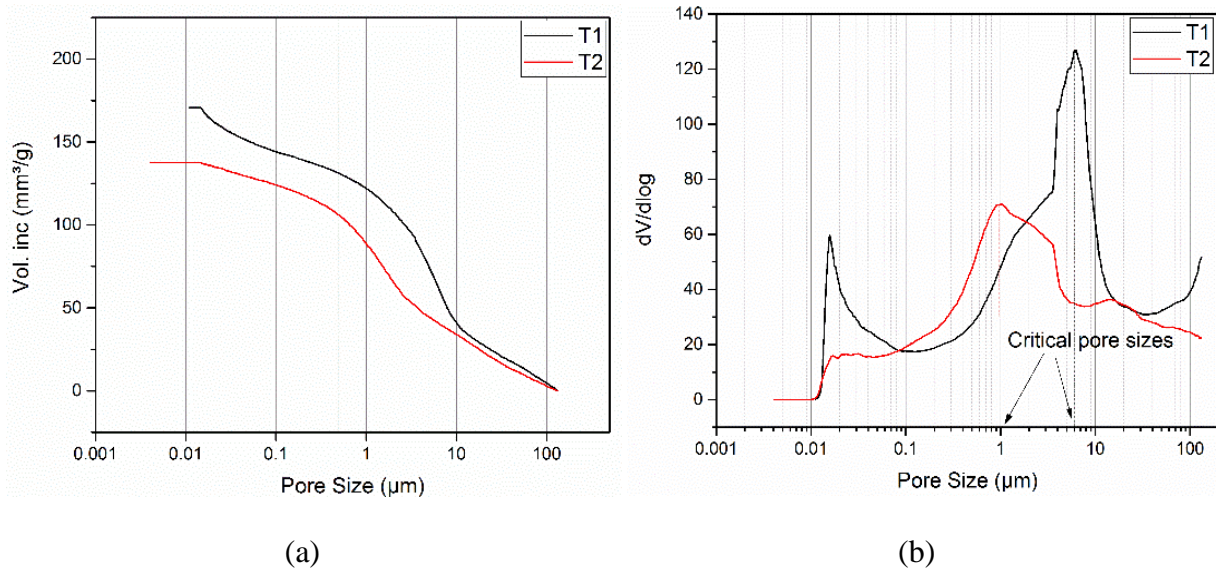
Figure 4.7. (a) Cumulative intrusion curves from MIP (b) Differential intrusion curves showing the critical pore diameter

Table 4.6 shows the pore structure parameters obtained from the test. The critical pore diameter of T1 is $6.27\ \mu\text{m}$, indicating the greater extent of damage inside compared to T2 where critical pore size is $1.01\ \mu\text{m}$. From analyzing the pore structure parameters in Figure 4.7, it is seen that the critical pore diameter has shifted to a larger size for T1 bricks. Critical pore size is the most common pore size among all the pores in the system.

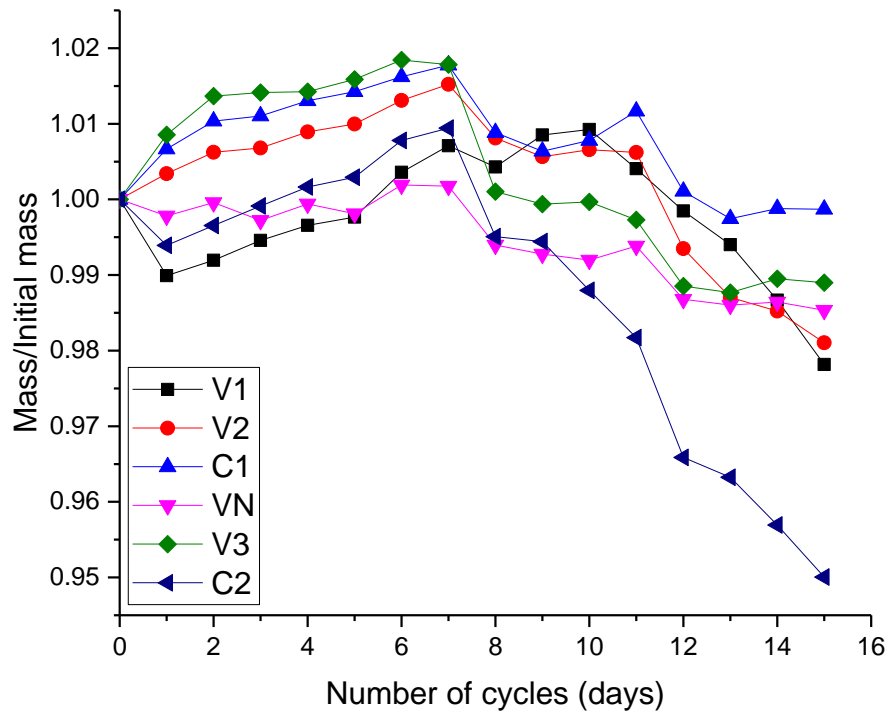
Figure 4.8. Mass changes for the samples during accelerated salt weathering (for 15 cycles)

of specimens in a 14% solution of sodium decahydrate followed by 16 hours of drying in an oven at a temperature of 105 °C and subsequent cooling for 6 hours in room temperature. Mass changes were documented for the samples after each day (each cycle), and Figure 4.8 shows the mass changes of the samples throughout the 15 cycles.

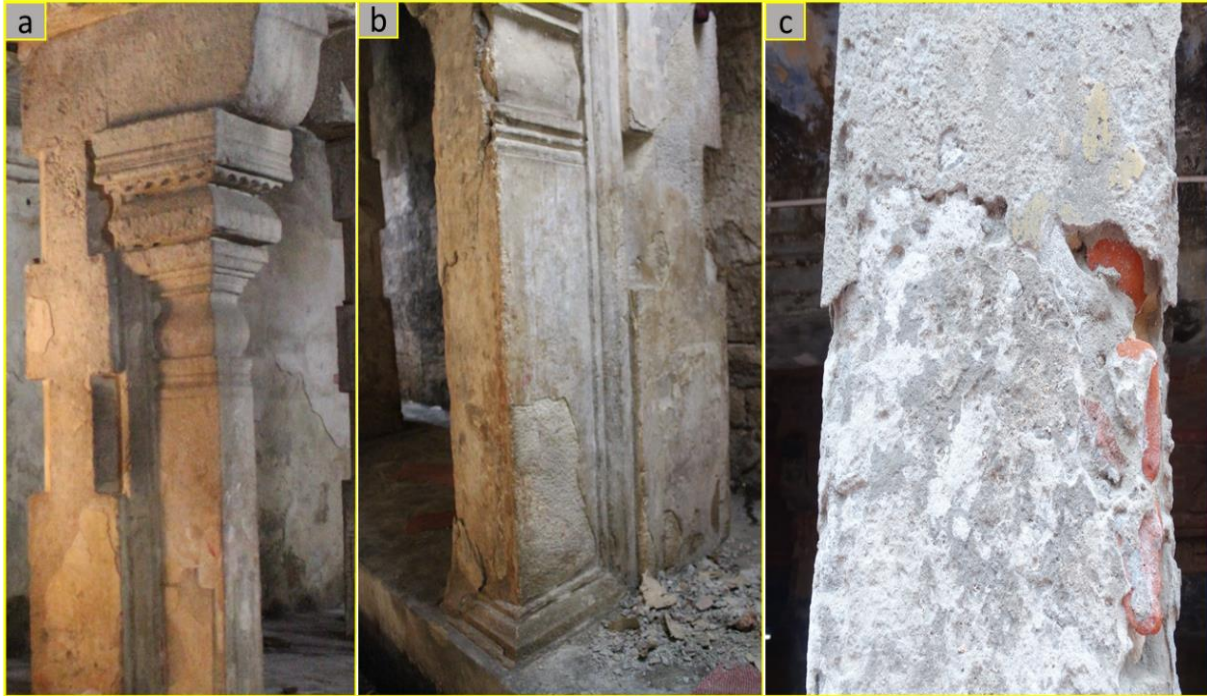
Figure 5.2. Coral stone columns showing damages of different degree (a) no damage (b) minor (spalling of plaster) (c) major (usage of improper incompatible brickbats leading to deterioration)

prominent weathering traces or damages, but sometimes with very slight smoothing of edges and they were categorized under “no damage” group. Minor damages were the surface damages on the columns such as spalling of plaster, blackening and presence of algae due to dampness, staining and other damages seen exclusively in the plaster. Moderate damages were those not responsible for any structural failure, which include loss of profile as a result of ridge formation, rounding off, material loss and alveolation (deeply pitted honey-combed structure due to closely spaced cavity formation). Major damages were those structural damages that disturb the loading pattern of the structure such as heavy loss in profile due to erosion and improper conservation by the introduction of new and incompatible materials like brickbats in cement mortar in the structure during renovations. Extreme damages were those structural damages that were more severe than the major damage problems, which can adversely affect the structural stability of the building. Figure 5.2 shows examples of coral stone columns with no damage, minor damage and major damages in the structure. Figure 5.3 shows some cases of extreme damages seen in different coral columns.

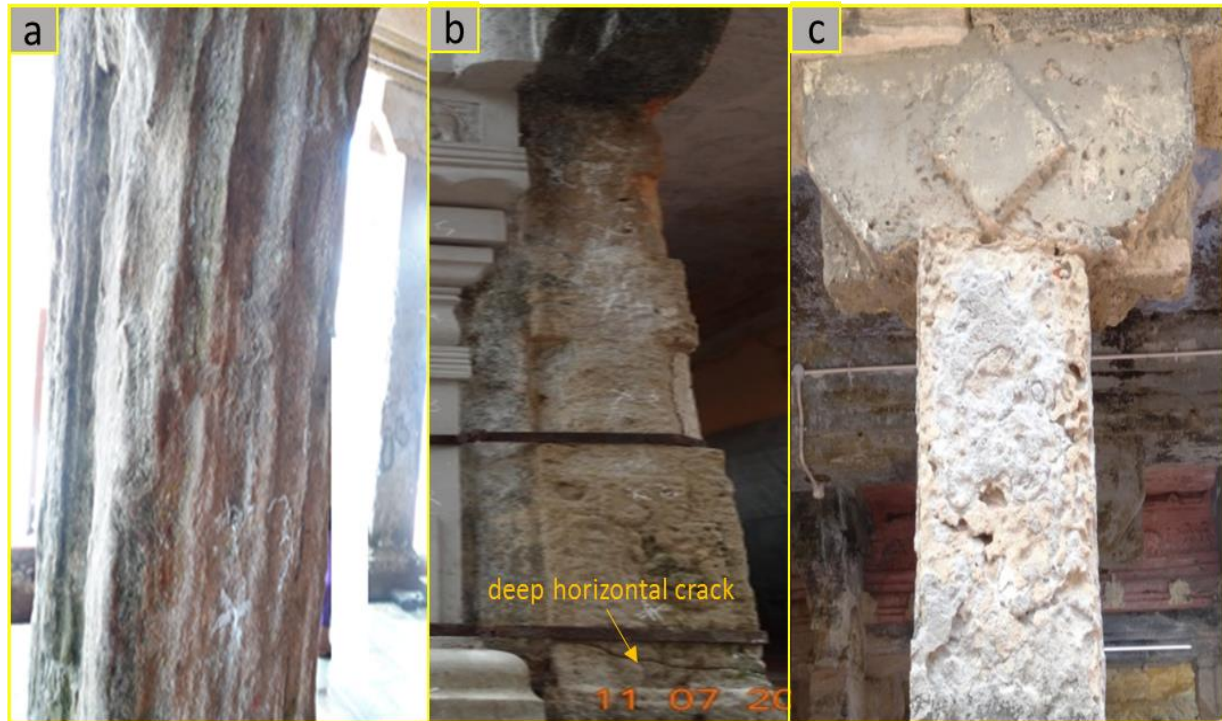
Figure 5.3. Examples of extreme damages in the columns (a) heavy ridging (b) deep cracking (c) fissures and loss of section

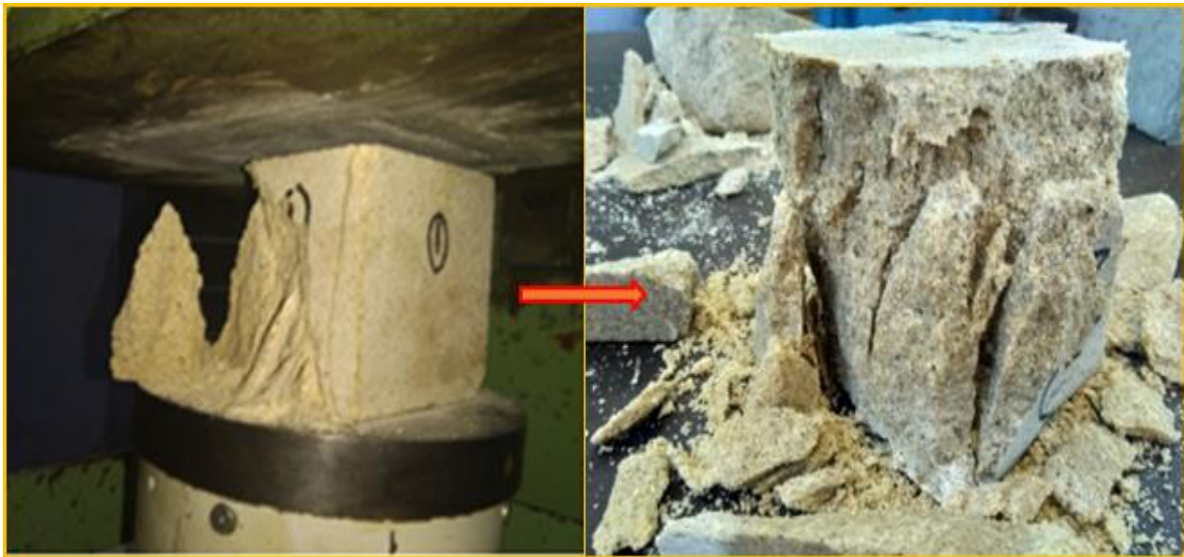
Figure 5.4. Failure of a coral stone cube under compression

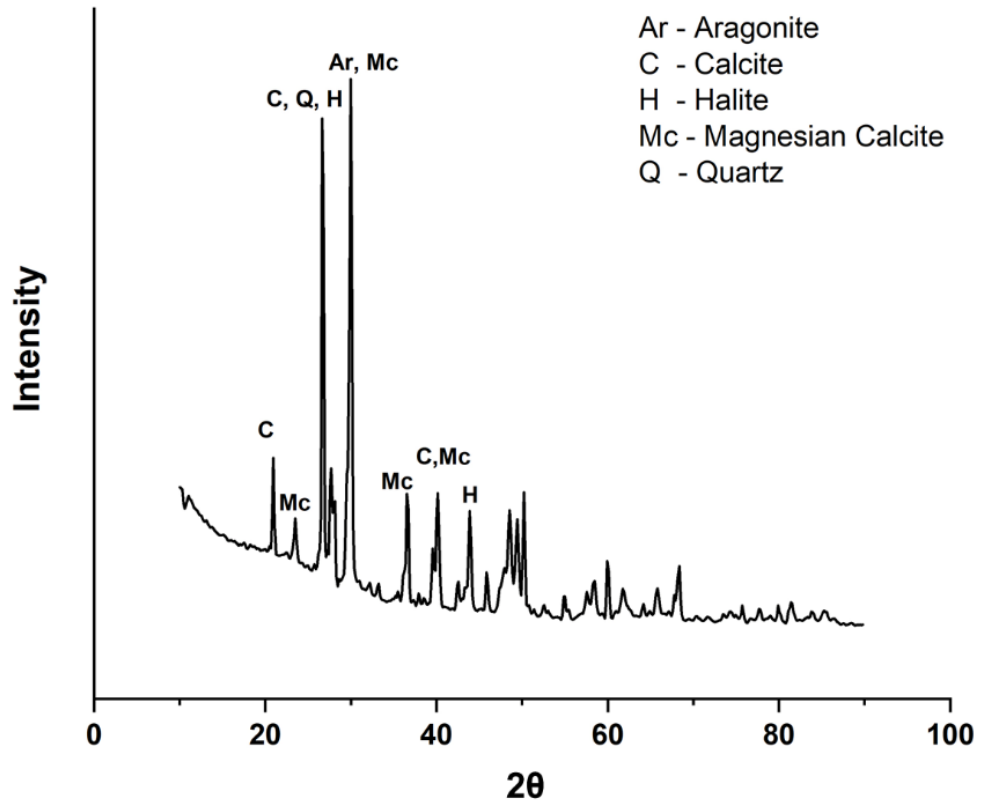
Figure 5.6. X-ray diffractogram of coral stone showing the major peaks

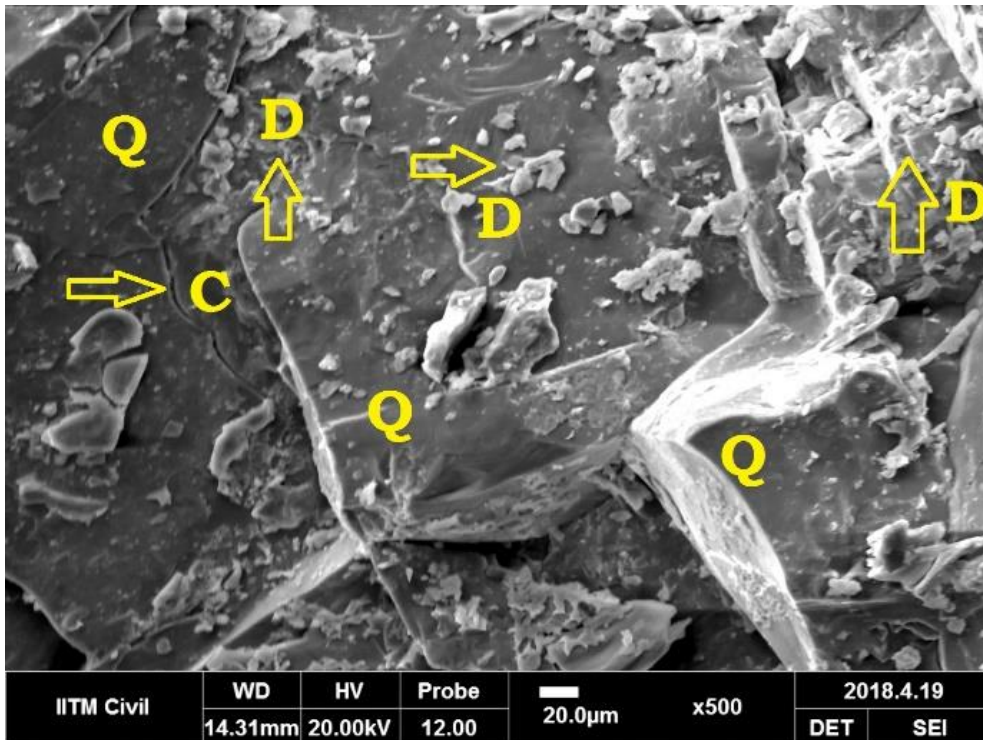
Figure 5.7. SE image of weathered granite

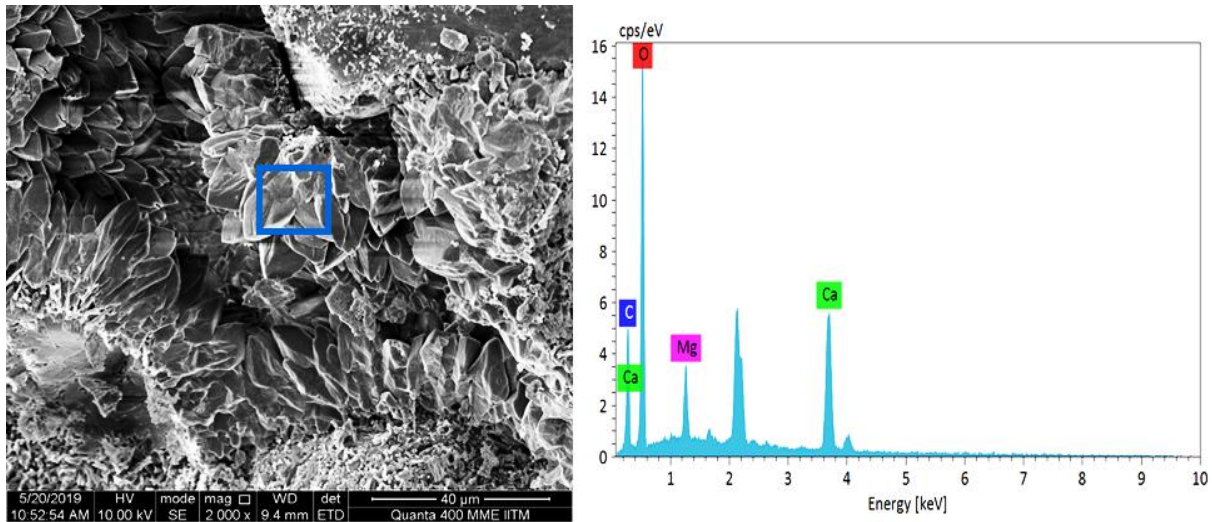
Figure 5.11. Petal-like lining of magnesian calcite around the quartz grains

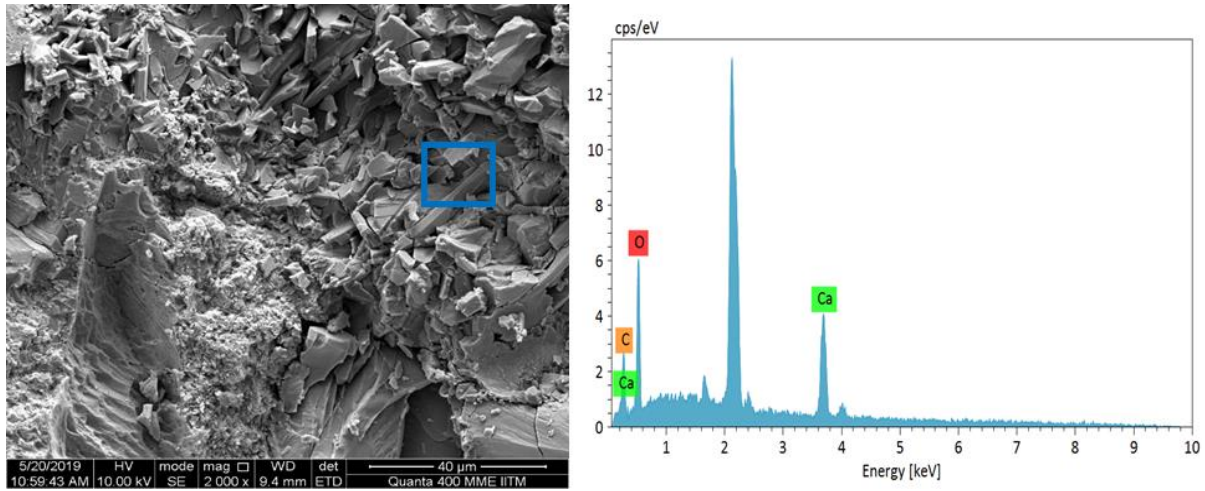
Figure 5.12. Distribution of prismatic crystals of calcite in the coral stone microstructure

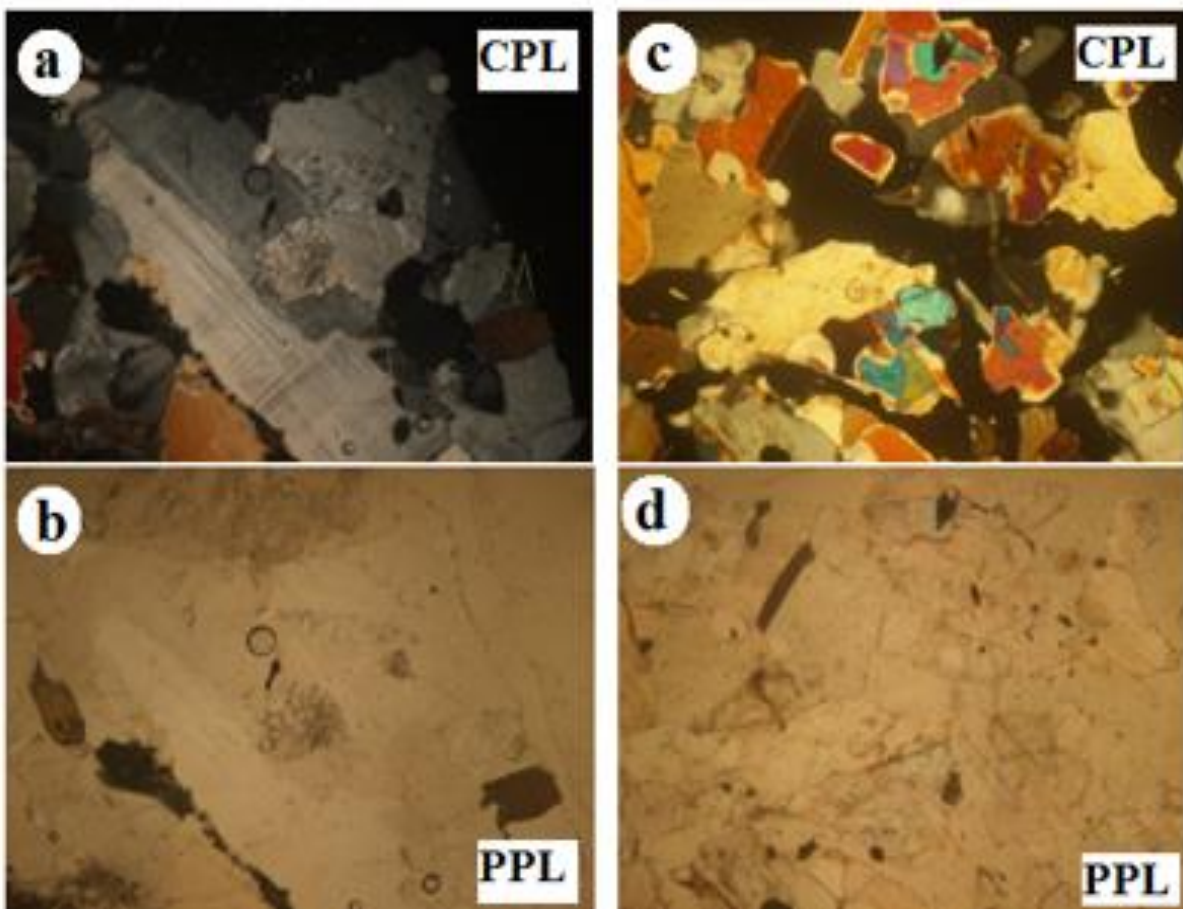
Figure 5.14. Petrographic images: (a&b) Unweathered granite (c & d) Weathered granite

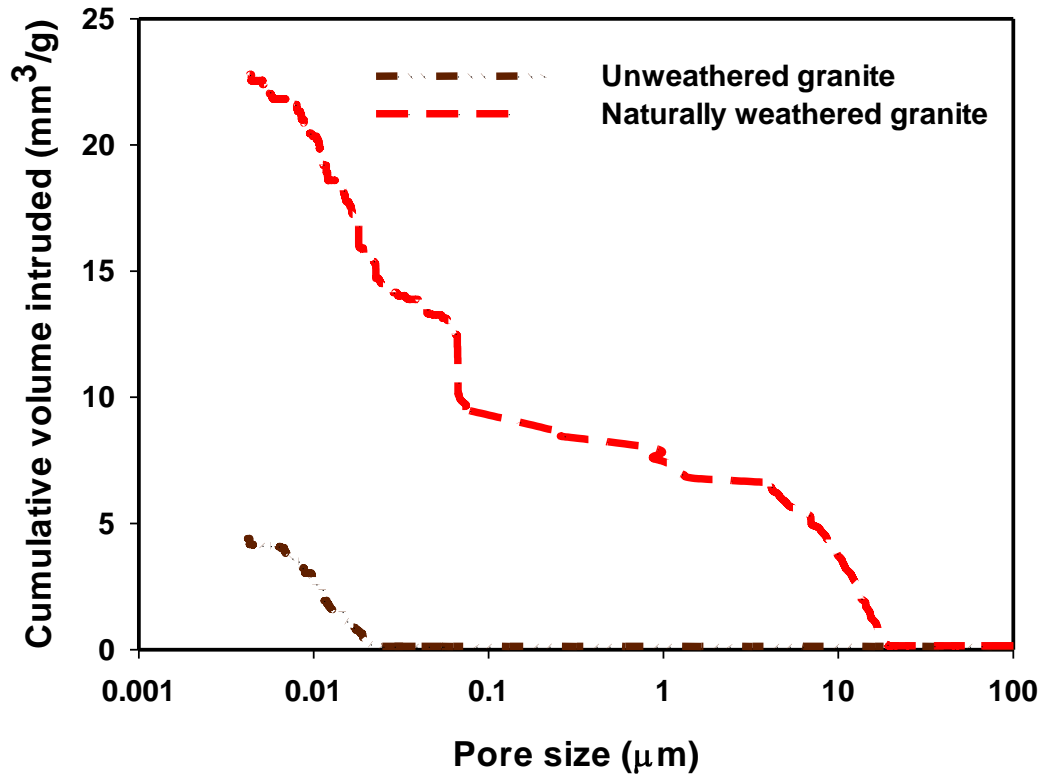
Figure 5.16. Cumulative intrusion curves for granite samples

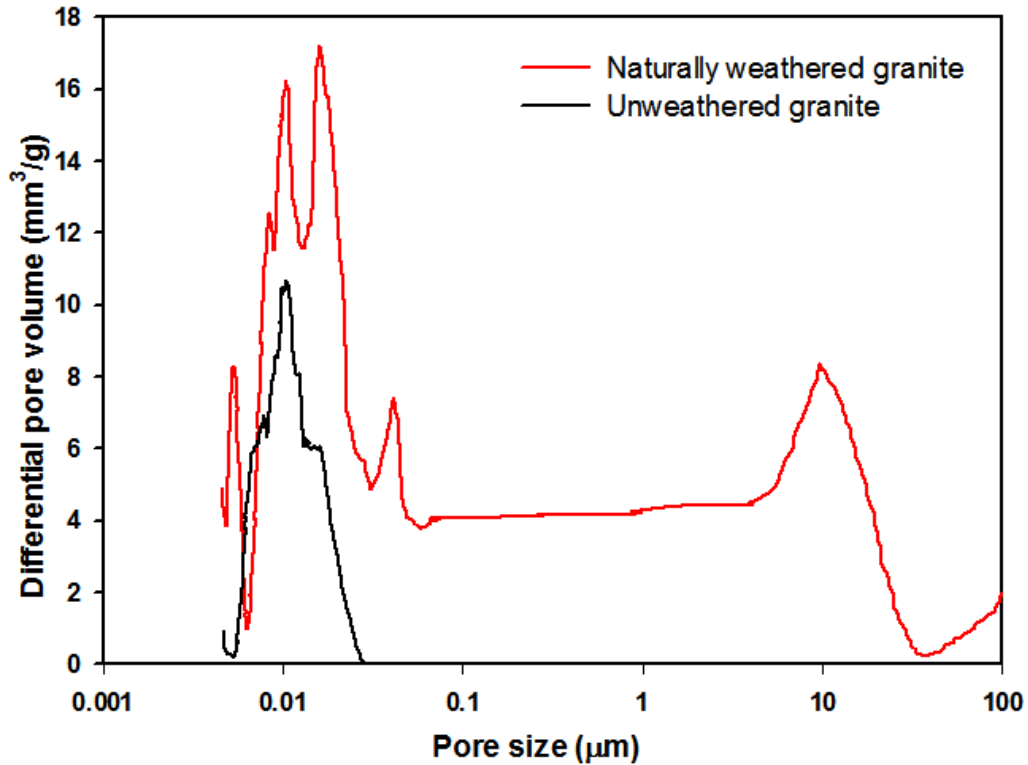
Figure 5.17. Differential intrusion curves for granite samples

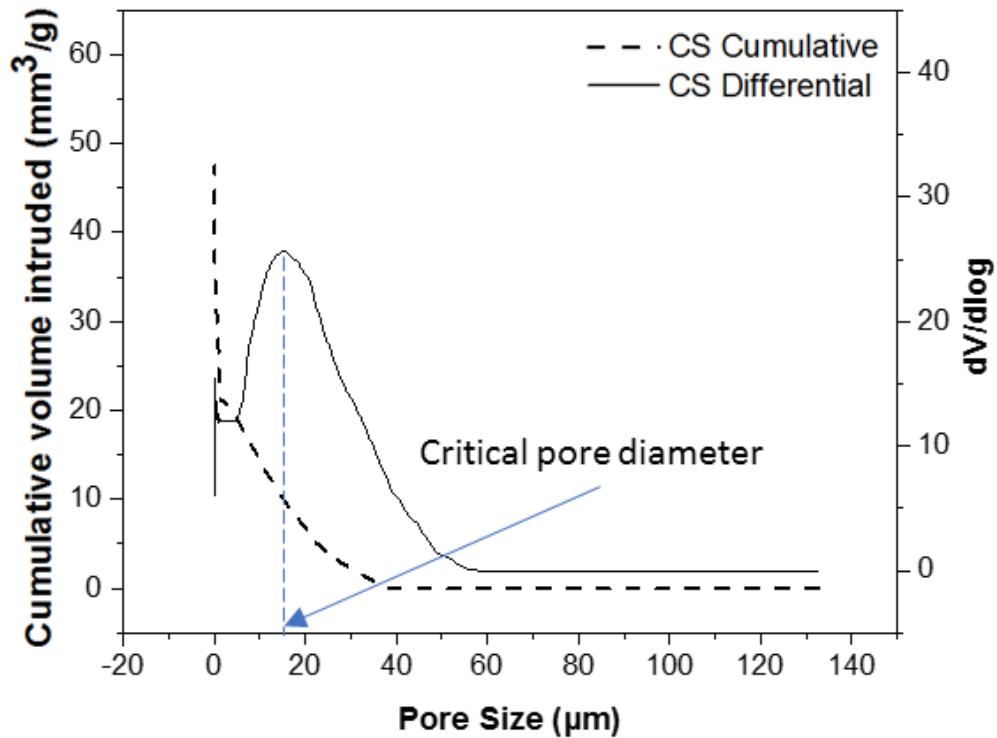
Figure 5.18. Cumulative and differential intrusion curves for a typical coral stone sample

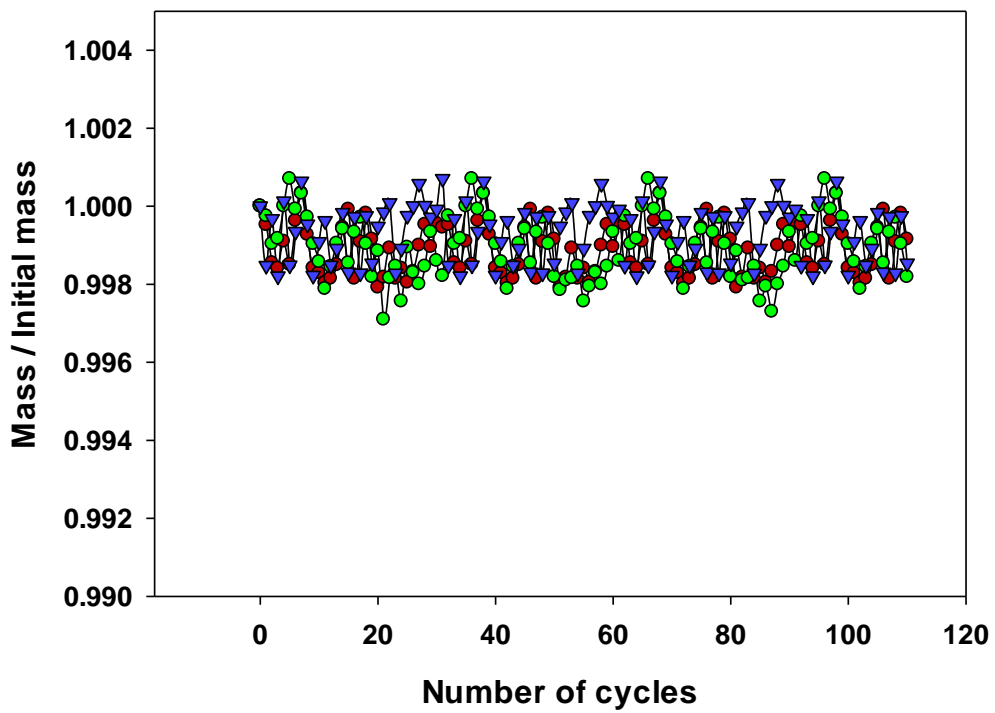
Figure 5.21. Mass change for granite samples under sodium chloride salt weathering cycles

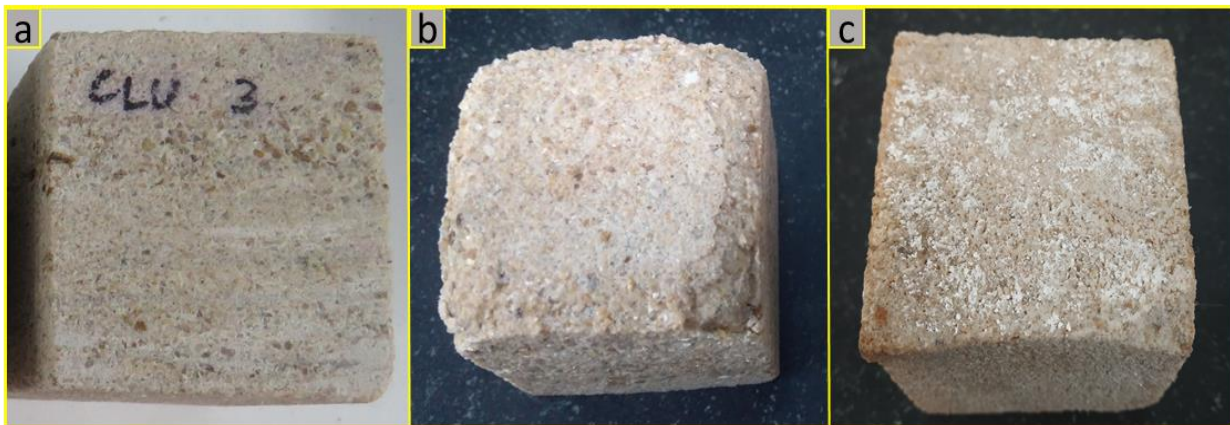
Figure 5.22. Coral stone specimens a) before subjecting to artificial weathering cycles b) after subjecting to Na_2SO_4 exposure c) after subjecting to NaCl exposure

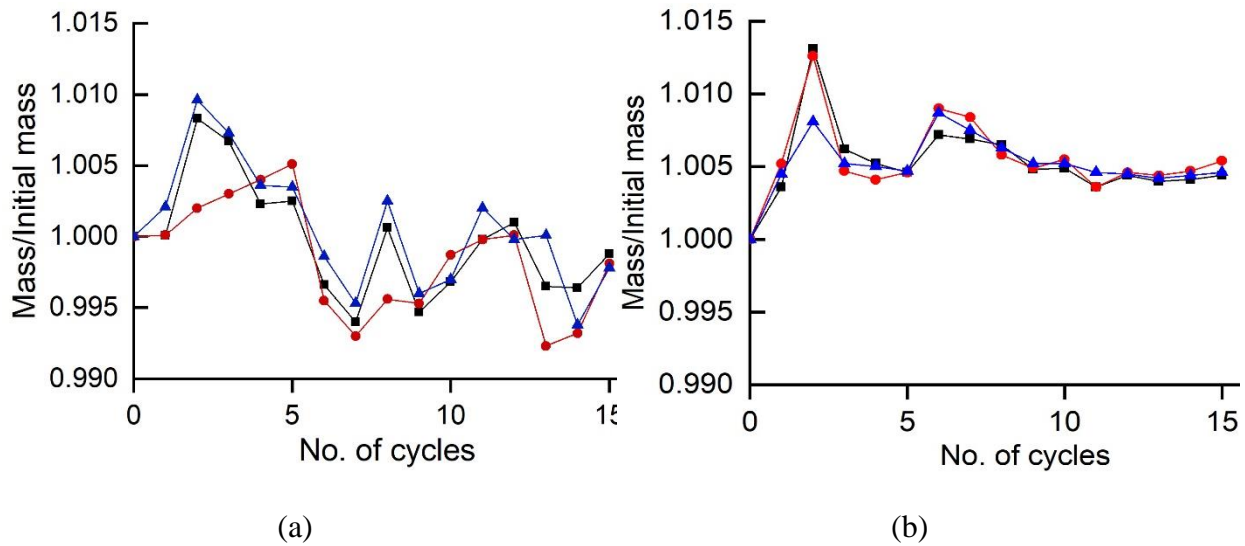
Figure 5.23. Mass change for the specimens (a) with Na₂SO₄ exposure (b) with NaCl exposure
