**A STUDY ON CHARACTERISATION, DETERIORATION
MECHANISMS AND PROTECTION OF BRICKS AND STONES IN
HISTORIC STRUCTURES**

A THESIS

**DEPARTMENT OF CIVIL ENGINEERING
INDIAN INSTITUTE OF TECHNOLOGY MADRAS
CHENNAI, INDIA**

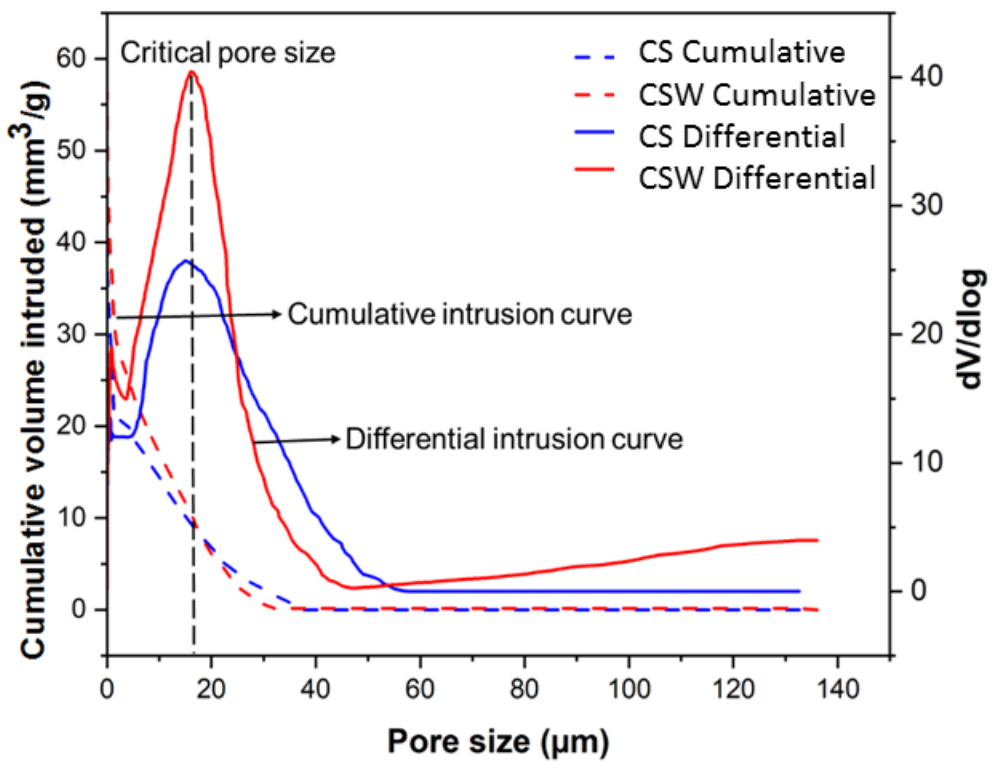
Figure 5.24. Curves from MIP data for natural undamaged coral stone and accelerated weathered coral stone

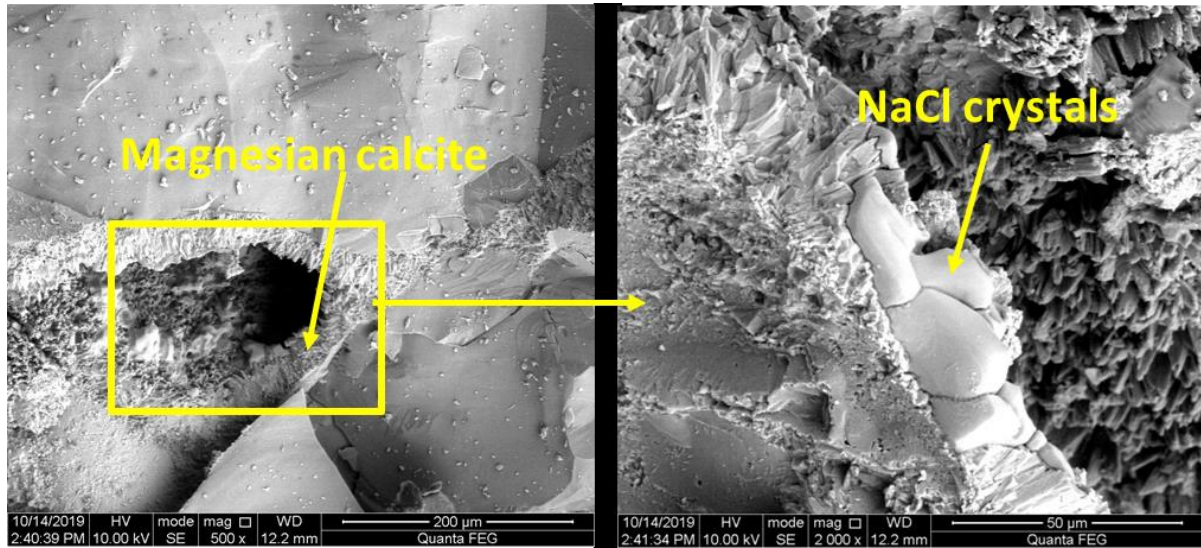
Figure 5.25. SEM image depicting preferential deposition of NaCl crystals over magnesian calcite

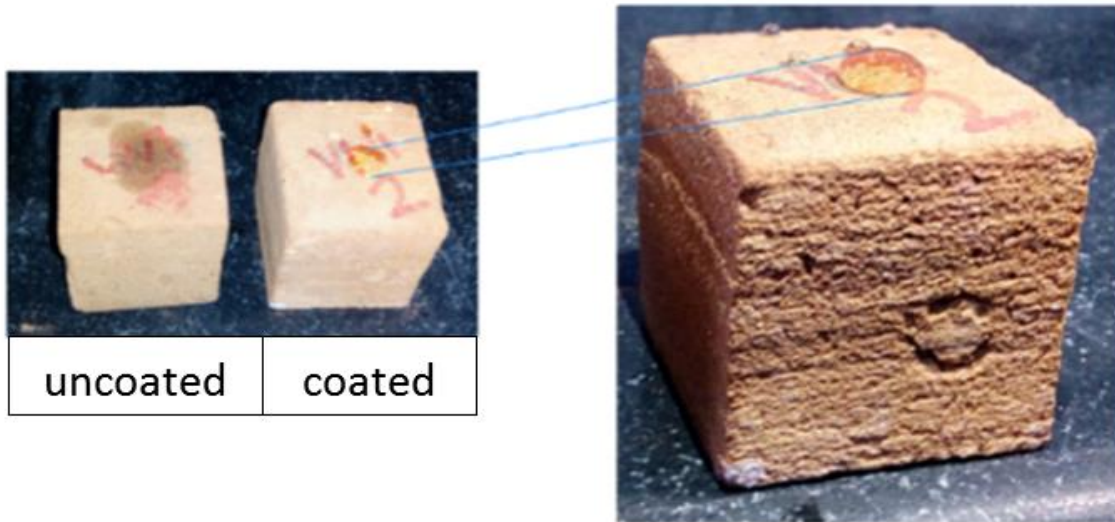
Figure 6.1. Illustration of water drop absorption test

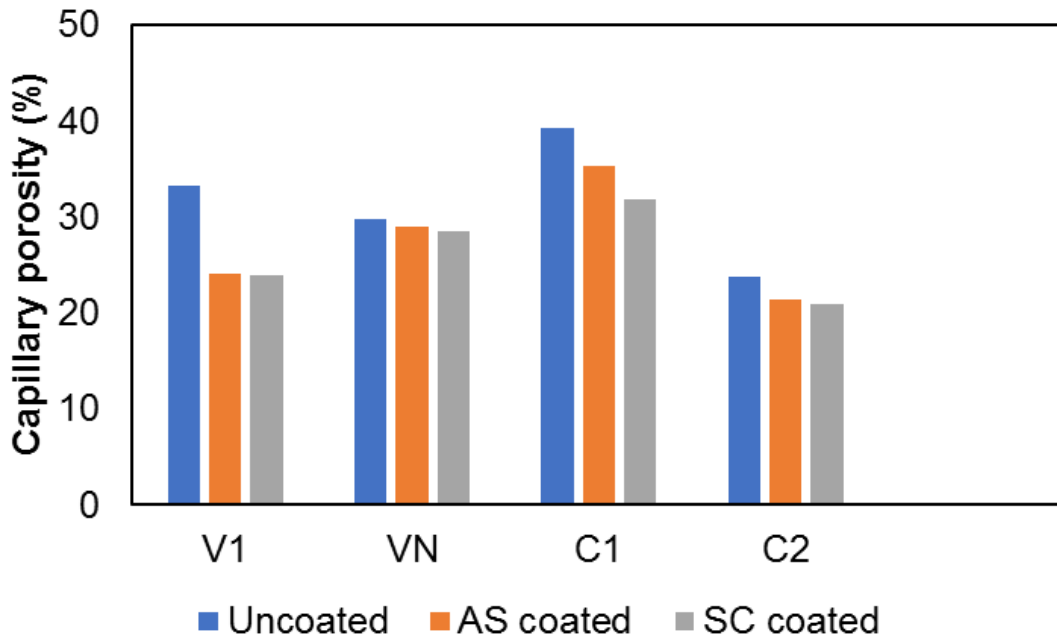
Figure 6.2. Variation of capillary porosity for specimens with different coatings

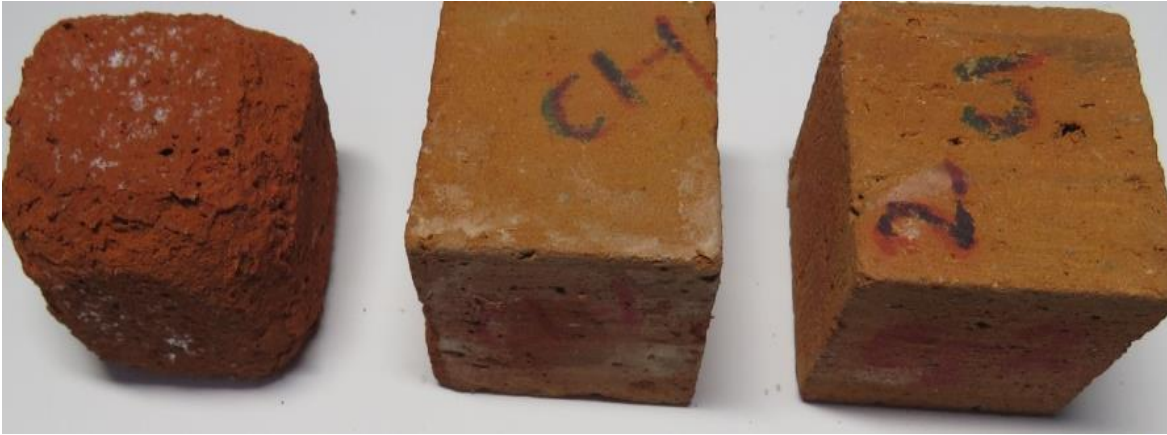
Figure 6.9. Damage state of specimens C1, C1-SC and C1-AS respectively after 20 weathering cycles

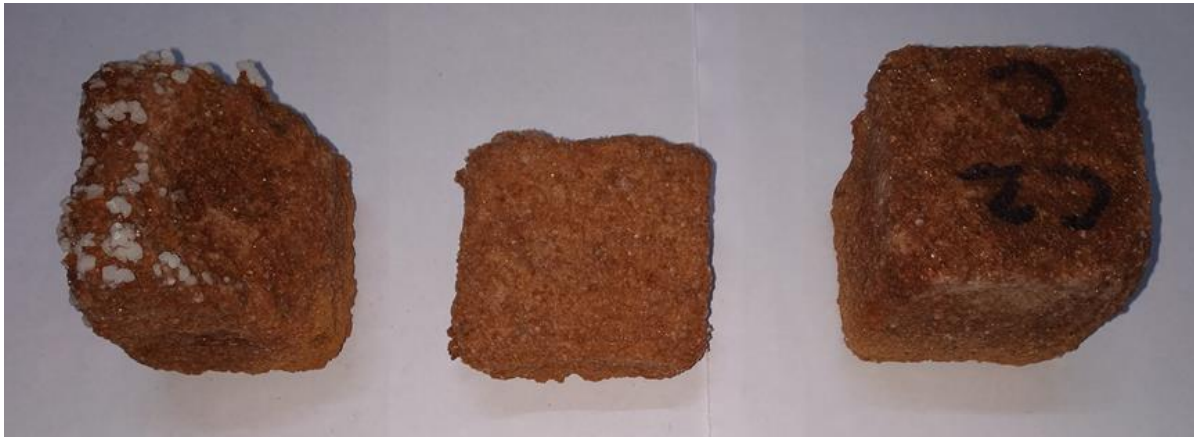
Figure 6.10. Damage state of specimens C2, C2-SC and C2-AS respectively after 20 weathering cycles

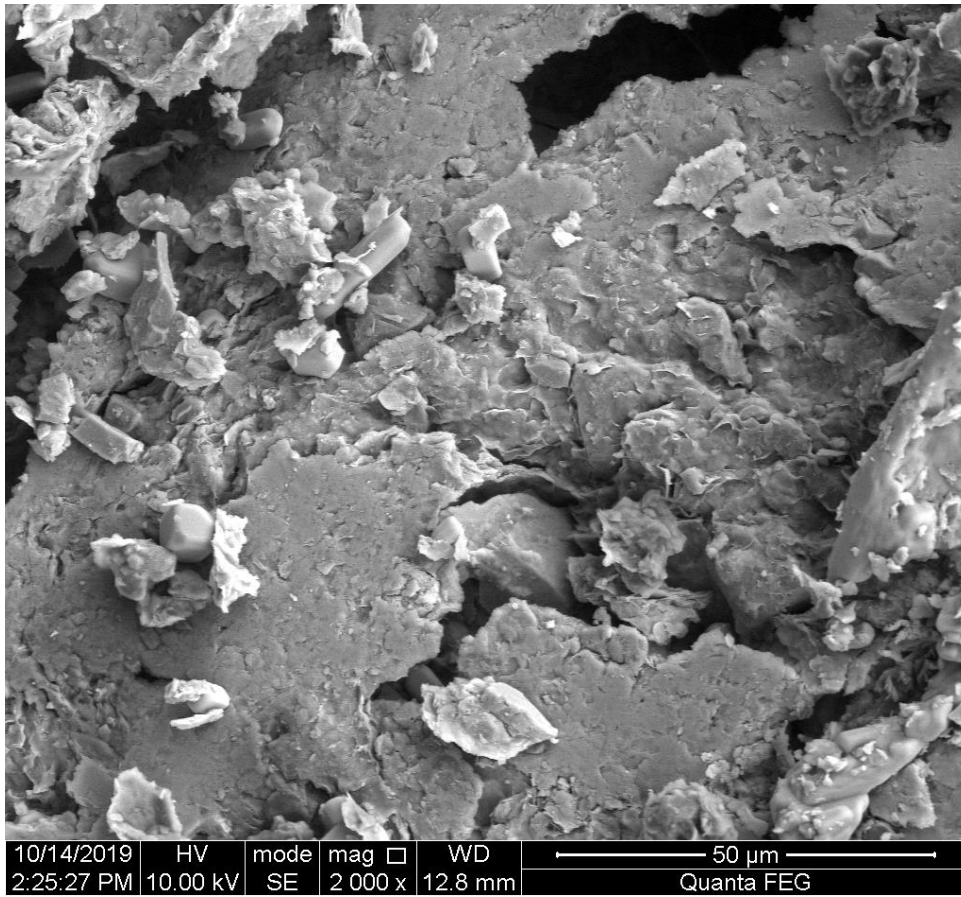
Figure 6.12. Surface of C2-AS specimen showing cracking of the acrylic-siloxane based coating

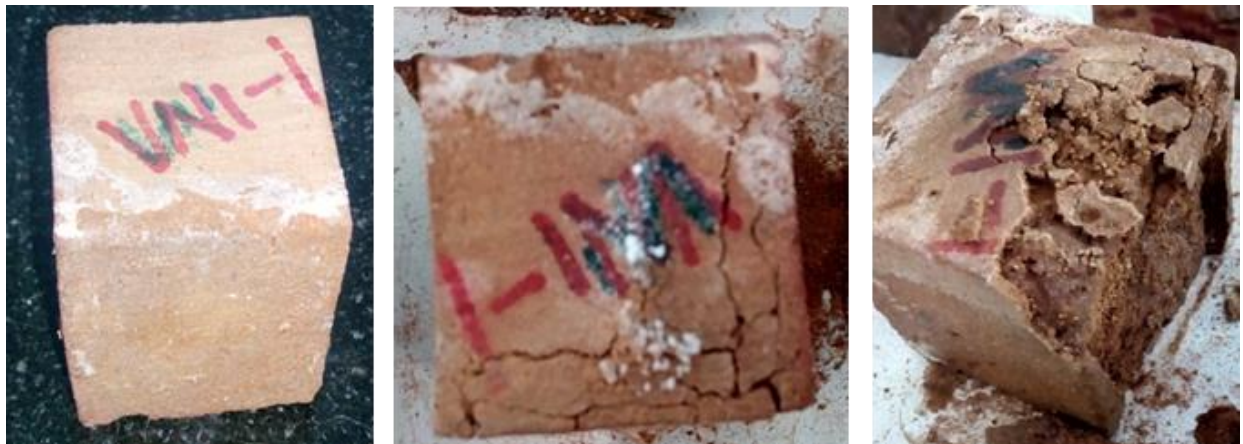
Figure 6.13. Sudden rupture of VN- specimen after 7th, 8th and 9th cycle respectively

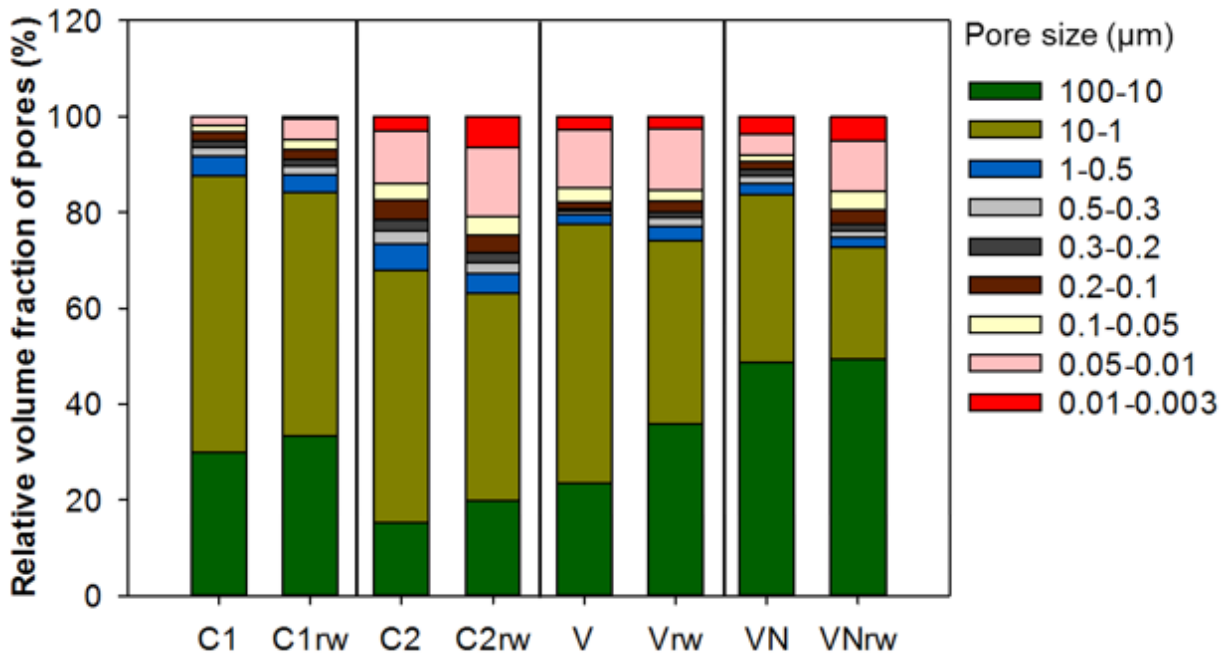
Figure 6.20. Relative volume fraction of pores of various size ranges for unweathered and weathered samples

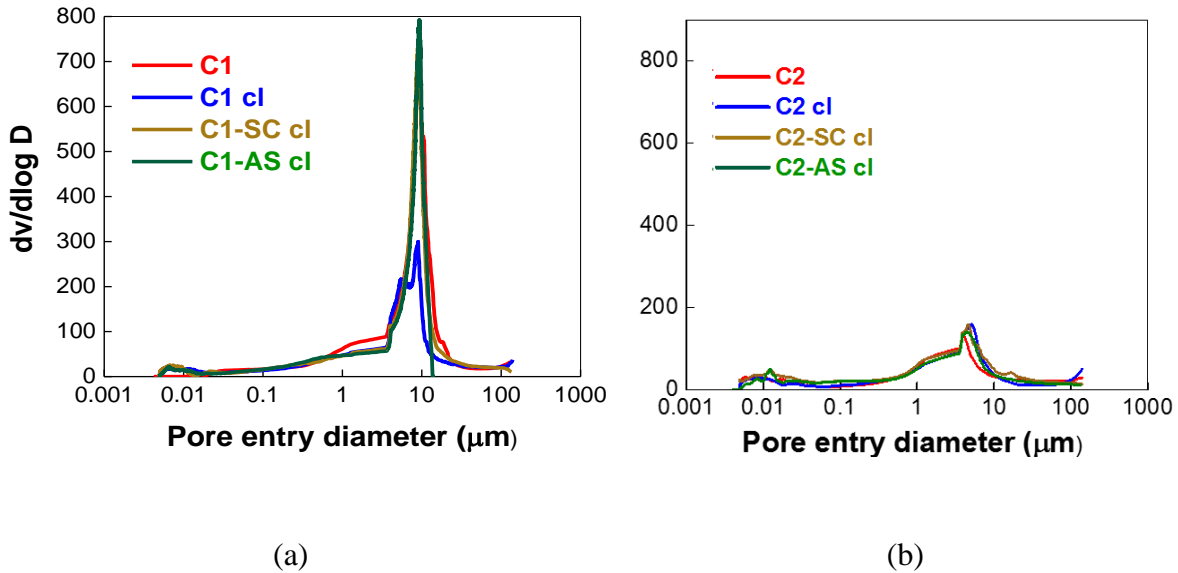
Figure 6.21. Comparison of differential intrusion curves for unweathered and weathered specimens with coatings with NaCl (a) for C1, (b) for C2

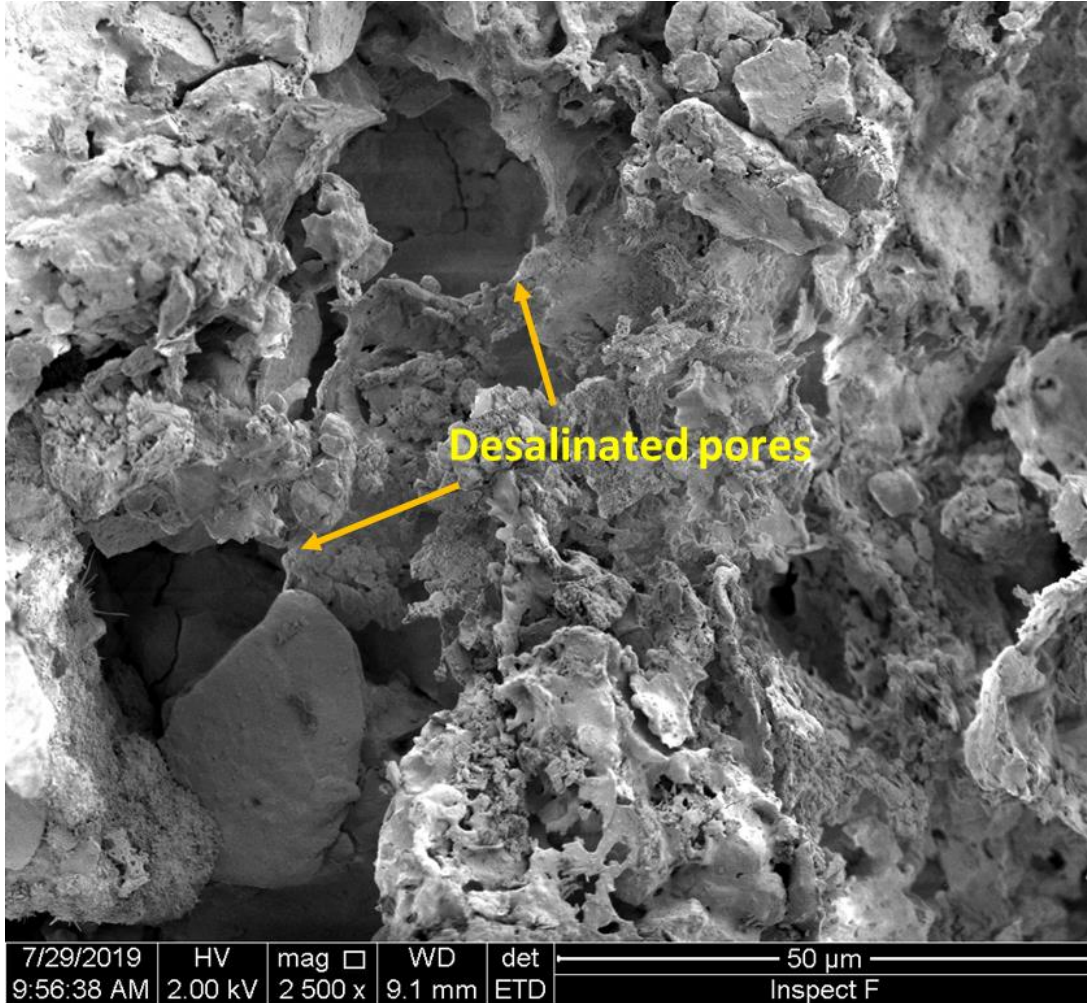
Figure 6.22. Interior of weathered (with Na_2SO_4) C2-SC sample after desalination

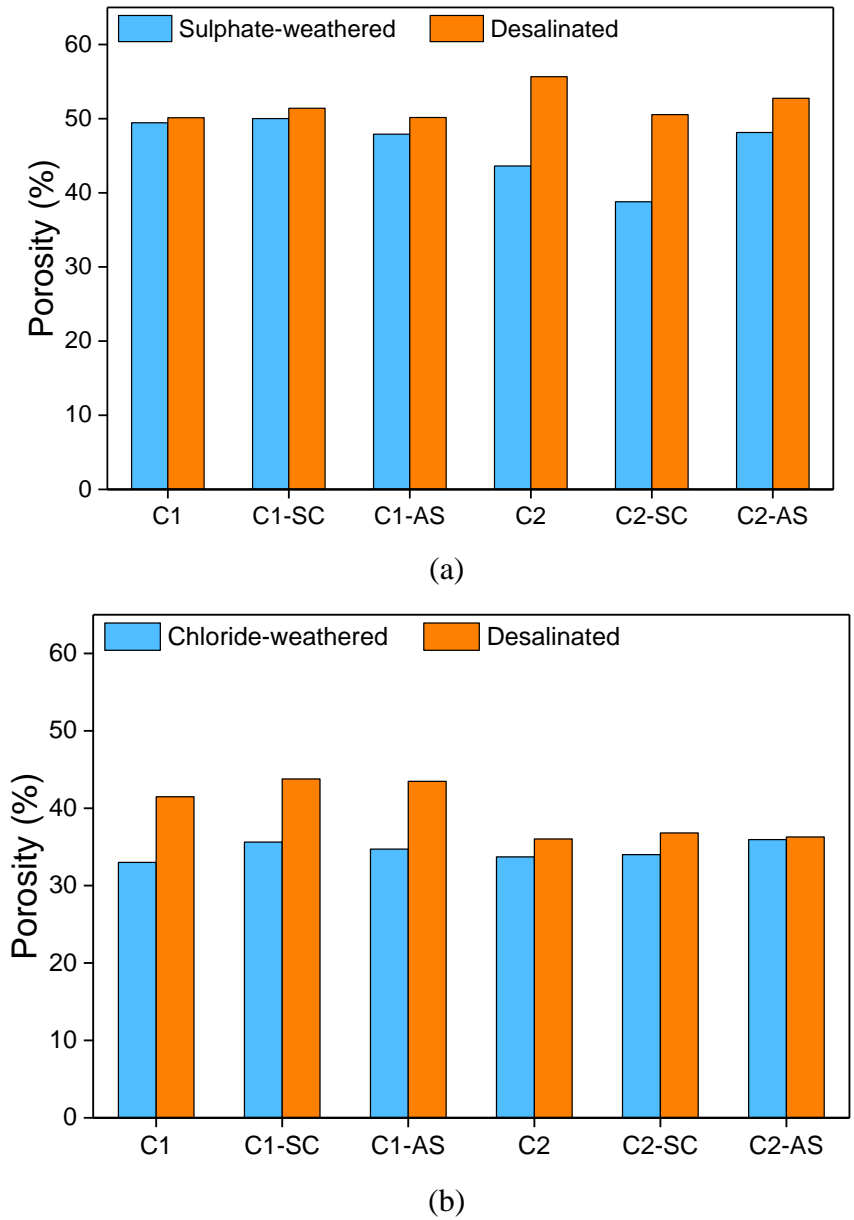
Figure 6.25. Comparison of total porosity values before and after desalination on (a) Samples weathered with sodium sulphate (b) Samples weathered with sodium chloride

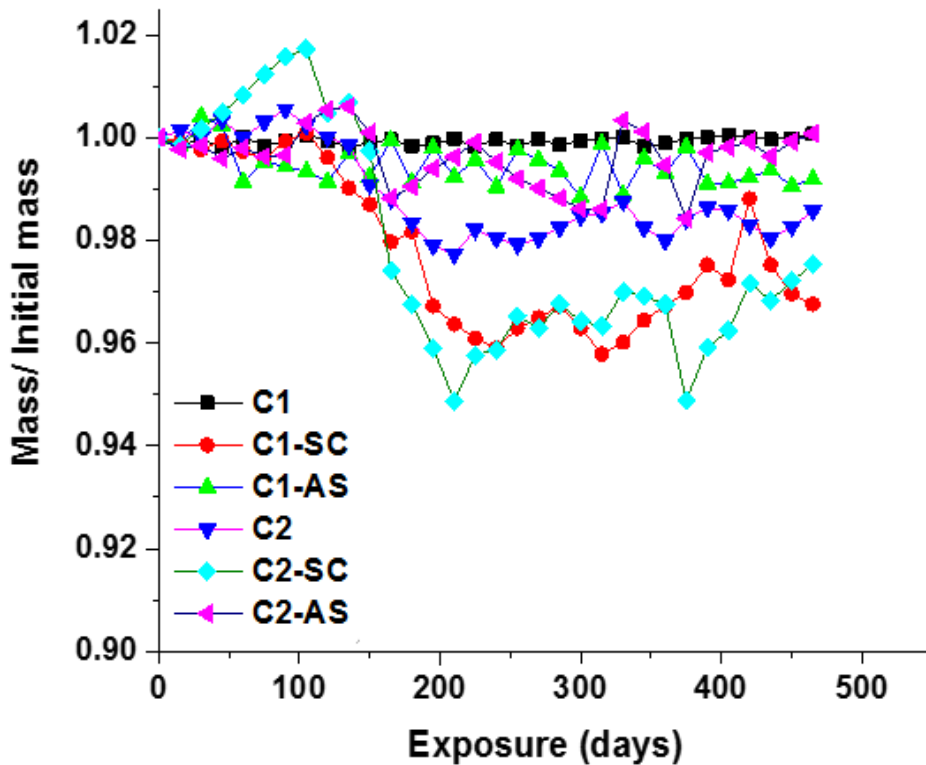
Figure 6.26. Mass changes with increasing exposure with NaCl spray

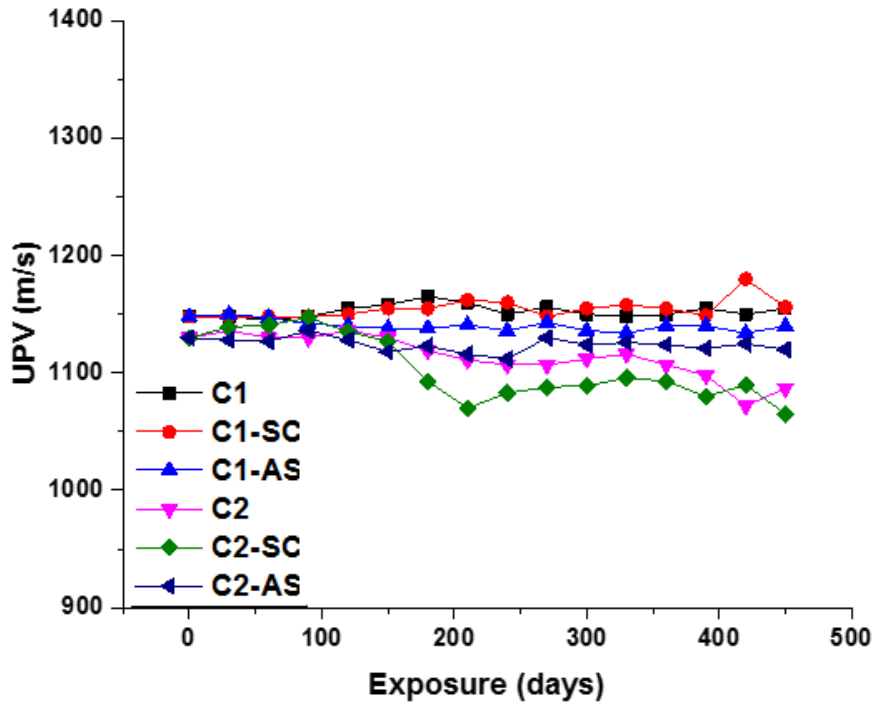
Figure 6.28. Ultrasonic pulse velocity values for the specimens during NaCl spray test

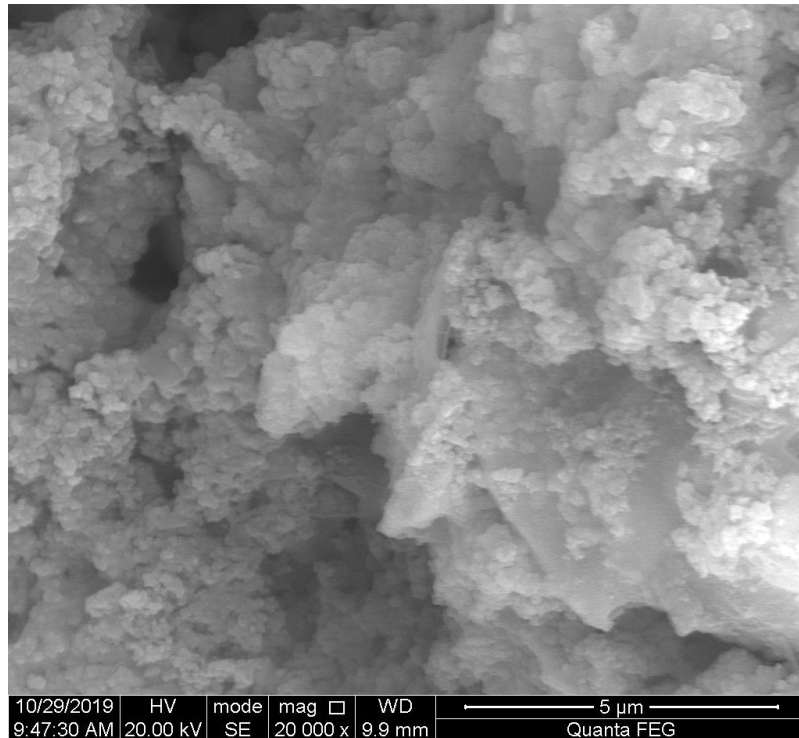
Figure 6.31. NaCl efflorescence in the exterior surface of a specimen subjected to salt spray test

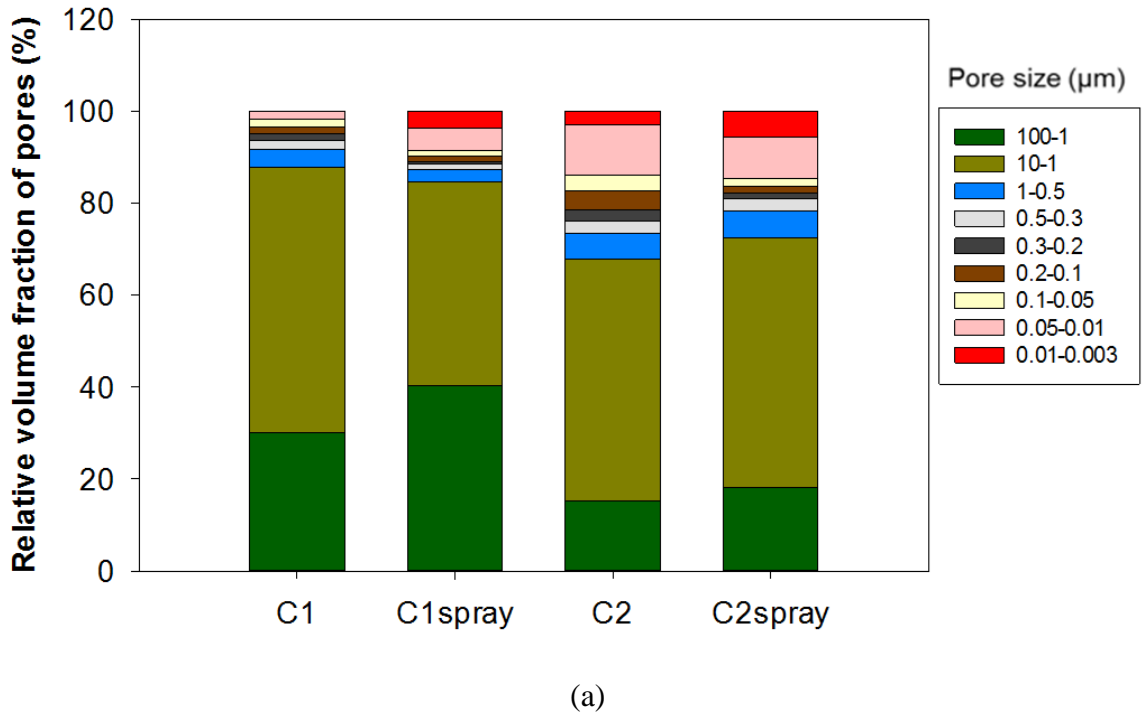
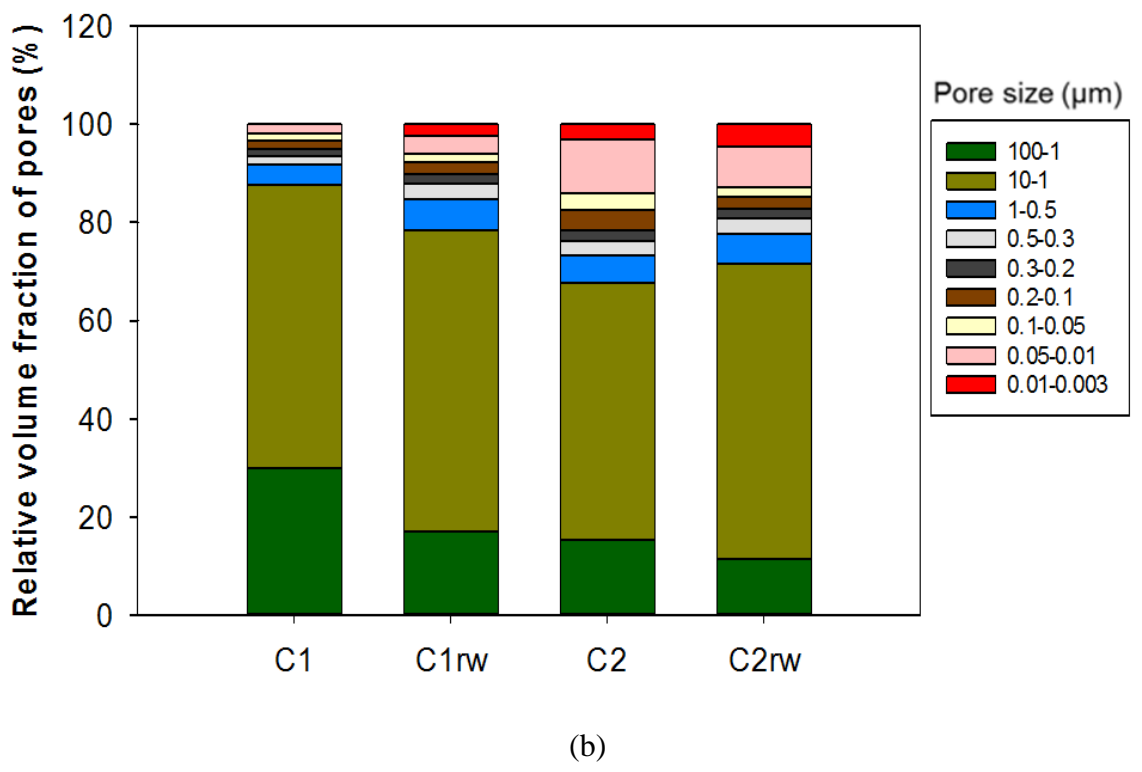
Figure 6.34. Relative volume fraction of pores in different size ranges

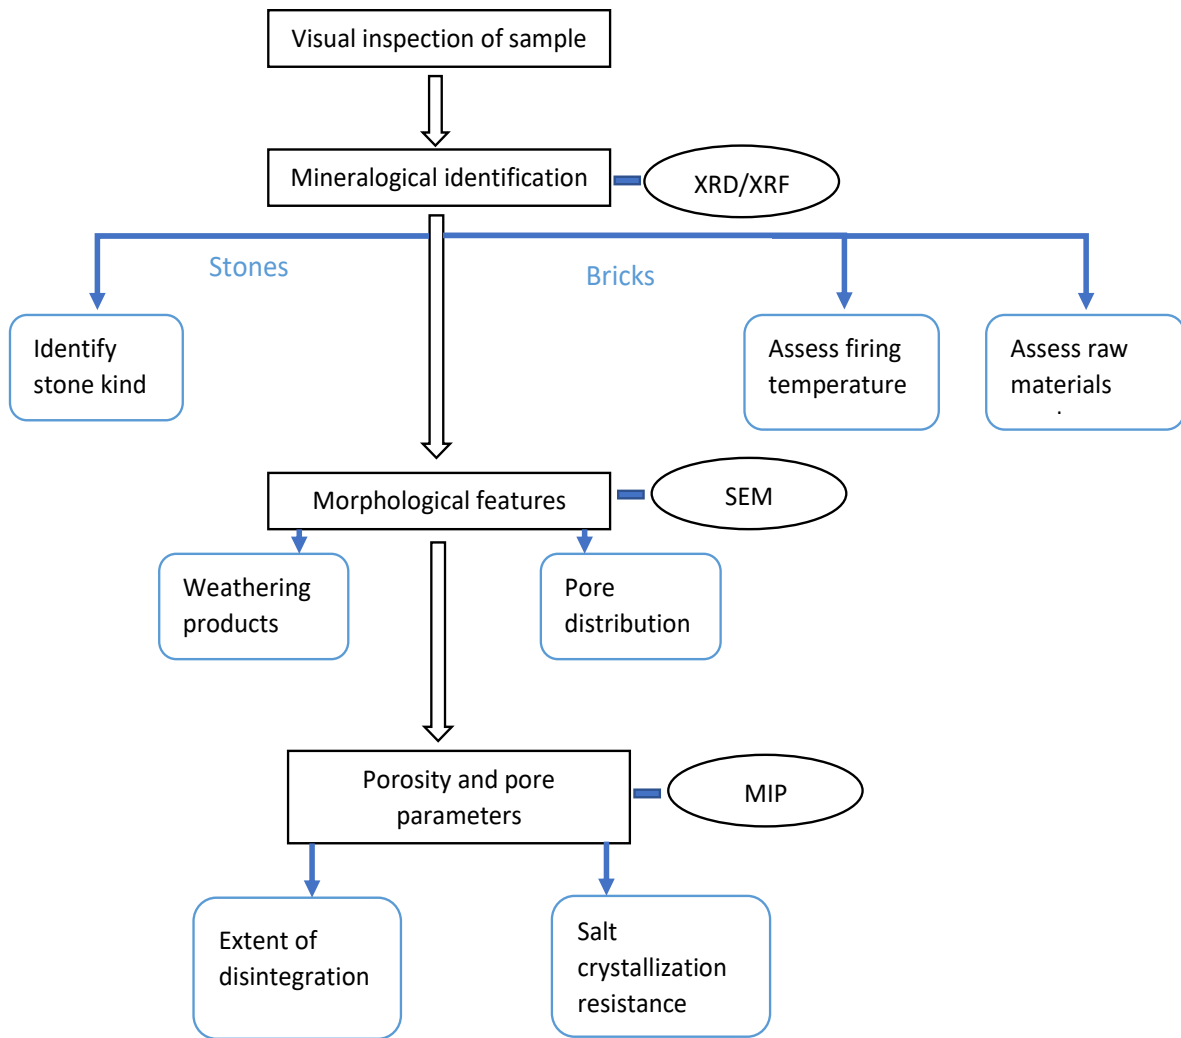
Figure 7.1. Framework for characterising historic masonry materials

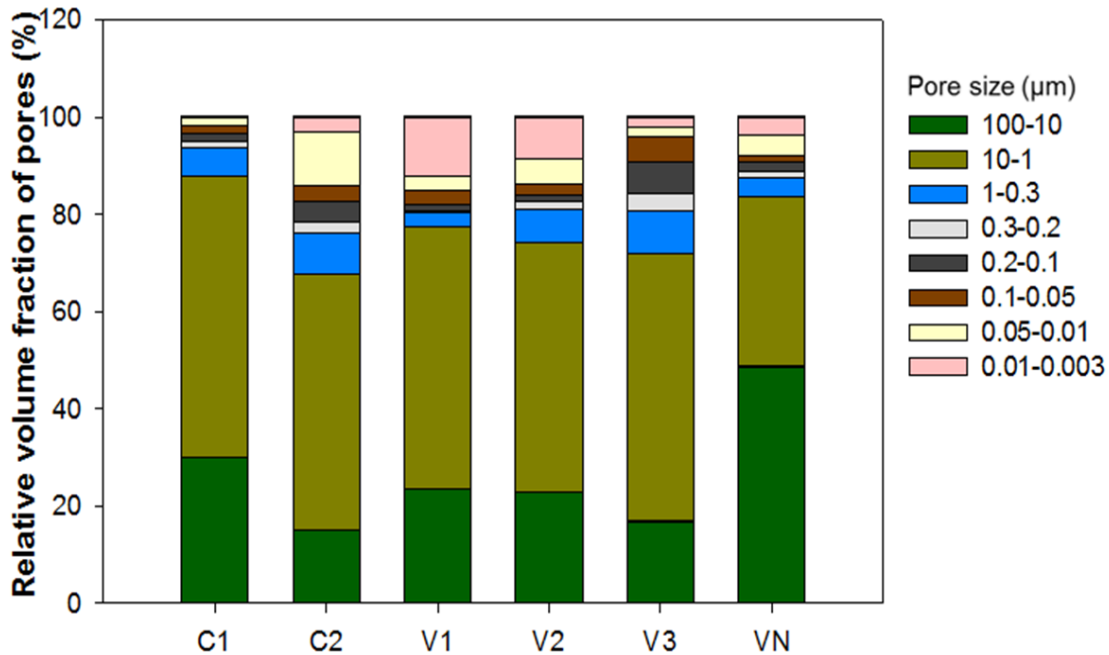
Figure 7.2. The relative volume fraction of pores of different sizes in various brick samples

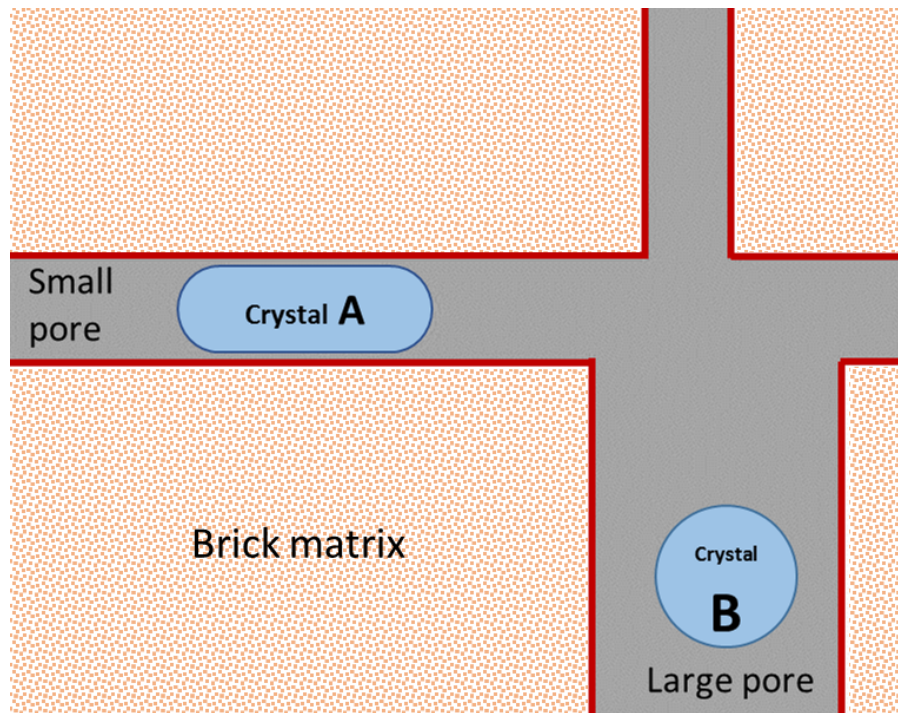
Figure 7.3. Representation of crystal formation in an interconnected pore-network
