**ELECTROCHEMICAL, BOND, AND SERVICE LIFE PARAMETERS OF
COATED STEEL - CEMENTITIOUS SYSTEMS EXPOSED TO CHLORIDES**

A THESIS

**DEPARTMENT OF CIVIL ENGINEERING
INDIAN INSTITUTE OF TECHNOLOGY MADRAS
CHENNAI 600 036, INDIA**

June 2020

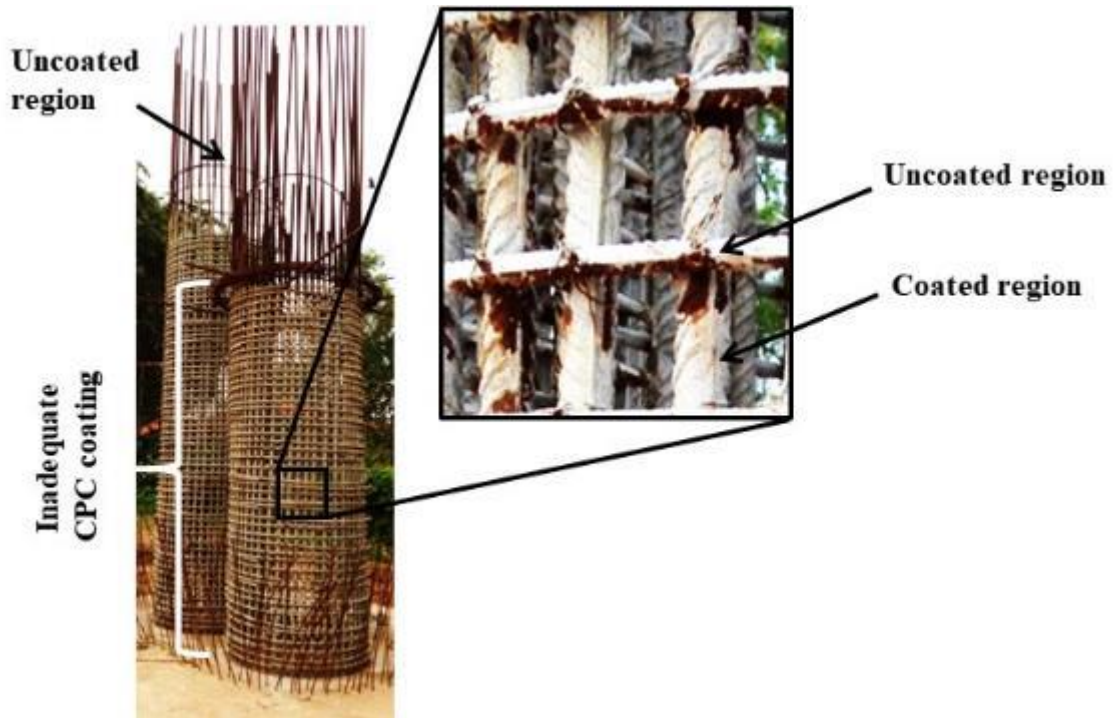
Figure 1.2 Photograph of a column under construction with CPC coated rebars and close-up showing inadequate CPC coating on rebar

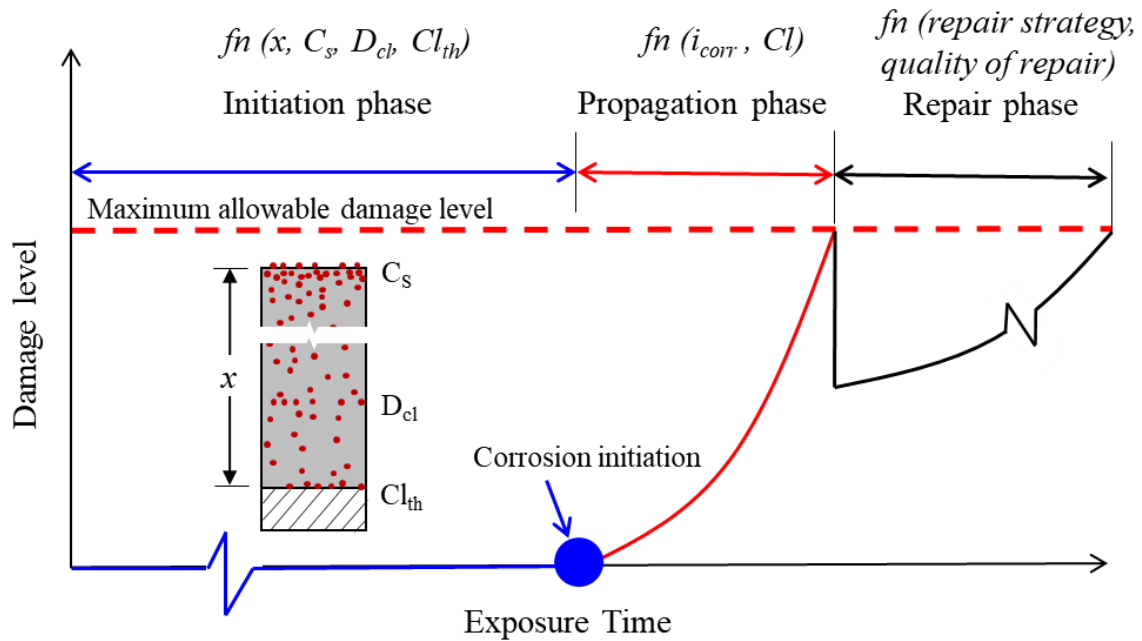
Figure 1.3 Service life model for RC systems with uncoated steel rebars

Service life: The duration from the start of exposure of the RC system to the environment until the RC system meets the structural requirements specified by the user. Figure 1.3 shows the widely used service life model for RC structures with uncoated steel rebars. Generally, service life is the summation of time to corrosion initiation and time to corrosion propagation. In this study, time to corrosion initiation is considered to be the end of the service lives of RC systems.

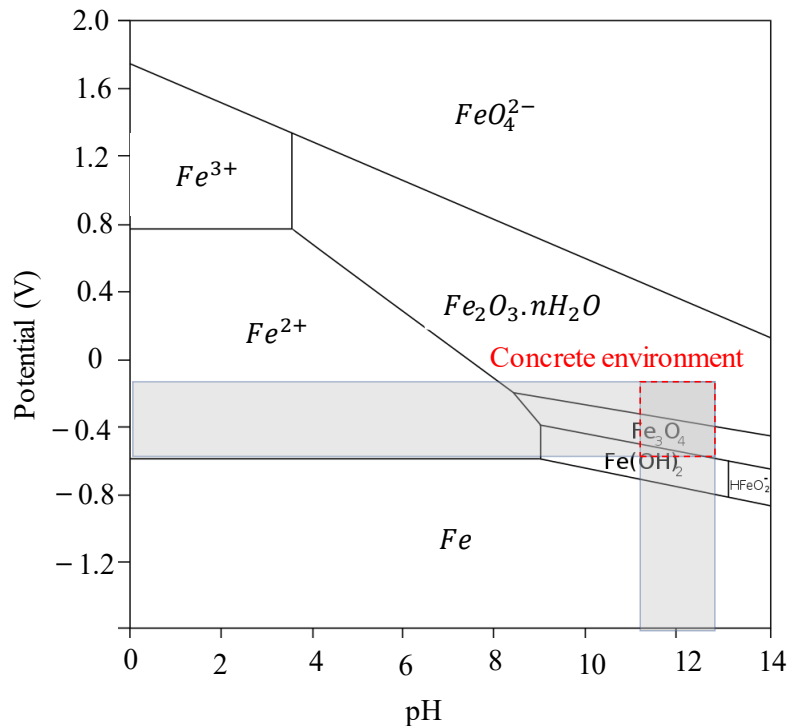
Figure 2.2 Pourbaix diagram of steel

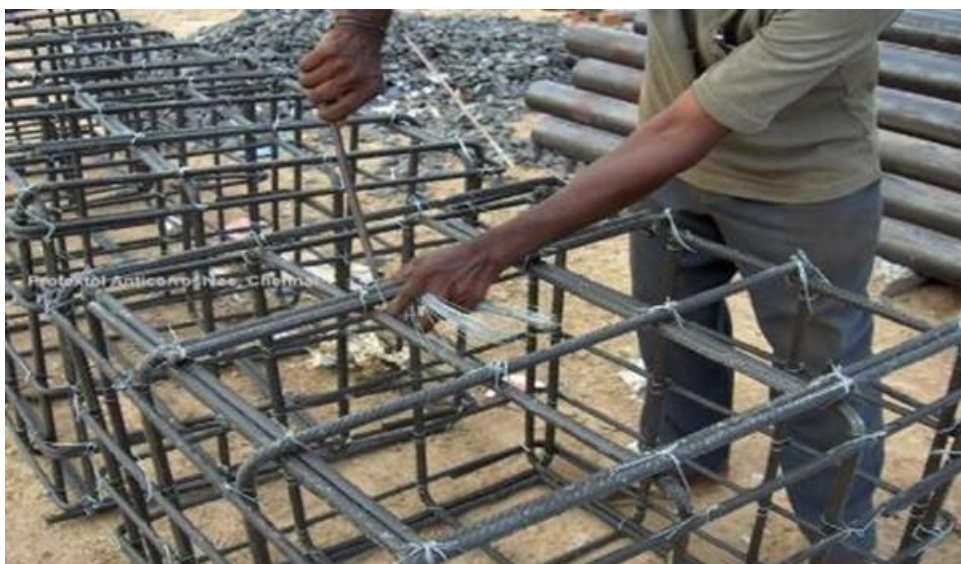
Figure 2.15 CPC Coated steel being tied by metallic uncoated tie wires (Central Electrochemical Research Institute Karaikudi 1993)

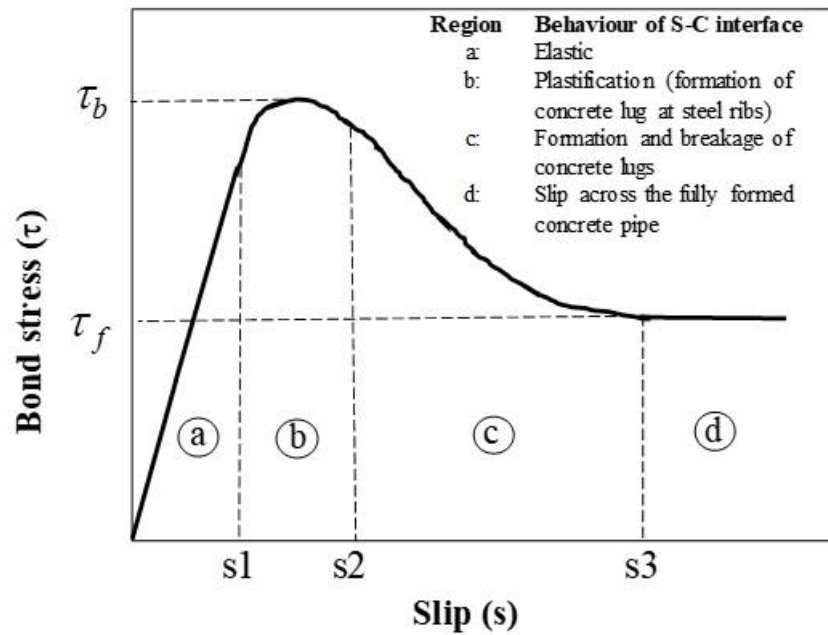
Figure 2.18 Typical bond stress-slip model for uncoated deformed steel rebar embedded in concrete (adapted from FIB Model Code 2010)

C interface after the effect of mechanical interlock vanishes, and only frictional force is responsible for the residual bond strength (τ_f) (Tastani and Pantazopoulou 2013).

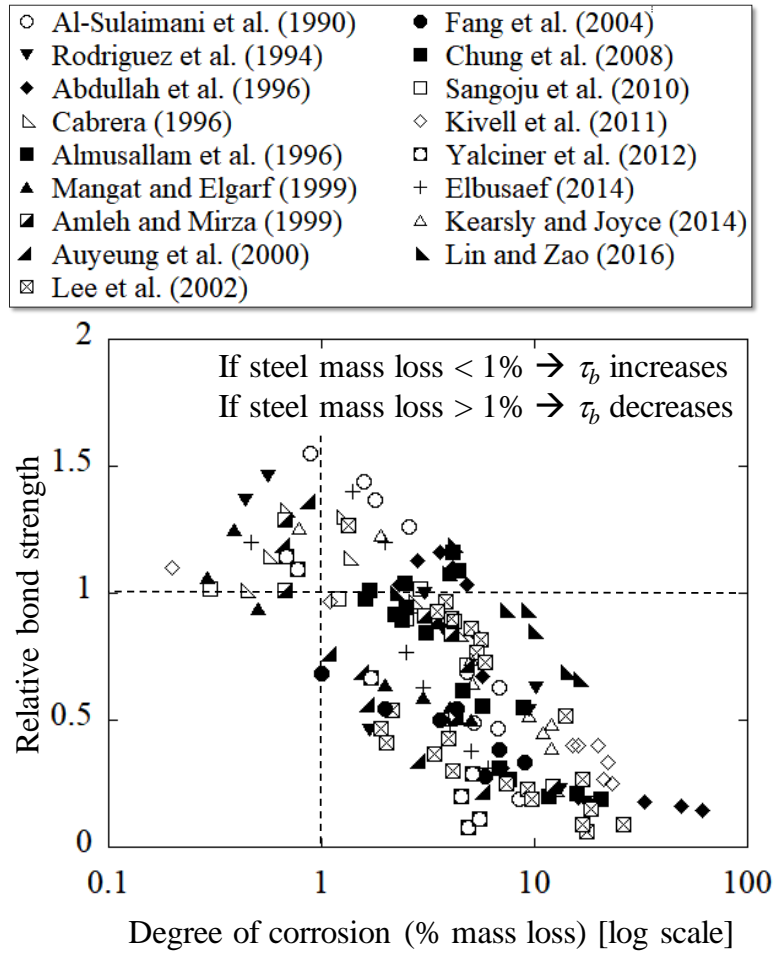
Figure 2.19 Effect of corrosion on bond strength of uncoated steel deformed rebars embedded in concrete (from literature)

Figure 2.19 shows that many literatures report that up to about 1% of steel mass loss can increase the bond strength due to the increase in frictional force and mechanical bonding due to reactionary confinement (Almusallam et al. 1996; Amleh and Mirza 1999; Auyeung et al. 2000; Bhaskar et al. 2010; Cabrera 1996; Chung et al. 2008; Elbusaefi 2014; Fang et al. 2004; Kearsley and Joyce 2014; Kivell et al. 2011; Lee et al. 2002; Lin and Zhao 2016; Mangat and Elgarf 1999; Rodriguez et al. 1997; Yalciner et al. 2012). When the mass loss is more than 1%, the chemical adhesion between steel and concrete diminishes, and reduced frictional forces and mechanical interlocking are responsible for the bond between steel and concrete (Li et al. 2014). When the corrosion level is about 10%, the bond strength can reduce by about 10 to 25% (Huang 2014). On the other hand, it was reported that when corrosion was induced using voltage application, the bond between uncoated, CPC coated steel rebars, and concrete was not affected (Natarajan et al. 2005). Note that the voltage application can alter the steel-concrete interface and failed to represent the real conditions (Choi et al. 2014). Accumulation of alkali ions (mainly Na^+ and K^+) at the S-C interface during voltage application appears detrimental to the interface integrity – resulting in the alteration of S-C interface properties (Ihekweba et al. 1996). Another most widely used method of inducing corrosion to the steel rebar is to expose pull-out specimens to cyclic wet and dry regimes with chloride solution (Marcos-Meson et al. 2020; Shang et al. 2019). Generally, pull-out specimens have very large concrete cover to reinforcement. Therefore, this method is time-consuming. Another way to induce corrosion is by premixing of chlorides in concrete, followed by cyclic wetting and drying with chloride/moiture solution. Premixing of chloride represent RC structure after exposure to the marine environment, where chlorides have reached the rebar level. Therefore, the premixing of chloride in concrete can be a short-term methodology to induce corrosion to the reinforcement, which is adopted in this study.

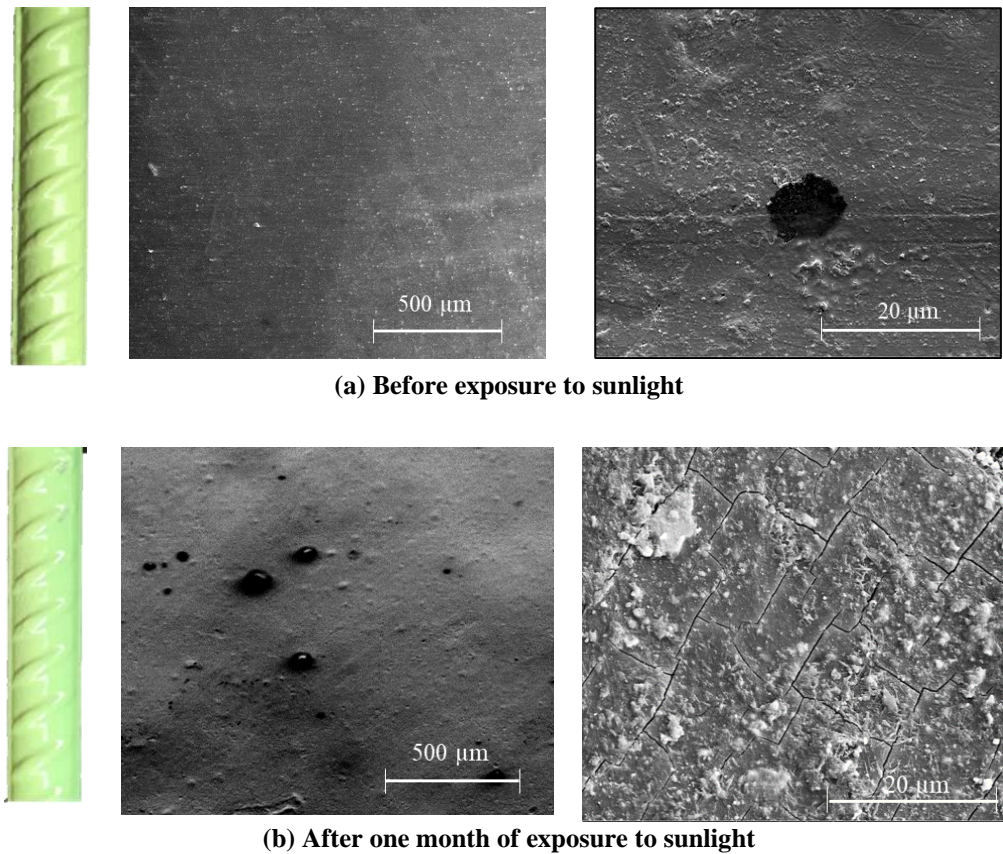
**Figure 3.3 Effect of exposure to sunlight/UV on FBE coating
(obtained from same rebar lot)**

exposed to sunlight for 12 days in UV chamber (see ASTM G154), which is equivalent to one month of sunlight exposure. The specimens were visually inspected and no cracks were observed with naked eyes. However, the first micrograph (from the same specimen; at 300X) in Figure 3.3(b) shows that the FBE coating can undergo UV-degradation resulting in new pinholes (see black regions/dots on the surface of epoxy coating) with diameter ranging up to 100 μm . The appearance of new pinholes in large number can be attributed to the evaporation of volatile materials in the coating; indicating inadequate chemical composition of coating material. In addition, UV/sunlight exposure also led to microcracks, which are due to restrained shrinkage of coating, see second micrograph (at 5000X) in Figure 3.3(b). This is mainly an effect of inadequate polymer structure and composition. Therefore, visual inspection alone is inadequate and the authors recommend to measure the number of pinholes/cracks/scratches at the manufacturing plant and at construction site; in particular, just before the placement of concrete around the rebars. Such approach will force the builders to handle the rebars with care to avoid abrasion-induced scratching and to prevent the prolonged exposure to sunlight/UV (even after the rebar cages are in place).

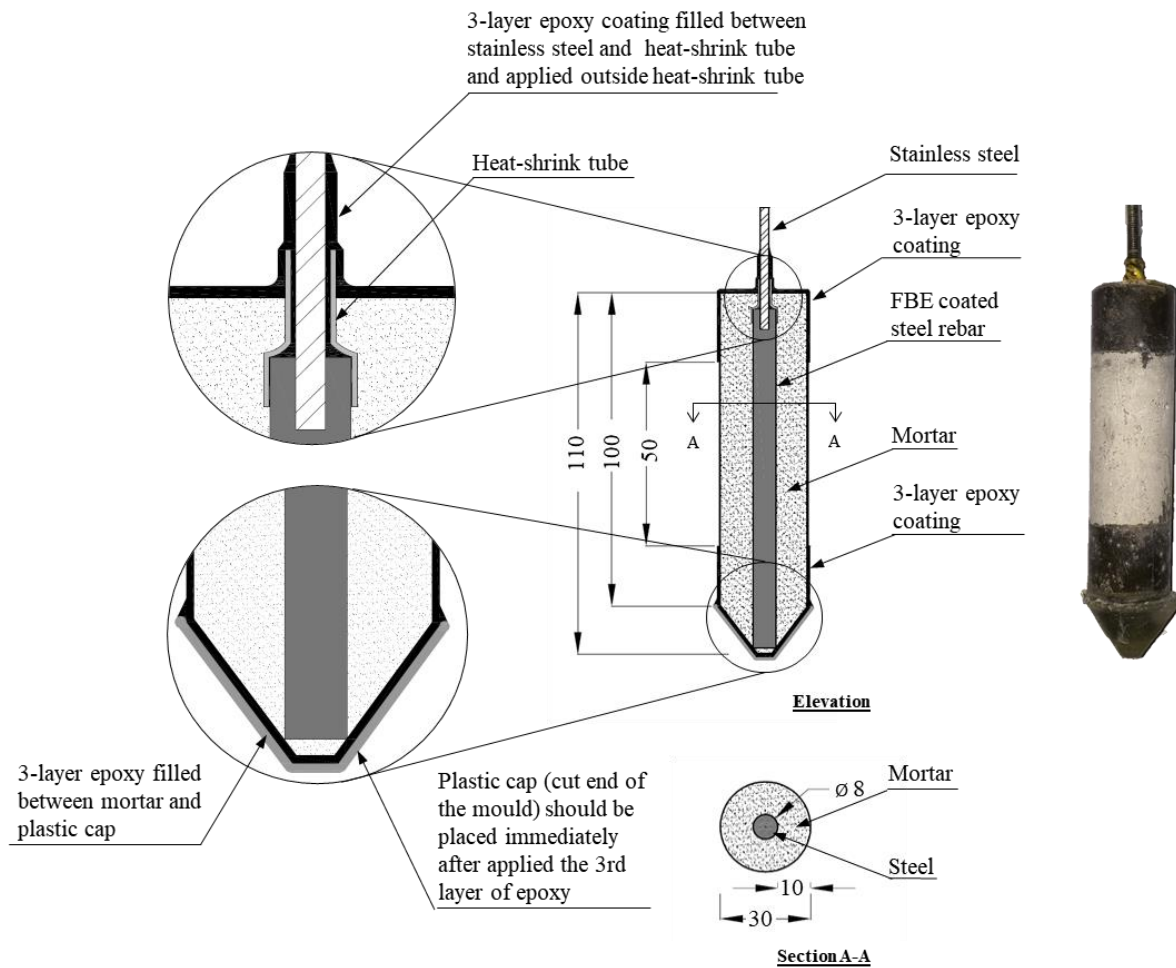
Figure 3.8 Schematic of the lollipop test specimen used for LPR and EIS test

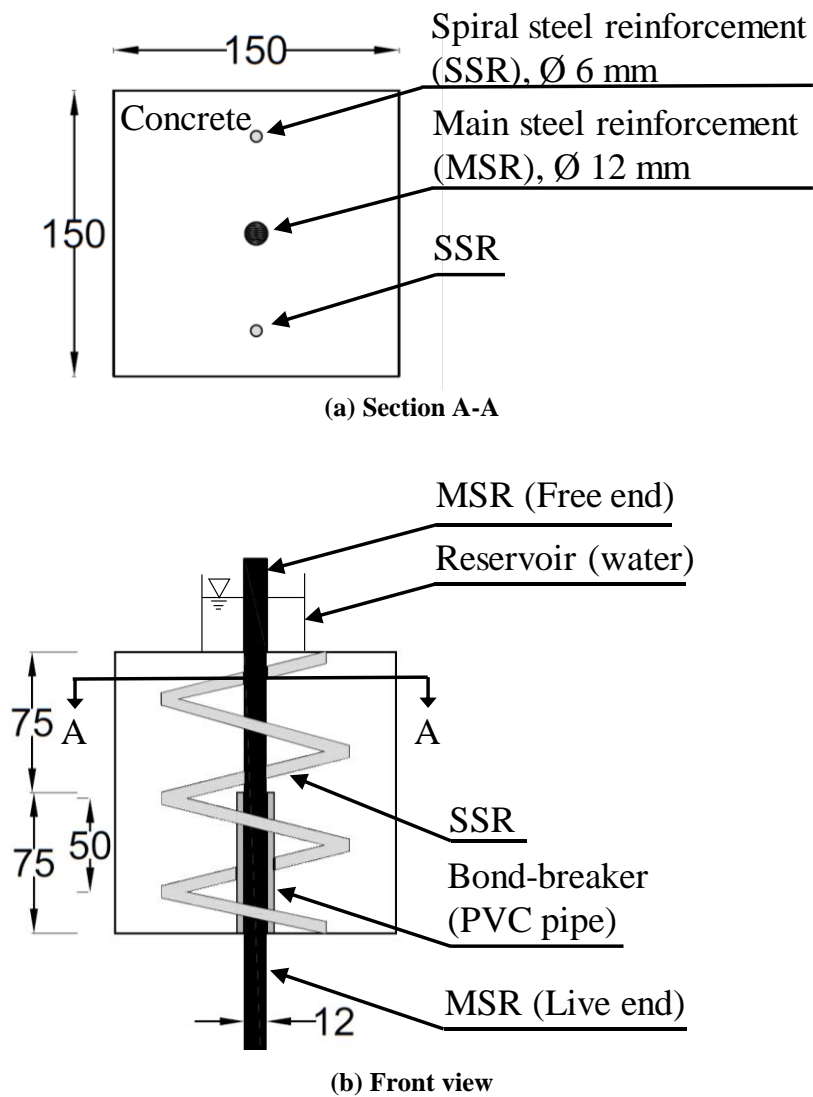
**Figure 3.15 Schematic and photograph of pull-out test specimen
(as per RILEM TC RC 6 1983)**

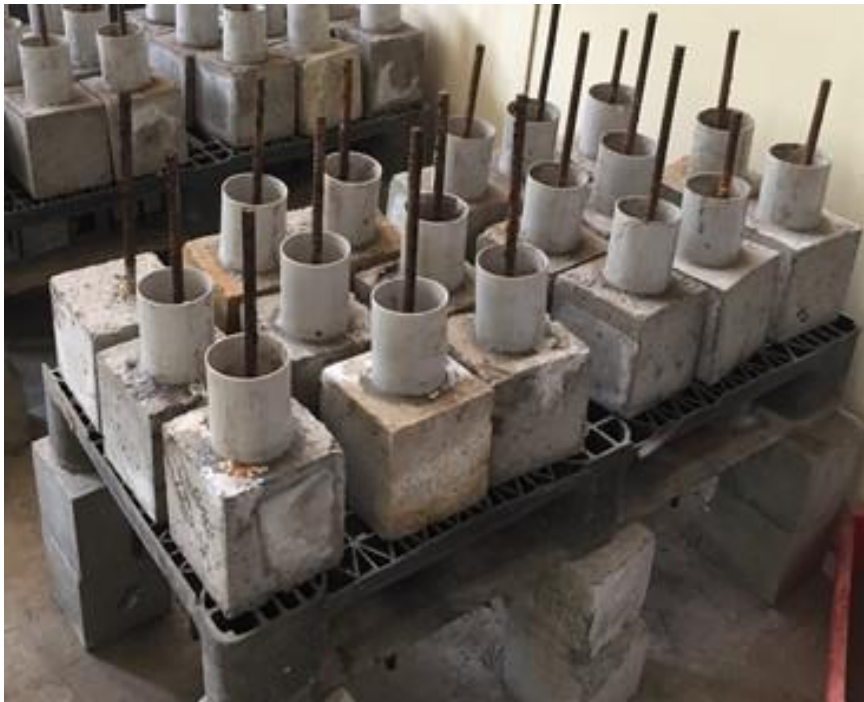
Figure 3.16 Pull-out specimens with admixed chlorides

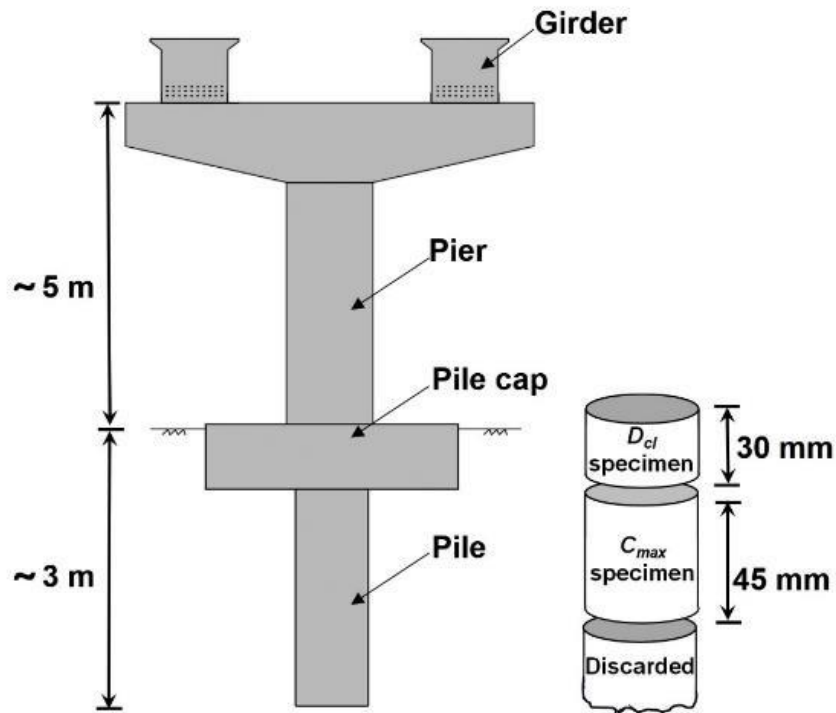
Figure 3.18 Schematics of the bridge elements under study and cylindrical concrete specimens cored from the bridge elements [Not drawn to scale]

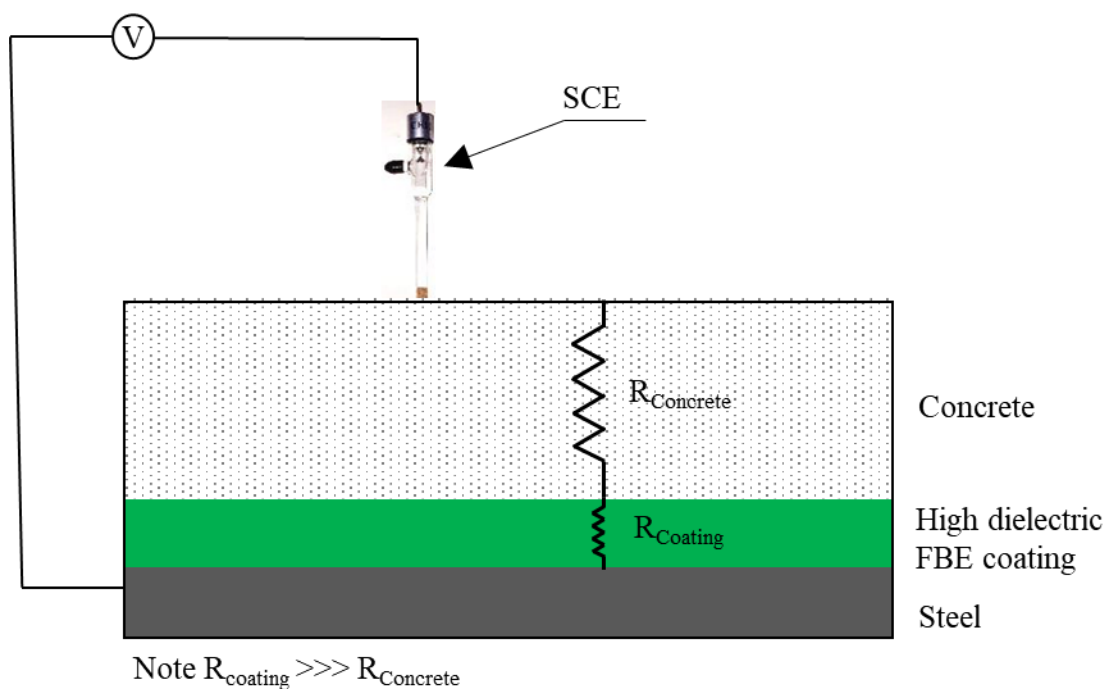
Figure 4.1 Schematic with HCP measurements of RC system with steel rebars coated with high dielectric coating material

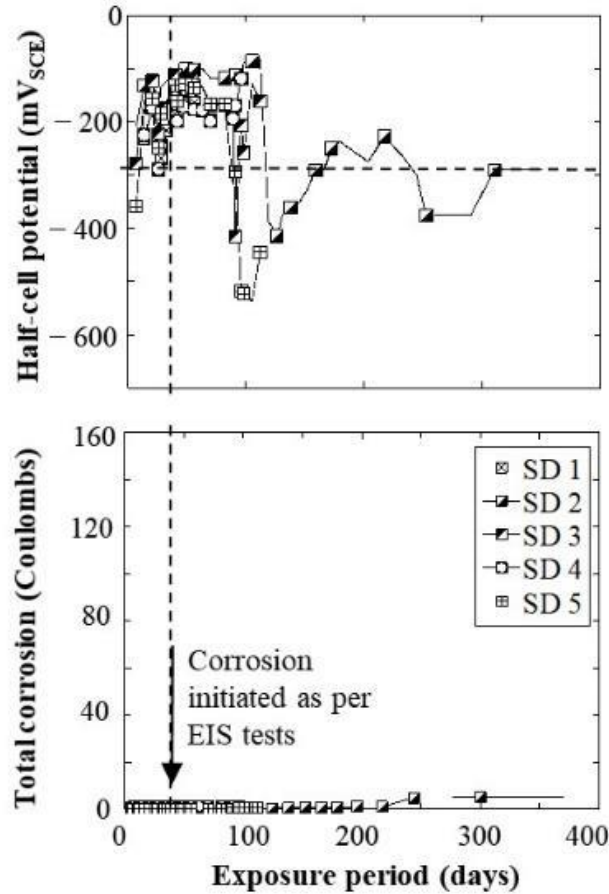
Figure 4.4 Calculated total corrosion and measured half-cell potentials from 3-bar prism specimens with FBE coated steel rebars with damaged coating

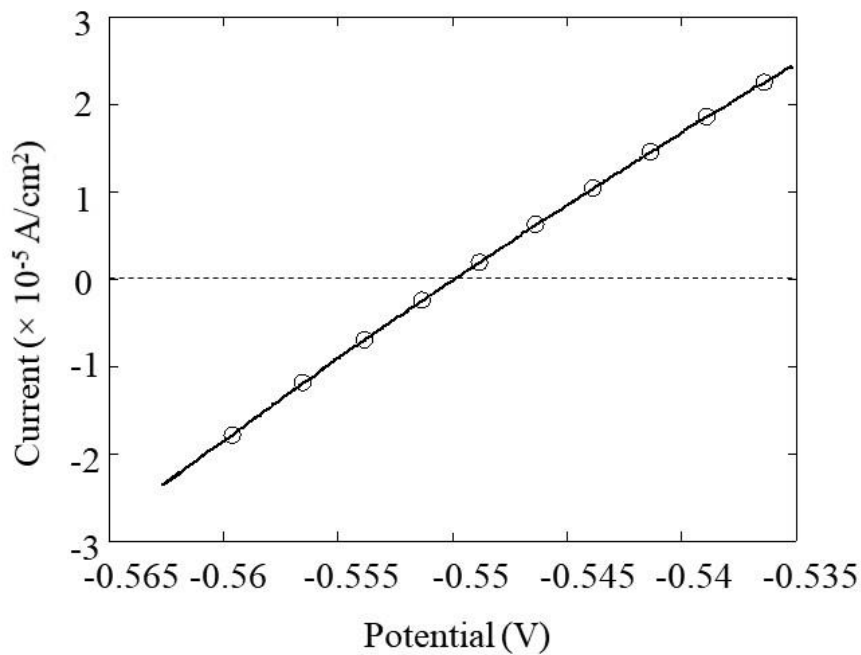
Figure 4.6 Typical linear polarisation resistance curve

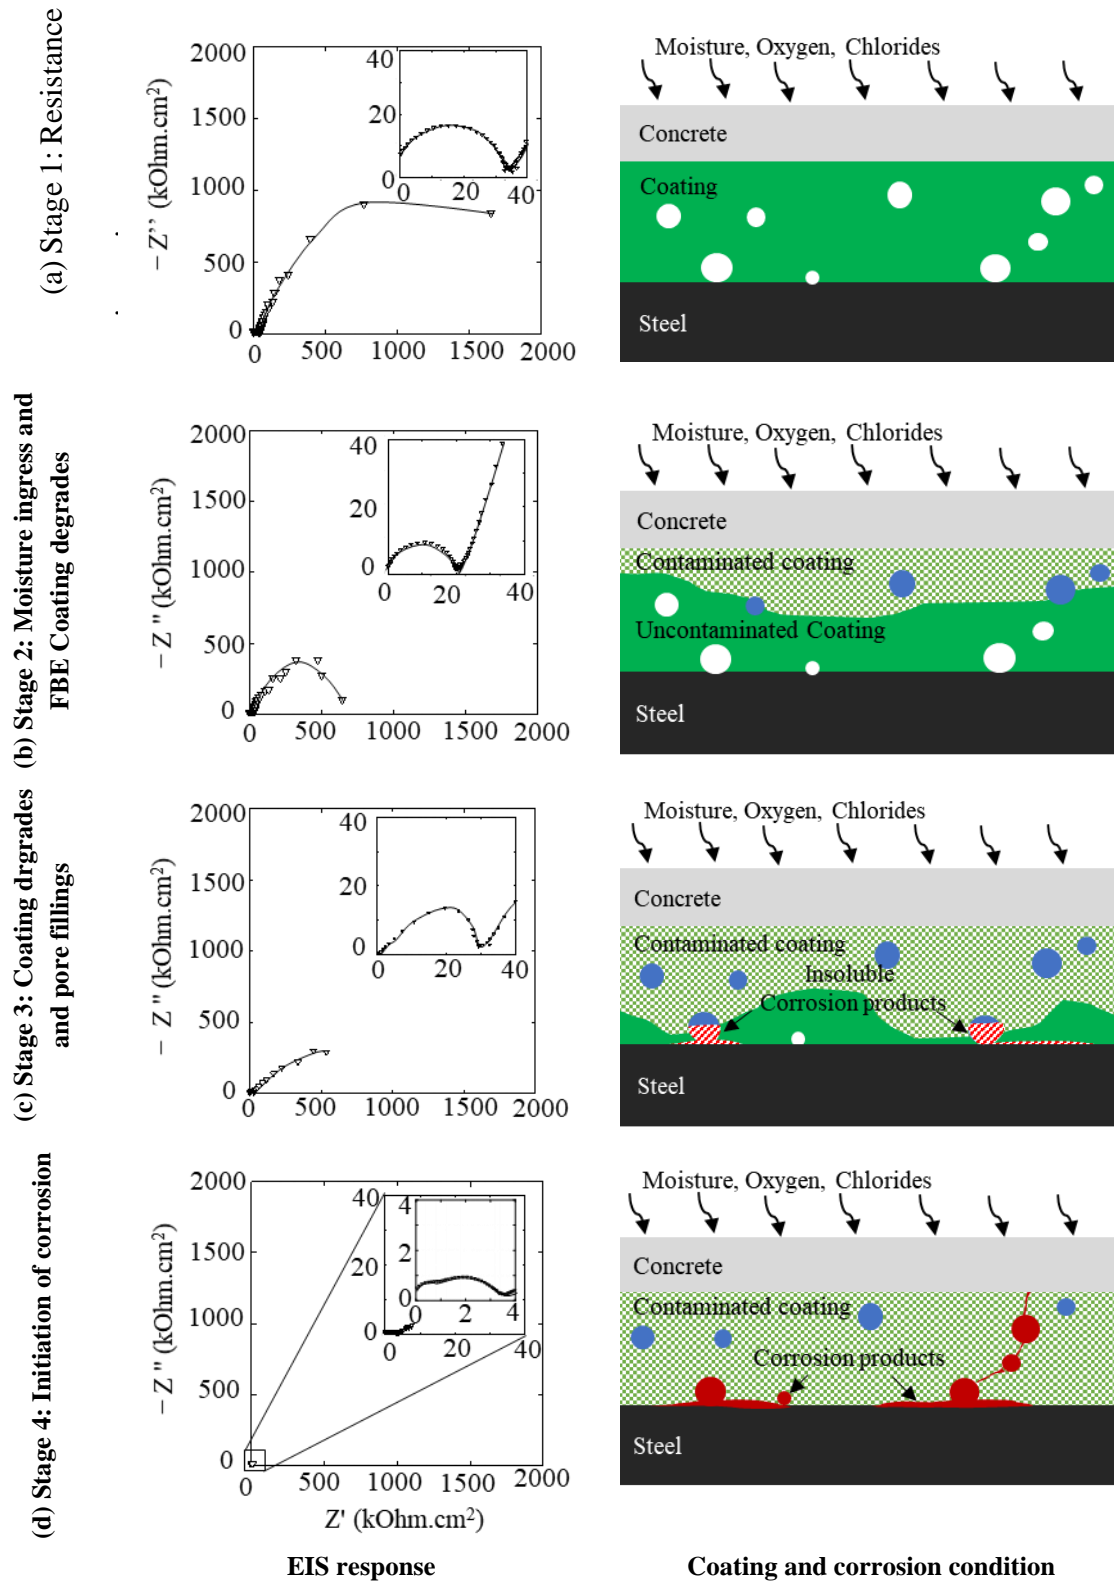
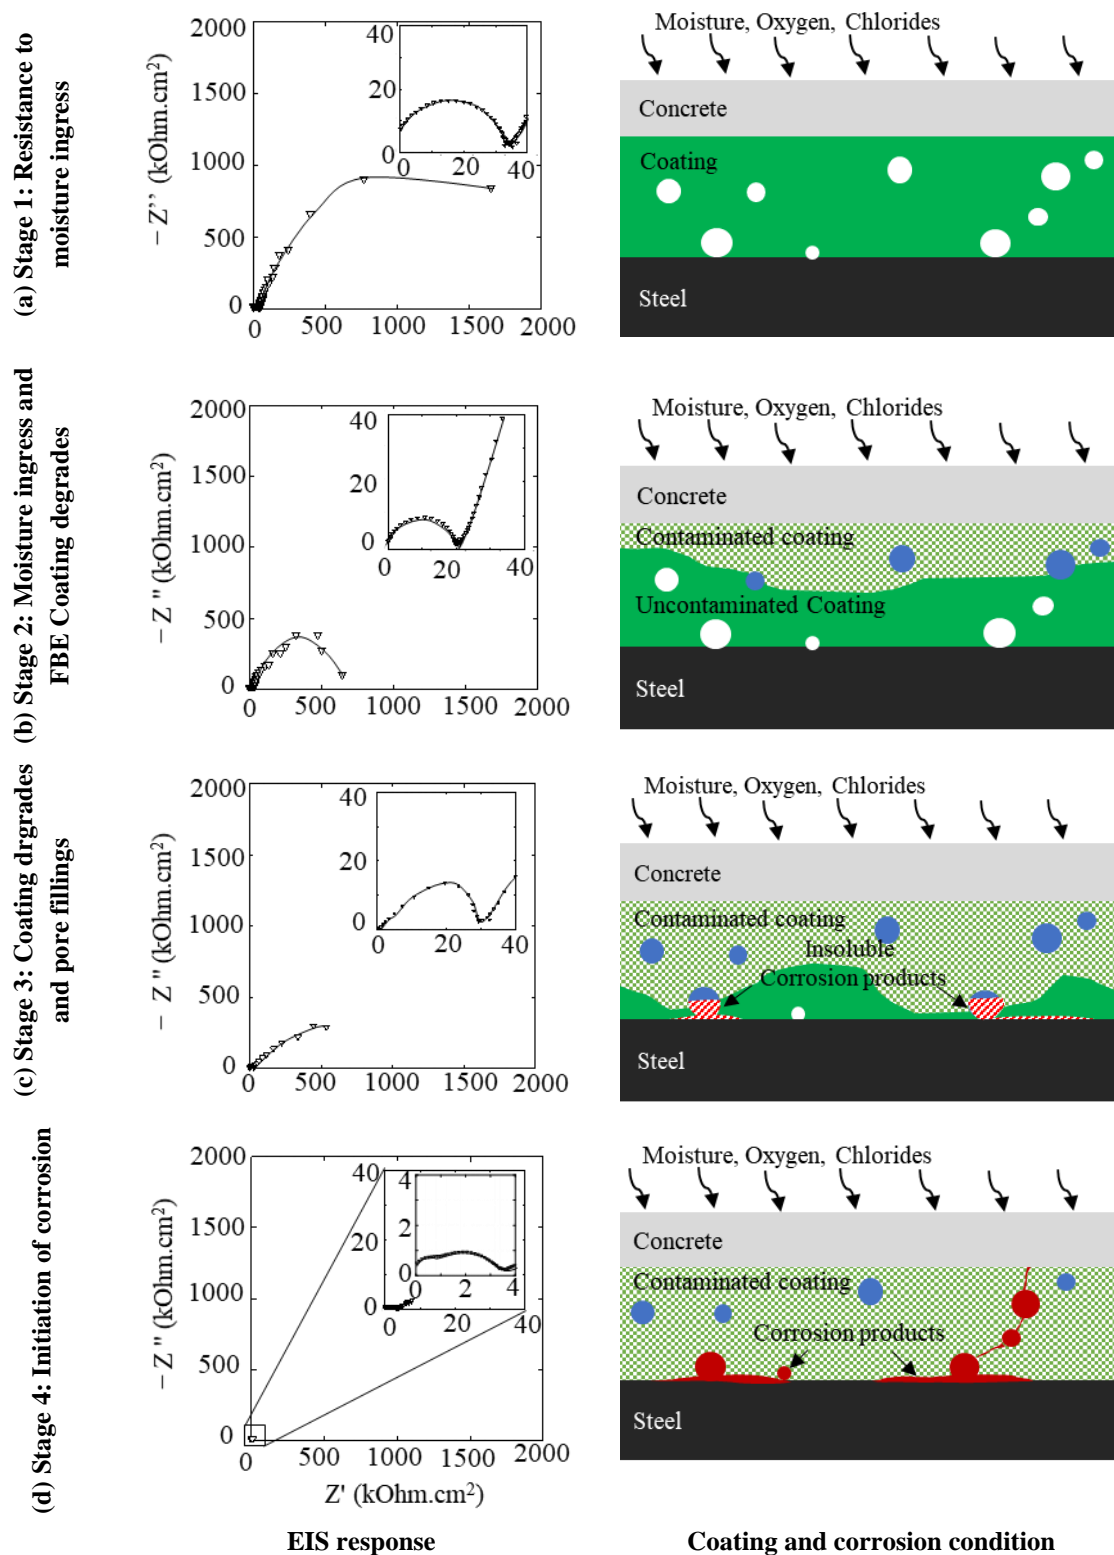
Figure 4.10 shows the typical Nyquist plots obtained from lollipop specimens with FBE coated steel embedded in the cementitious mortar at the following four stages discussed next. Stage 1: resistance to ingress of moisture, oxygen, chlorides, etc. (the initial phase of exposure), Stage

Figure 4.10 (b) shows that the resistance offered by the FBE coating and S-C interface decreases (Stage 2). During this stage, the FBE coating may have degraded due to ingress of moisture/pore solution (Nazarov et al. 2008) and chlorides [see schematic in

Figure 4.10 (b)]. Therefore, the impedance modulus offered by FBE coating was decreased from $\approx 40 \text{ kOhm}\cdot\text{cm}^2$ to $\approx 20 \text{ kOhm}\cdot\text{cm}^2$. The impedance modulus of the steel-coating interface was captured within the operational frequency range ($10^6 - 0.01 \text{ Hz}$). Note

Figure 4.10 EIS response from lollipop specimens with FBE coated steel at various stages during exposure to chloride solution

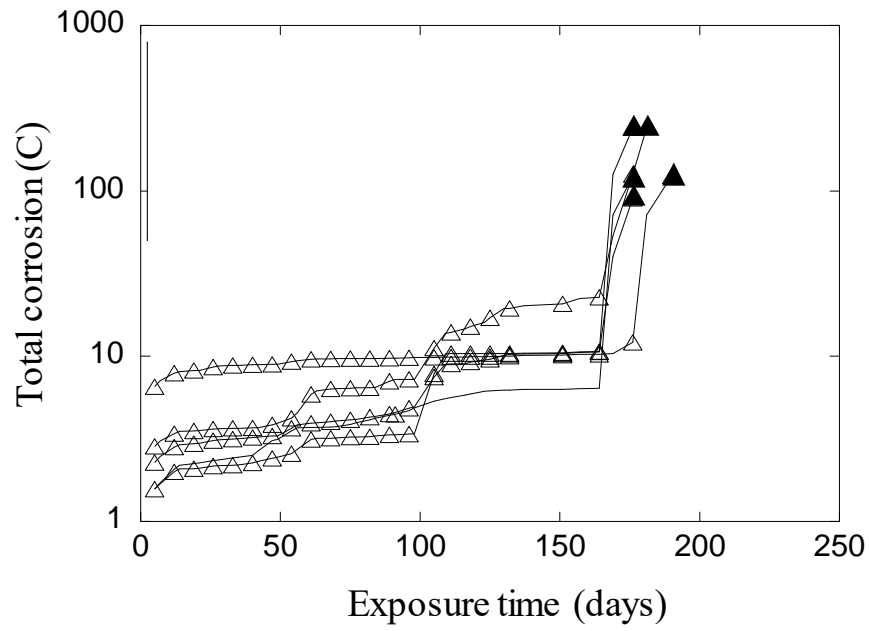
(a) Variation of total macrocell corrosion current during exposure time

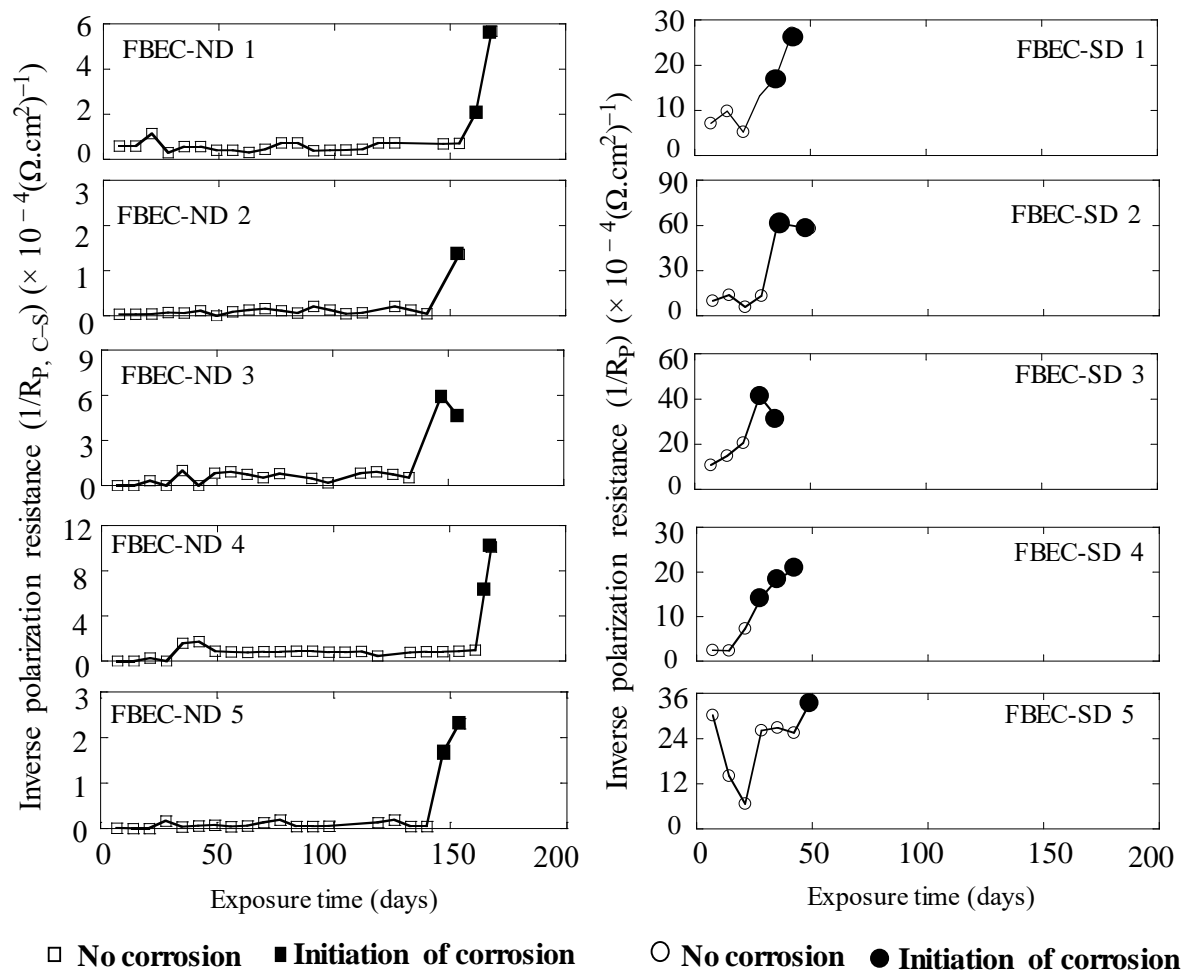
Figure 5.2 Detection of initiation of corrosion (unfilled and filled markers indicate passive and active corrosion measurements, respectively)

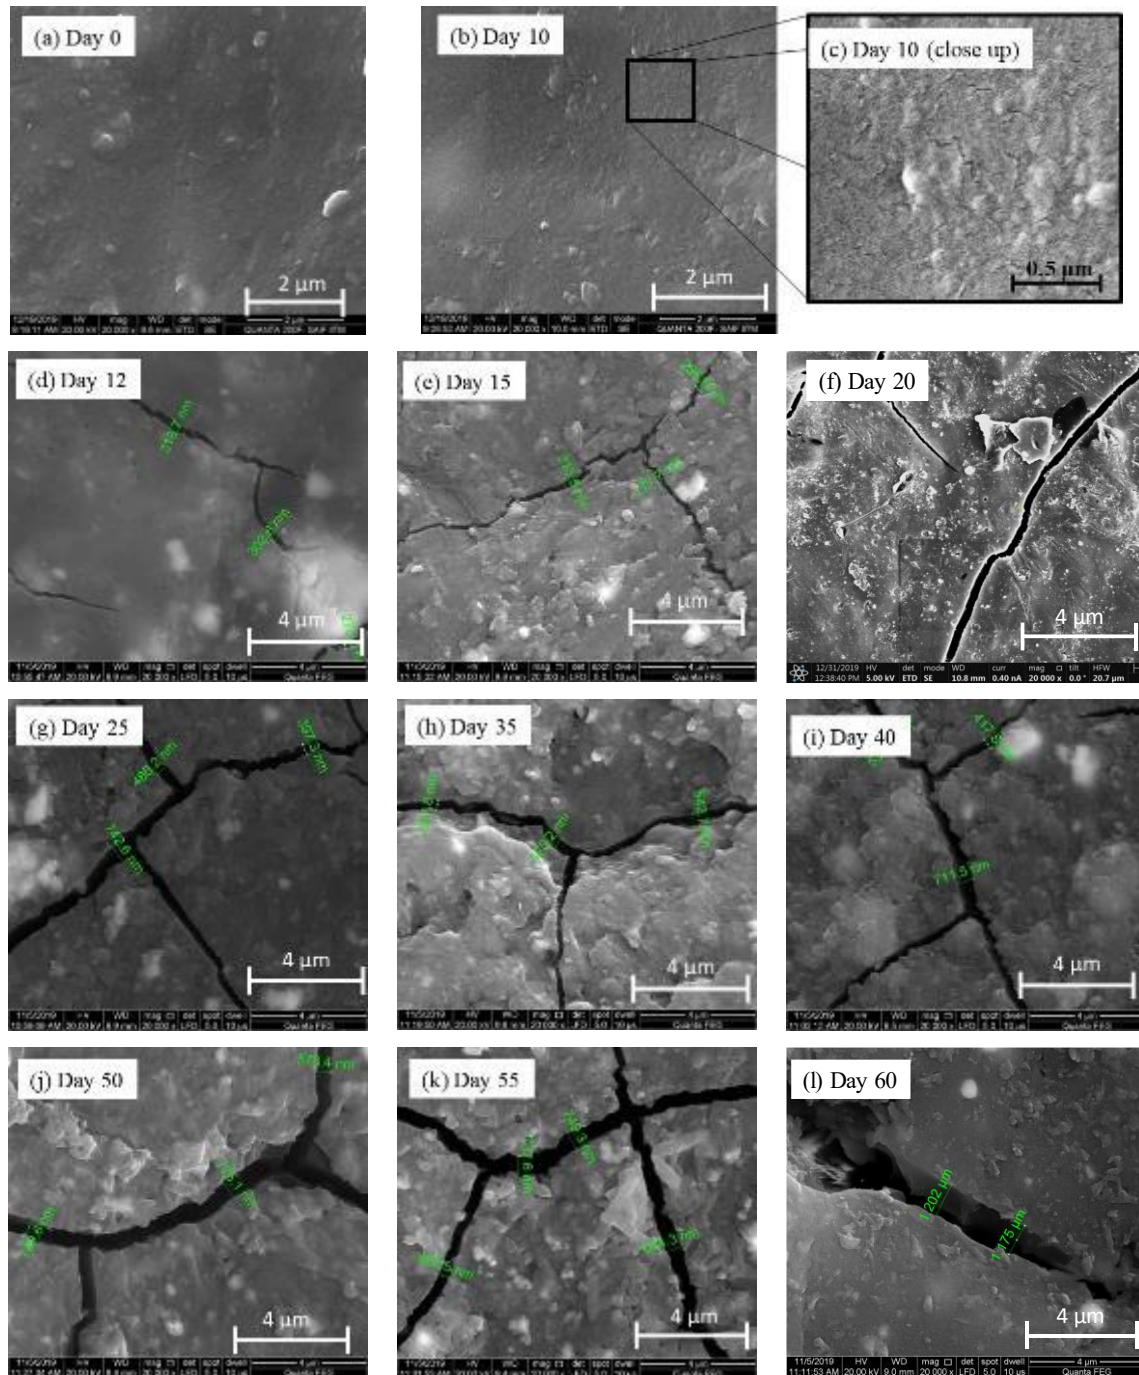
Figure 5.5 Micrographs showing crack evolution on epoxy coating exposed to UV rays

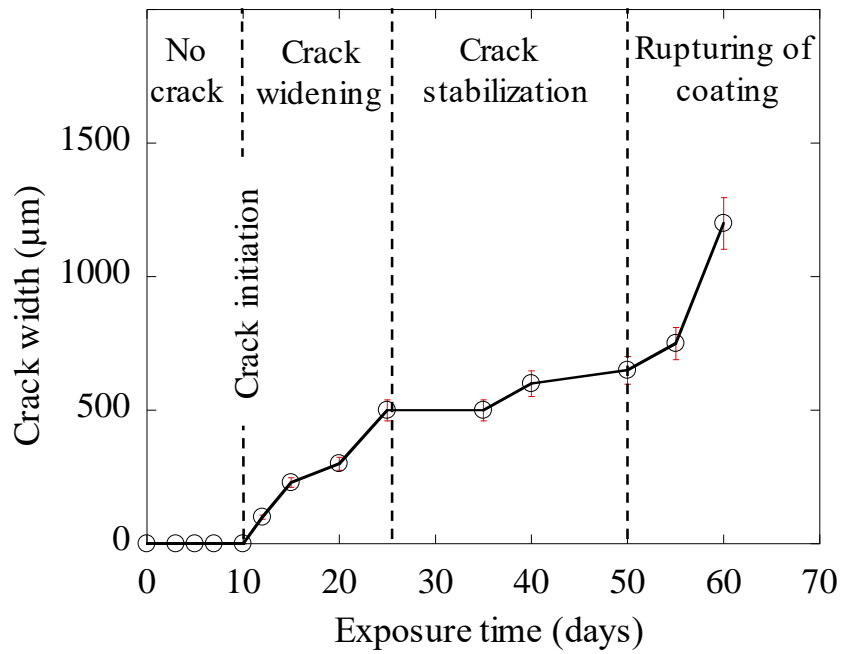
Figure 5.6 Effect of ultraviolet exposure on crack width on the FBE coating surface

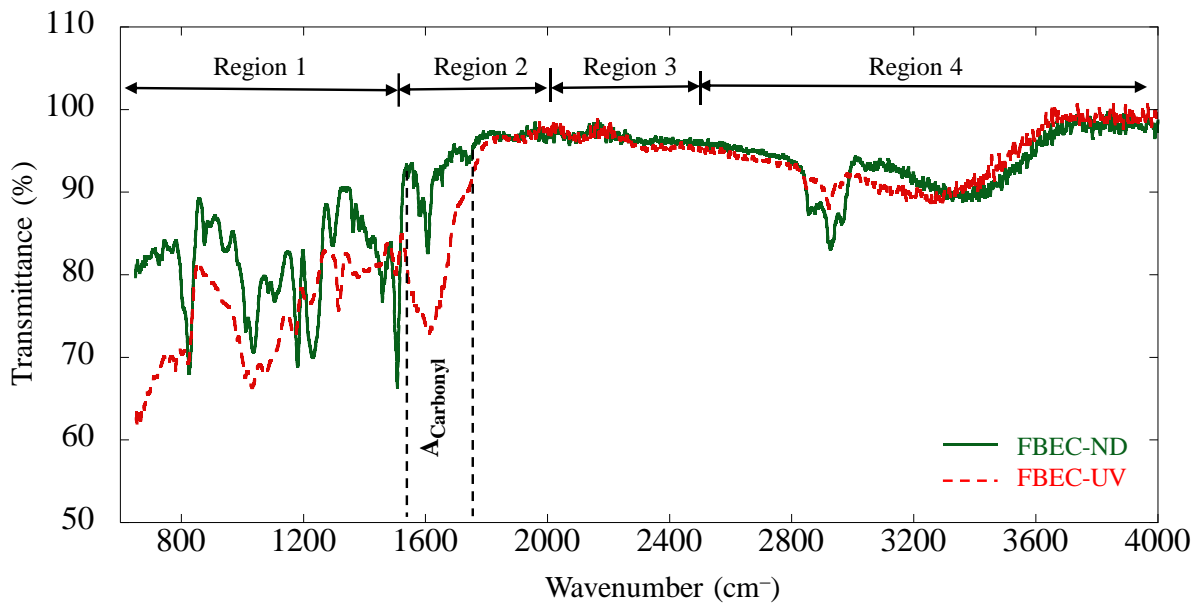
Figure 5.8 FT-IR spectra of FBE coating with and without exposure to UV rays

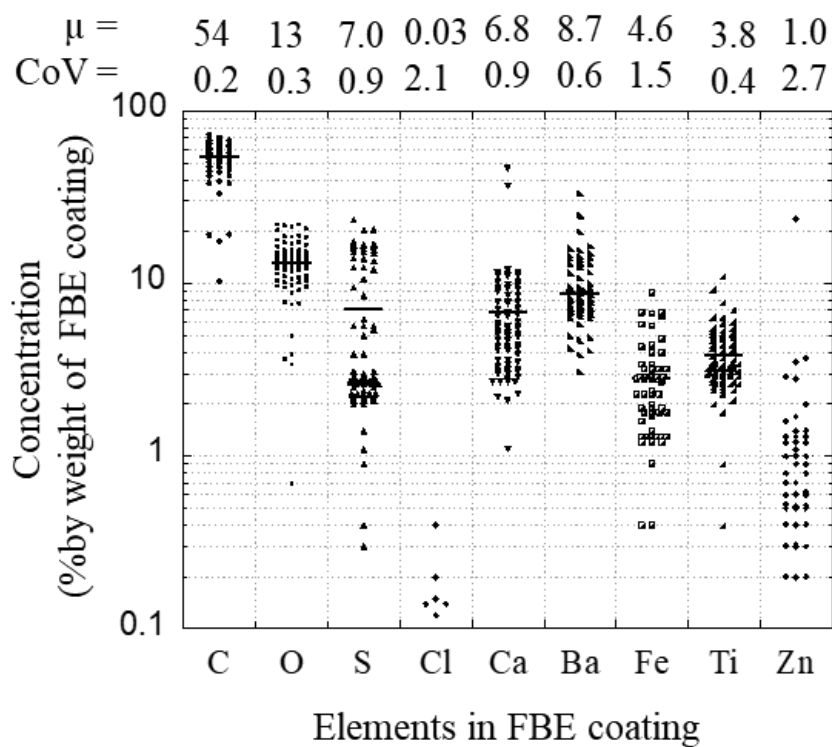
Figure 5.9: Variation in the chemical composition of FBE coating

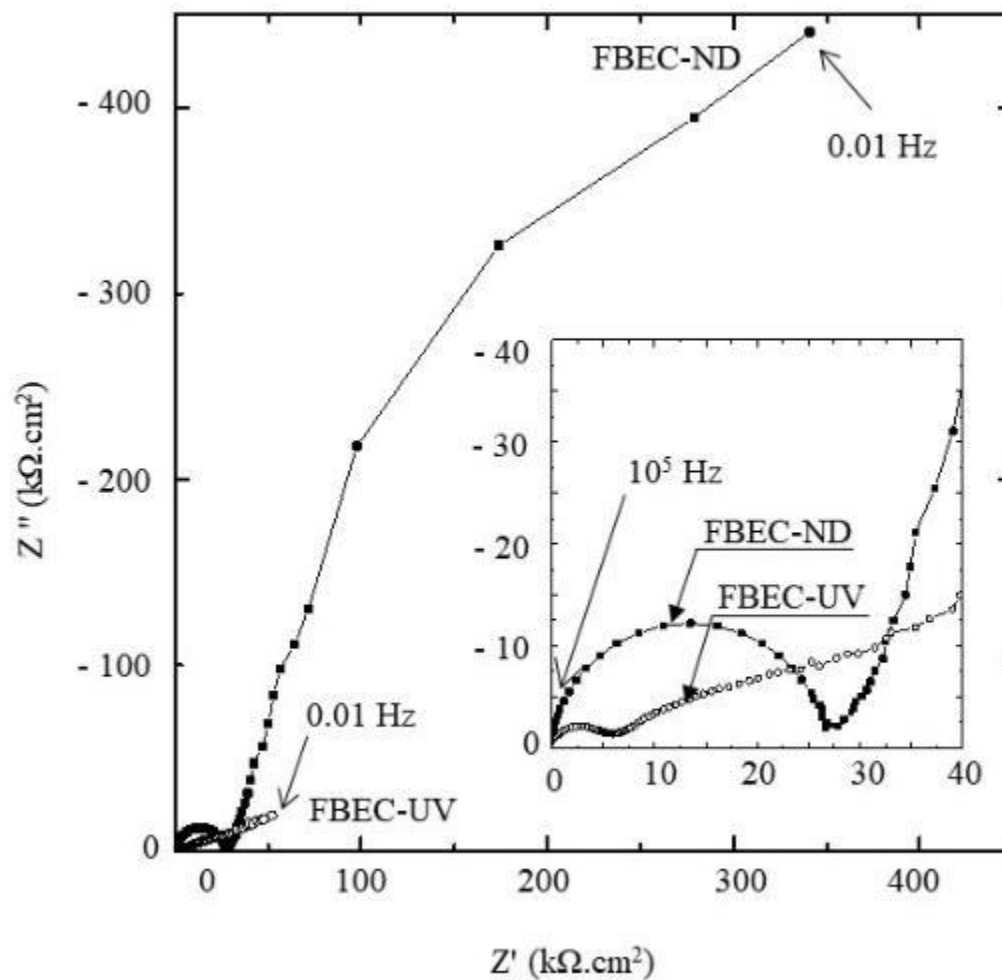
Figure 5.10 EIS response from FBE coated steels - with and without UV exposure and then embedded in mortar

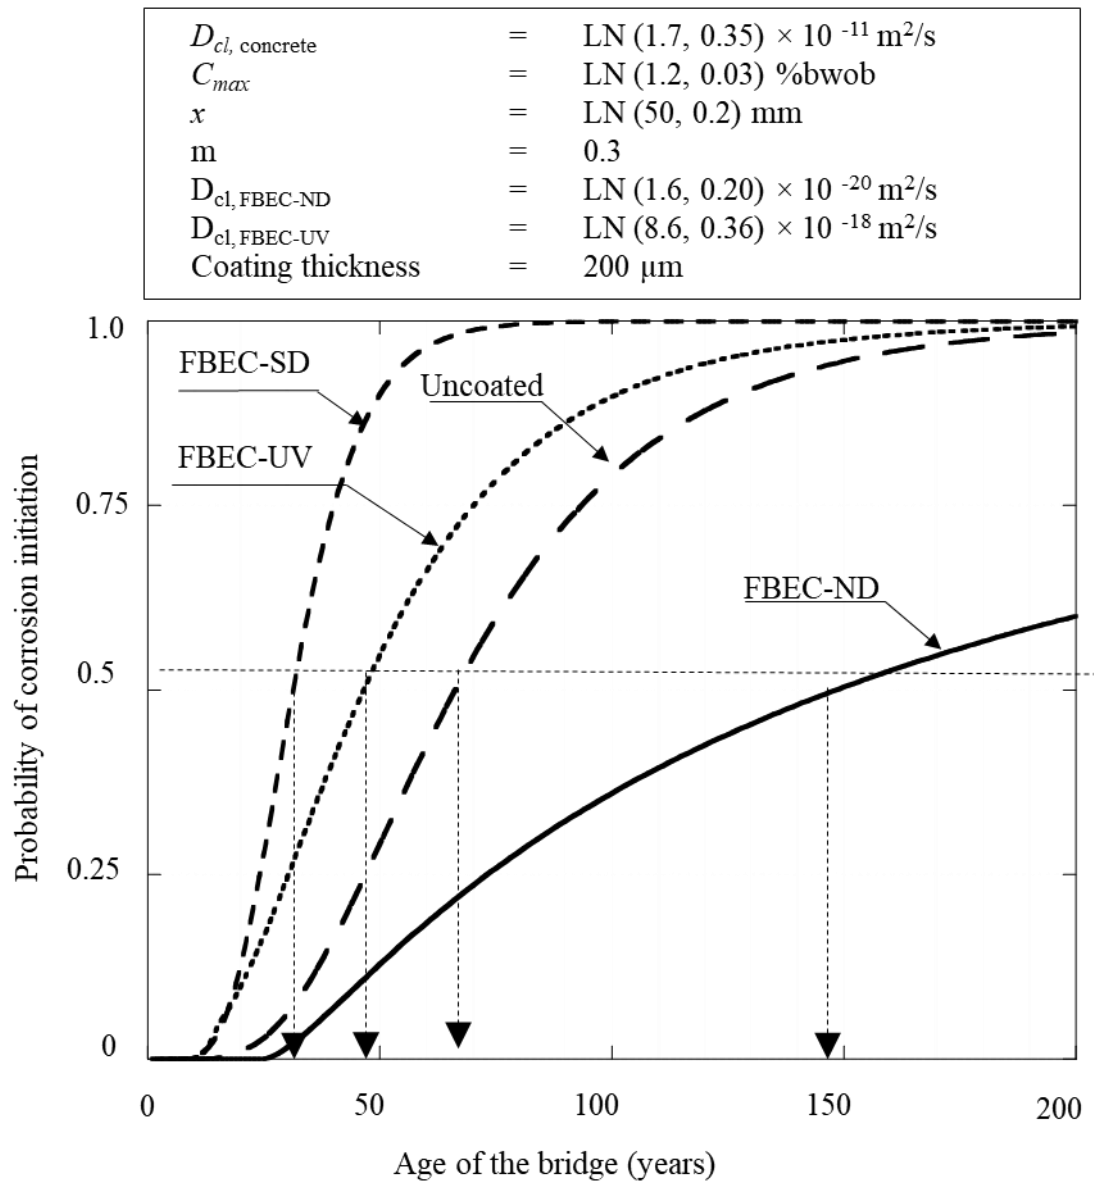
Figure 5.18 Cumulative distribution function for time to corrosion initiation
