**ELECTROCHEMICAL, BOND, AND SERVICE LIFE PARAMETERS OF
COATED STEEL - CEMENTITIOUS SYSTEMS EXPOSED TO CHLORIDES**

A THESIS

**DEPARTMENT OF CIVIL ENGINEERING
INDIAN INSTITUTE OF TECHNOLOGY MADRAS
CHENNAI 600 036, INDIA**

June 2020

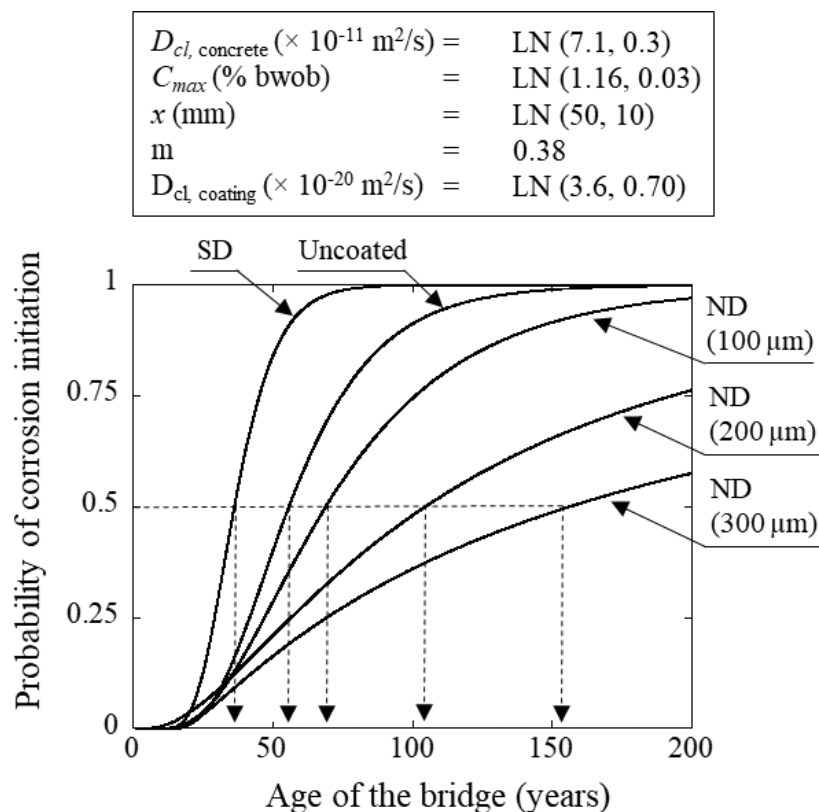
Figure 5.20 Effect of coating thickness and damage to the coating on the service lives of RC systems with FBE coated steel rebars

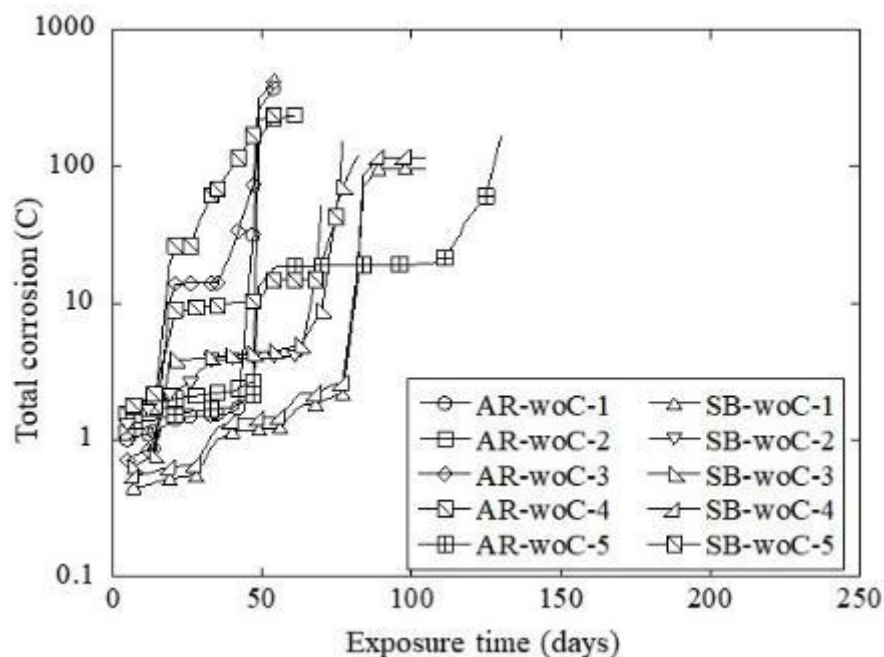
Figure 6.2 Effect of sandblasting on corrosion initiation of uncoated steel rebars

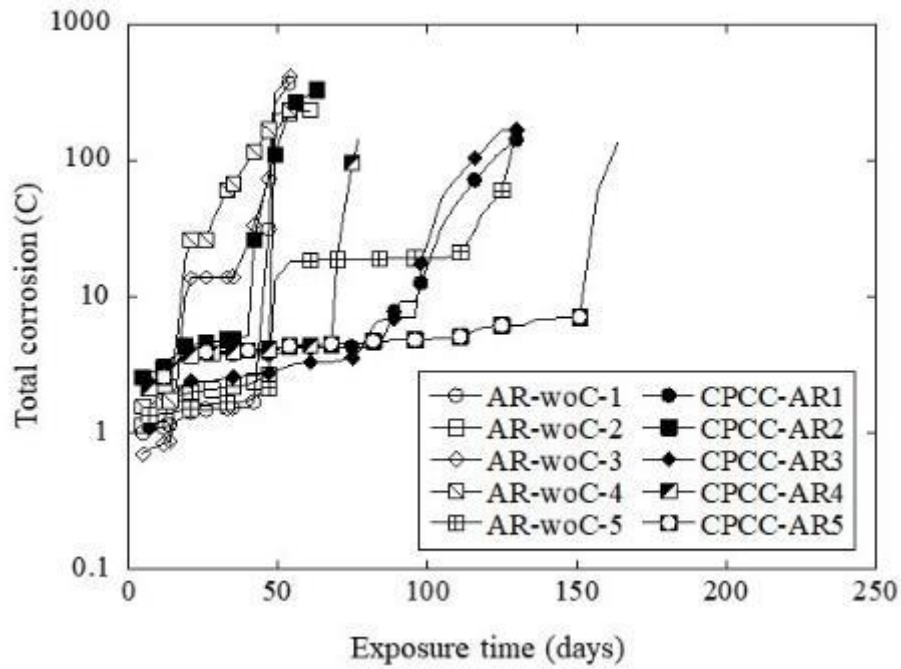
Figure 6.3 Effect of CPC coating on ‘as-received’ steel surface on corrosion initiation

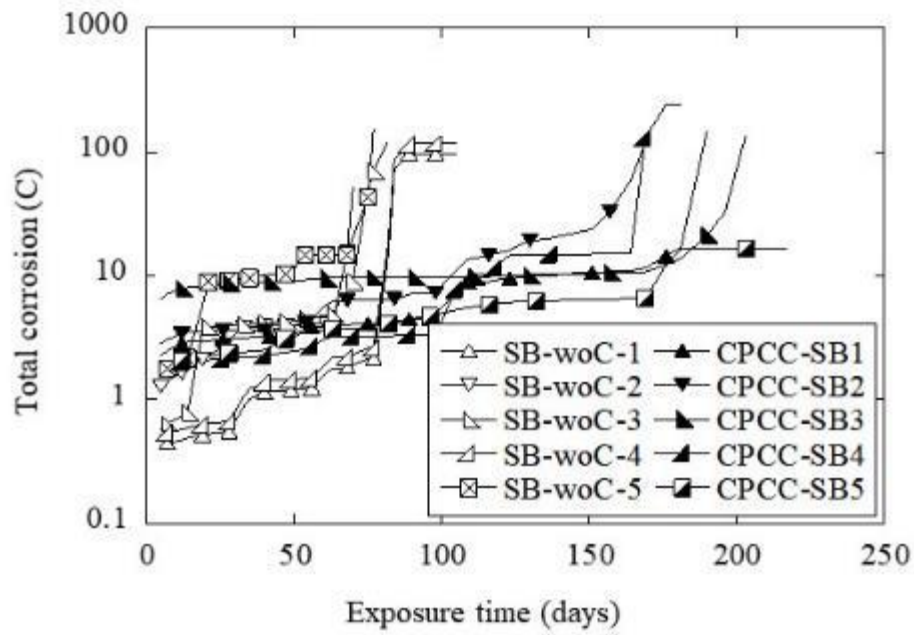
Figure 6.4 Effect of CPC coating on sandblasted steel surface on corrosion initiation

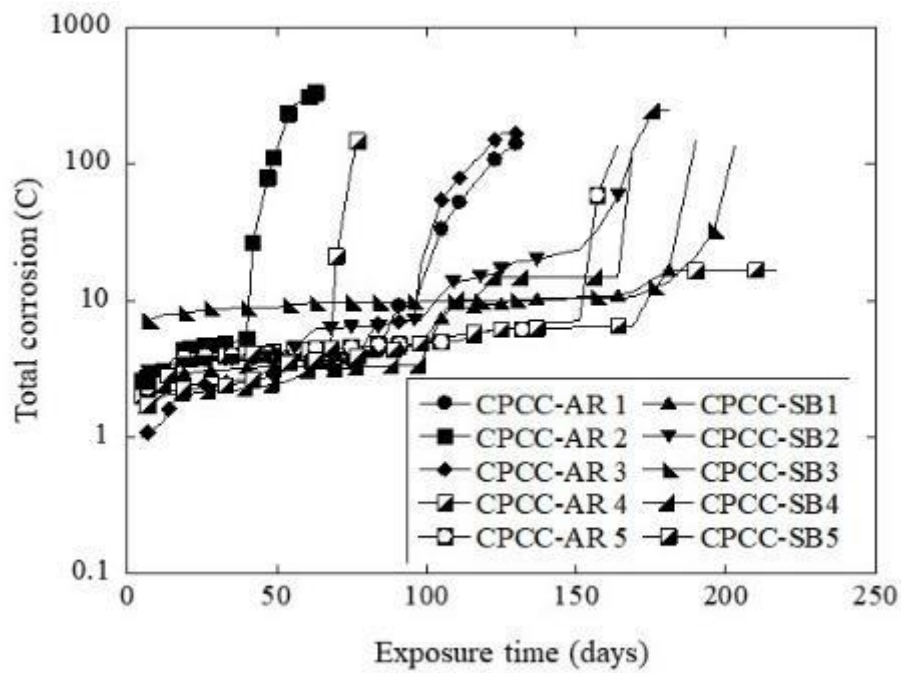
Figure 6.5 Effect of surface initiation on corrosion initiation of CPC coated steel rebars

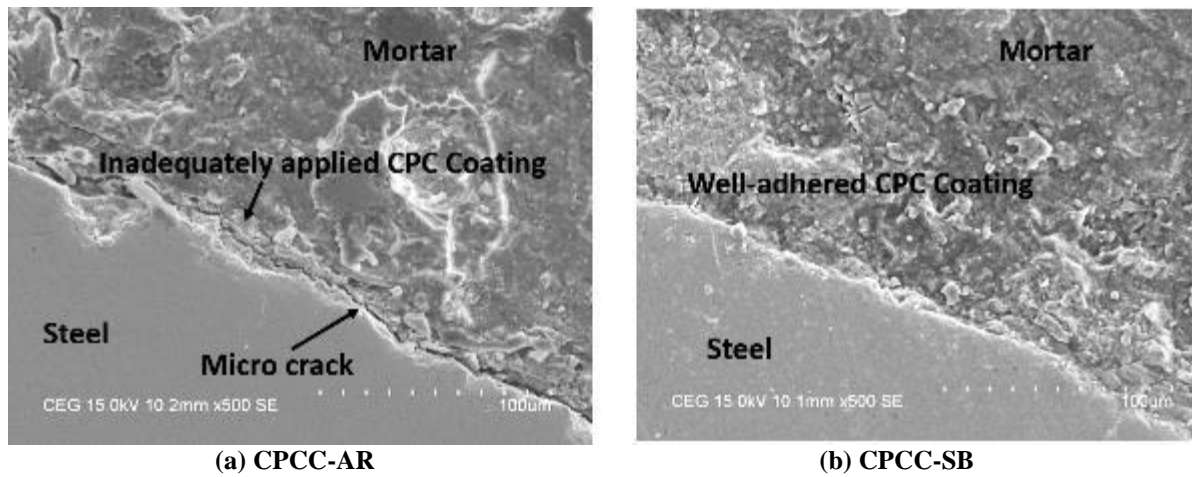
Figure 6.6 SE micrographs of the steel-coating-mortar interface

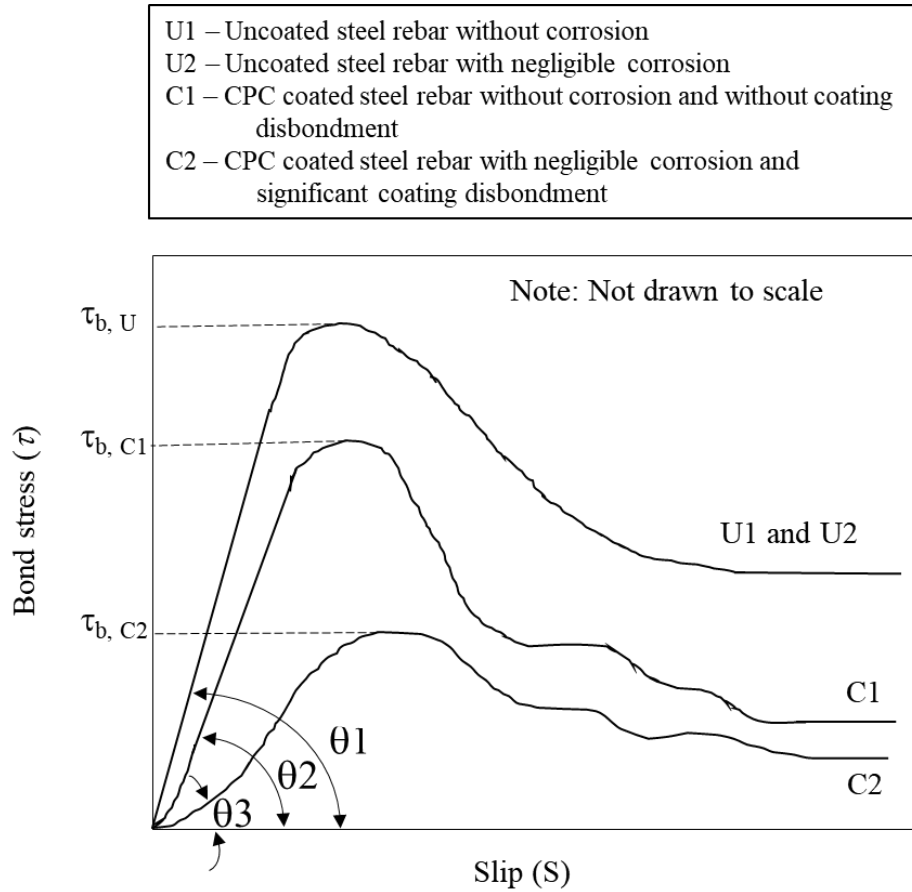
Figure 6.15 Proposed bond stress-slip model for CPC coated steel rebars with and without disbonded coating

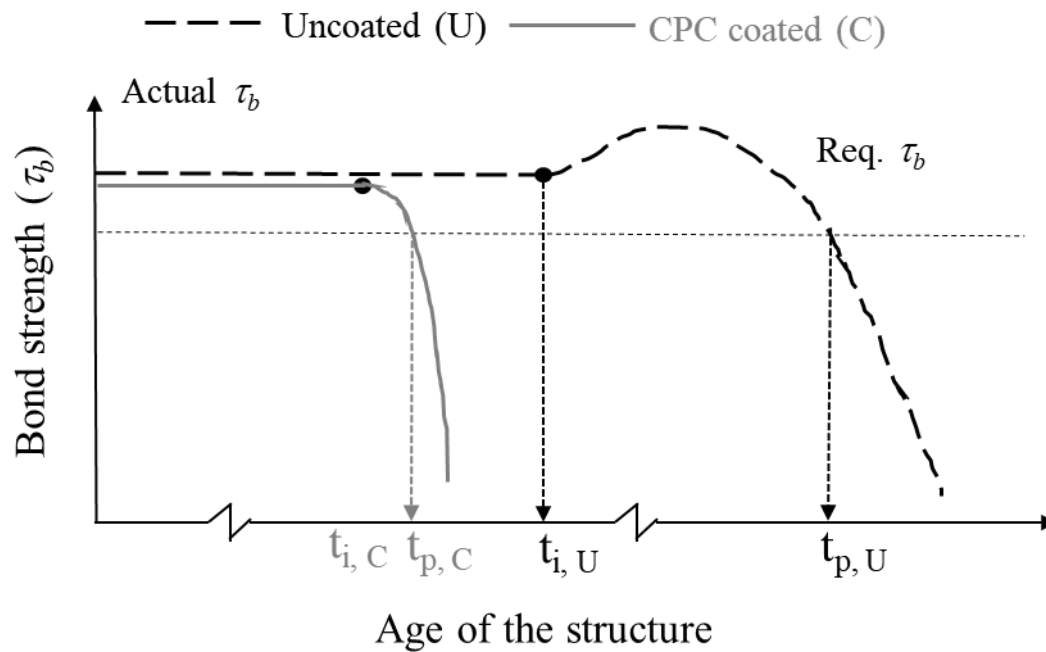
Figure 6.16 Proposed service life model based on bond loss for RC structures
