GROUTING MATERIALS AND PRACTICES FOR CENTURY-LONG CORROSION PROTECTION OF POST-TENSIONED CONCRETE BRIDGES

KARTHIKEYAN MANICKAM
RADHAKRISHNA G. PILLAI*

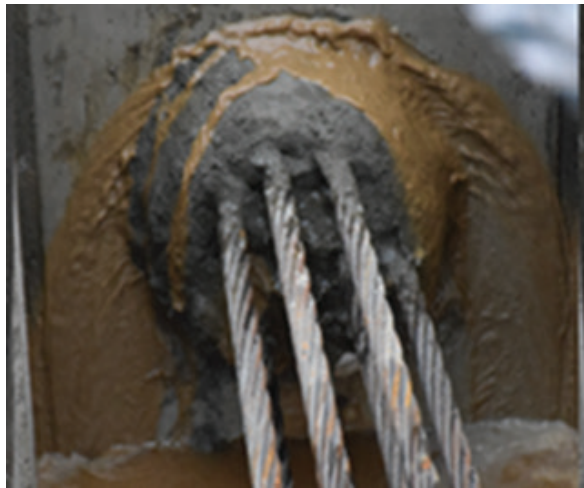
(a) Corrosion of strands due to flushing the PT ducts with water before grouting

1. In some projects, it is still a practice to flush the PT ducts with water. This is done after stressing the strands and before grouting to clean the duct, and to wet the inside surface of the duct (to promote the flow of grout), and/or to assess the watertightness of the duct. However, due to construction delays, water can be left within the duct for many days. Also, it is very challenging to entirely remove the water from the interstitial spaces (between the wires of a strand and between adjacent strands). The remaining water can get mixed with the cementitious grout, lead to increased bleeding, and promote corrosion of strands^[10]. Situation can get worsened if this flushing water has more chlorides than the allowable limits. Figure 2(a) shows a case, where water mixed with rust is flowing out of a tendon that was flushed with water. This practice was probably required for ensuring the flow of the plain ordinary Portland cement (OPC) grout, which is not in use today. Today's thixotropic grouts do not need such flushing of ducts with water prior to grouting, and the use of such flushing practices can be detrimental.

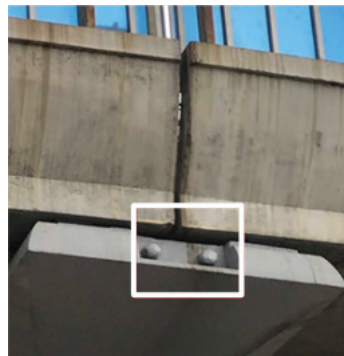
(d) Polymeric coating applied over cementitious caps and exposed to sunlight

4. Figure 2(d) shows a case with waterproofing coating applied on cementitious cap at the anchorages and not covered with concrete. Typically, such coatings would develop microcracks and lose their efficiency within a few years (due to exposure to sunlight/UV rays)^[12] after which they would allow the ingress of moisture/chlorides and carbonation leading to accelerated corrosion of the wedge-gripped portions of the strands. Also, the coatings must be reapplied every few years (considering their service life of coatings) unless protected from the sunlight (say, by covering with concrete). Considering the change in the maintenance policies and associated personnel, it is very challenging to monitor and ensure routine re-coating of the anchorage caps with waterproofing systems and achieve 100+ years of corrosion-free service life.

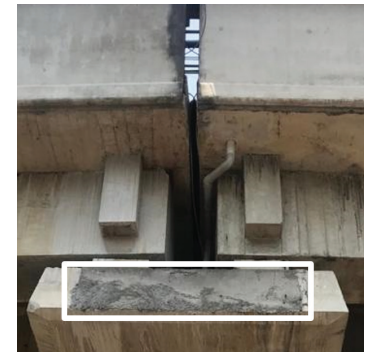
(e) Anchorage recess filled with poor-quality concrete

5. Figure 2(e) shows the photo of a PTd metro bridge with honey-combed and porous concrete filling at the

anchorage recess, which can provide easy pathways for the moisture and chlorides to ingress, carbonation to occur, and promote the corrosion of strands, especially the wedge-gripped portion.

6. Figure 2(e) also shows that the anchorages are placed at or below the expansion joints without proper detailing for the rainwater runoff – resulting in moisture attack.
7. Filling of tendons from the end anchorages is a common practice. Such practice can often result in incomplete filling of the duct due to the downward flow of grout leading to the formation of entrapped air voids^[13].

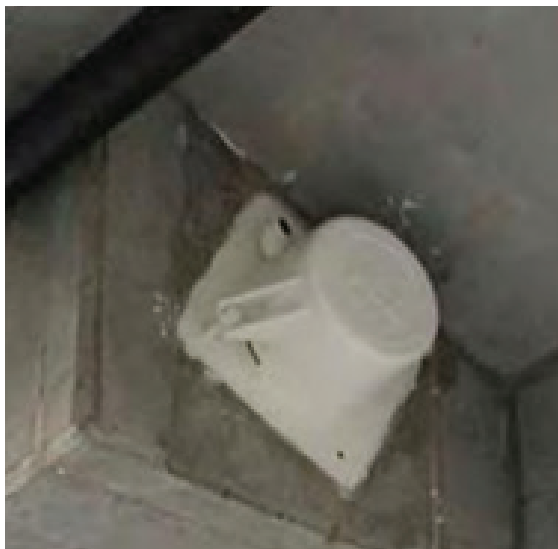
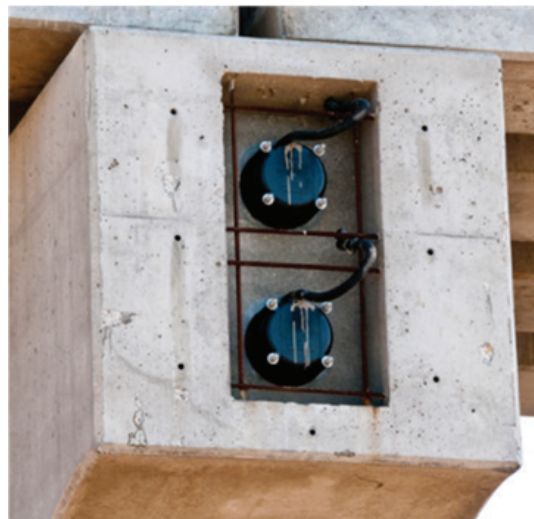
Figure 3: Multi-level corrosion protection system for anchorages^[14]

(a) Non-metallic anchorage cap

(b) Non-metallic anchorage caps kept well within the recess to be filled with reinforced concrete

Ideally, the anchorage can be fully grouted; encased in non-metallic or metallic caps; sealed by a waterproofing membrane; then covered with concrete pour backs^[14]. Such practices can prevent the entry of moisture, chlorides, CO₂, and other deleterious elements into the tendon system. Figure 3 shows a good practice of covering the anchorage with non-metallic caps. Metallic caps can be avoided and transparent acrylic caps may be used to ensure good visibility of the grout filling at the anchor heads. Also, metallic caps may corrode in the long run due to possibly less cover concrete. In addition, the deck slab should be designed and constructed to prevent the flow of rainwater into the anchorage region^[15]. Providing such multi-level protection will prevent the corrosion of anchorages and tendons. However, it was observed that many of these protection systems are largely neglected on many structures and can lead to severe corrosion of strands within about 10 to 15 years^[16,17]. Figure 4 shows a list of PTD bridges that had experienced premature tendon corrosion or failure due to inadequate grouting materials and practices.

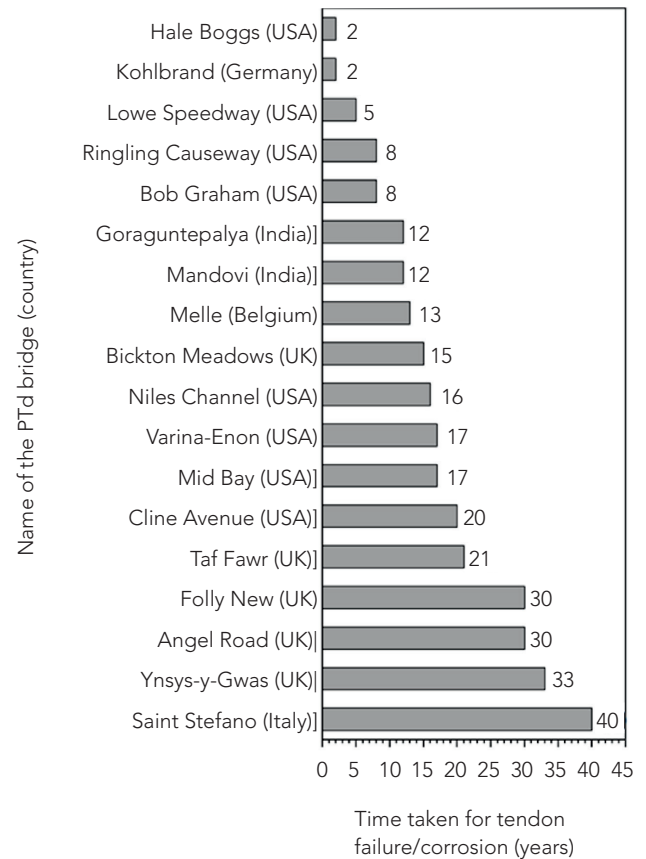
Figure 4: Time taken for tendon failure/corrosion of PTD bridges [adapted from Mohan et al. (2021)^[16]

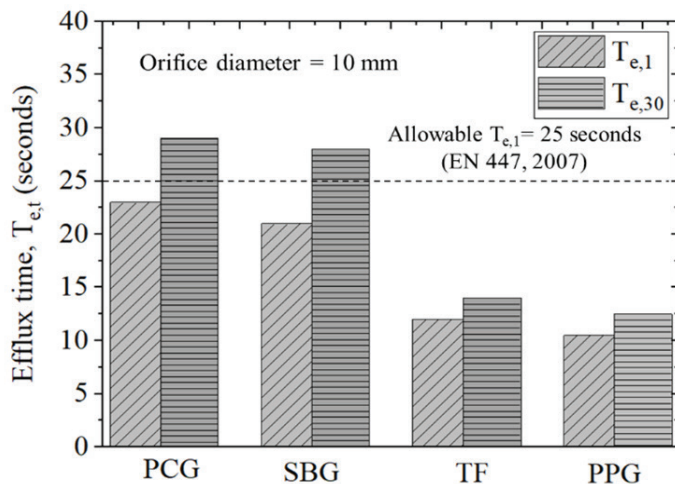
Figure 9: Efflux time of PT grouts

Figure 9 compares the efflux time of the grouts measured immediately ($T_{e,1}$) and at 30 minutes ($T_{e,30}$) of grouting. The acceptance criterion specifies that $T_{e,1}$ should not be more than 25 seconds as per EN 447:2007 [24], and all the four grouts have satisfied the criterion. PCG and SBG exhibited sufficient fluidity because of their high w/b ratios. At the same time, TF and PPG showed excellent fluidity despite their low w/b ratios because of their thixotropic property (shear thinning behavior). Also, the enhanced fluidity of TF can be due to the ball bearing action of the spherical flyash particles [16]. When it comes to fluidity retention after 30 minutes of grouting ($T_{e,30}$), PCG and SBG could not satisfy the acceptance criterion specified by EN 447:2007 [24]. This criterion specifies that the percentage change in fluidity should not be more than 20 % from immediately after mixing to

30 minutes after mixing. The $T_{e,30}$ of PCG and SBG are ~25 % and ~33 % more than $T_{e,1}$, possibly due to the thickening of the grout mix due to hydration as time passes. On the other hand, TF showed excellent fluidity retention owing to the incorporation of shrinkage reducing admixture (SRA) in its mix, that decreases the surface tension of the liquid phase. In this experimental program, the fluidity retention of the grouts after 30 minutes only is determined. However, fluidity retention must be checked up to 3 hours after grouting since the grouting operations could last for a couple of hours after mixing.

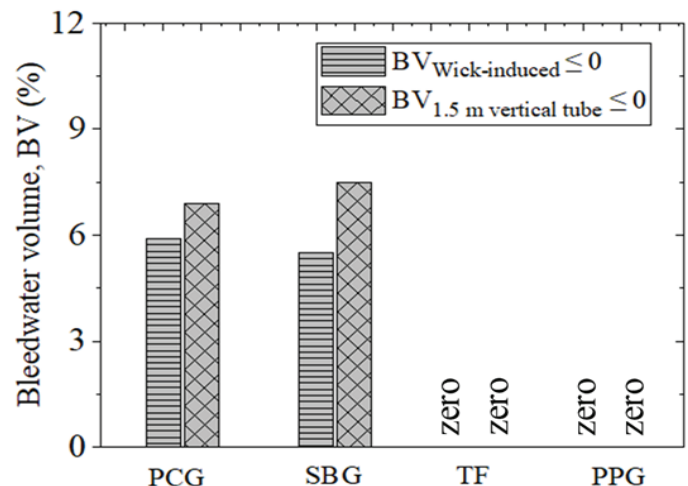
Figure 10: Bleedwater volume of PT grouts

Figure 10 compares the bleedwater volume of all four grouts measured after three hours of grouting. The results show that PCG and SBG exhibited severe bleeding in wick-induced and 1.5 m vertical tube tests and failed to comply with the acceptance criteria mentioned in Table 3. However, TF and PPG showed excellent bleed resistance (zero bleedwater volume) in the two tests. The poor performance of PCG and SBG is because of the high w/b ratios (PCG with 0.44 and SBG with 0.45). TF exhibited zero bleeding due to the incorporation of viscosity modifying admixture (VMA) in its mix, which increased the viscosity of the grout and thereby reducing the settling of cementitious phase. Also, it can be observed that the bleedwater volume for the same grout increases from one test to the other. The increase in the bleedwater volume is due to the presence of strands in the test setup. The narrow interstitial spaces between the seven wires of the strand act as capillary pathways and promote additional bleeding. Also, the quantity of bleedwater will be more in large-scale test setups than in small-scale test setups. In addition, it is important to note that PCG and SBG have satisfied the acceptance criterion for fluidity ($T_{e,0} \leq 25$ seconds); however, they exhibited the highest bleed (~ 8 %). Hence, the marsh cone test alone shall not be used as the screening test for grouts. In addition to fluidity, the bleed resistance of the grouts should be assessed and used for screening the grouts.

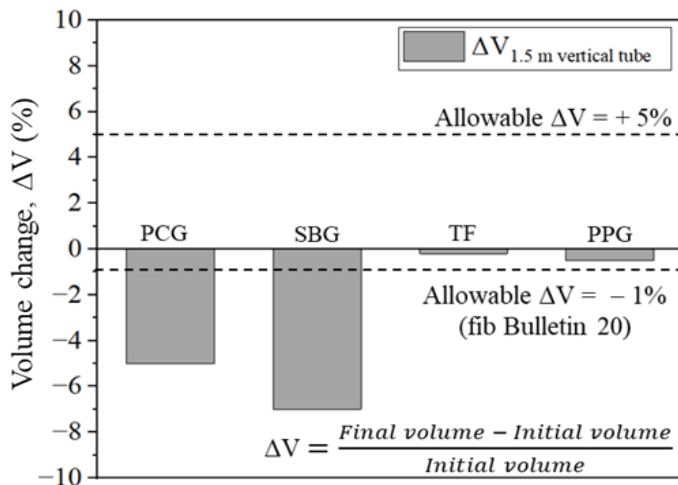
Figure 11: Volume change of PT grouts

The resistance to volume change is an important property of the grout and is to be maintained within a specified range around zero to completely fill the tendon duct. Figure 11 shows the comparison of volume change determined from the 1.5 m vertical tube test. PCG and SBG exhibited severe negative volume change because of the bleeding and segregation of the constituent ingredients. Also, PCG and SBG failed to comply with the acceptance limit specified in the fib Bulletin 20^[22] (i.e., $-1\% \leq \Delta V \leq +5\%$). TF and PPG showed negligible volume change and satisfied the acceptance limit. The negligible volume change of TF and PPG can be attributed to their thixotropic behavior. The viscosity of the mixes increases with time, and hence reducing the settling of the cementitious phase. In addition, the incorporation of VMA in TF increased the viscosity of the grout and thereby reducing the settling of cementitious phase leading to a negligible volume change.

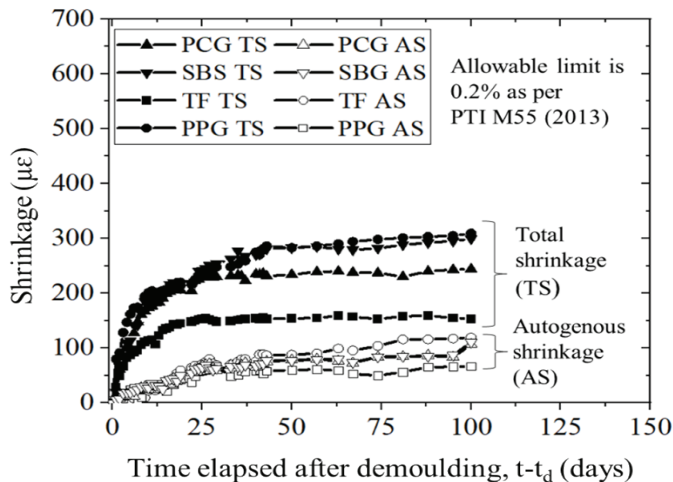
Figure 12: Shrinkage deformation of PT grouts (t_d = 1 day)

Figure 12 shows the shrinkage of the PT grouts. PTI specifies that shrinkage at the end of 1 day should be less than 0.1 % and at the end of 28 days should lie within -0.2 to +0.2 %.

All four grouts are within the acceptable limit specified by PTI M55:2013^[19]. PPG exhibited more total and autogenous shrinkage among the grouts. TF showed the least shrinkage among the grouts and the reasoning is due to the use of SRA in its mix. SRA can reduce the surface tension of the liquid phase in the fresh grout resulting in reduced shrinkage. The lesser the surface tension of the liquid phase in the capillary pores, the less will be the shrinkage^[16]. All four PT grouts did not exhibit any softgrout formation.

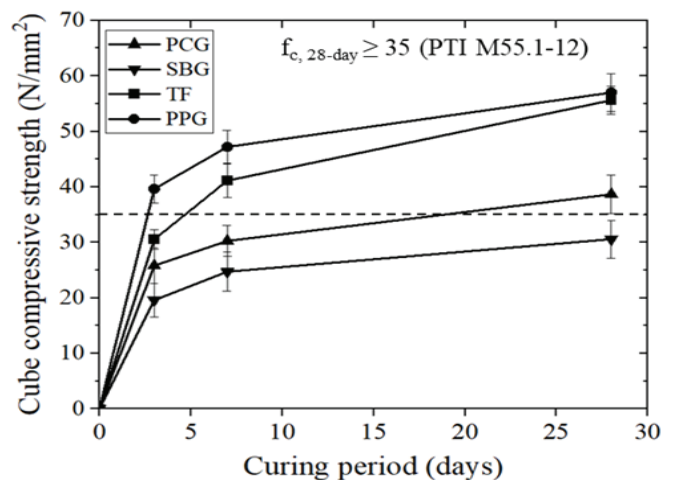
Figure 13: Compressive strength of PT grouts

Figure 13 shows the 50 mm cube compressive strength of all grouts at 3, 7 and 28 days of curing. All grouts, except SBG, satisfied the minimum recommended 28 day compressive strength of 35 MPa as per the PTI M55.1-12:2013^[19]. A w/b ratio of about 0.45 and the addition of plasticized expansive admixture have resulted in a porous microstructure with a lower compressive strength at 28 days (see inverse triangular markers in Figure 13).
