1 **Long-term performance and life-cycle-cost benefits of cathodic protection of**
2 **concrete structures using galvanic anodes**

11 This paper presents a market study indicating that Patch Repair without galvanic anodes (PR
12 strategy) can lead to continued corrosion (due to the halo effect and residual chloride effect)
13 and another major repair in about five years. Repeated patch repairs can lead to continued
14 corrosion and eventual replacement of structures and huge life cycle cost (LCC). On the other
15 hand, the strategy of cathodic protection using galvanic anodes (CP strategy) can enhance the
16 service life and reduce LCC. The data on long-term depolarized potential of steel, output
17 current from the anodes and/or visual observations indicated that the galvanic anodes were
18 successful in controlling the chloride-induced corrosion for up to 14 and 10 years, in a jetty
19 and industrial building, respectively. It was also found that the additional cost of galvanic
20 anodes is only about 4% of the repair cost for the jetty structure – breaking the myth of high

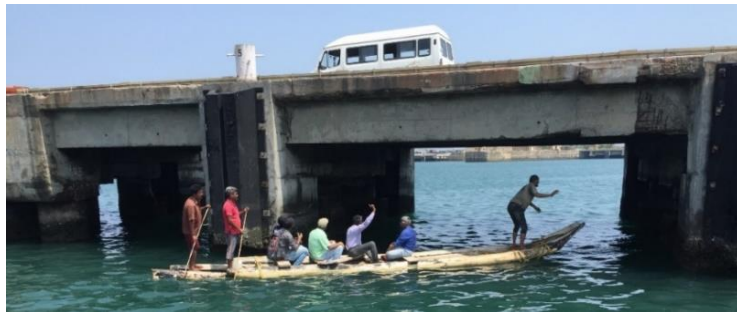
(a) Repaired piers of finger jetty (Photograph taken in 2019)

295 Figure 6 shows the photograph, schematic, and layout of finger jetty constructed in 1992 and
296 located at Chennai city in the East Coast of India. As shown in Figure 6(b), the typical tidal
297 variation is 0.7 m and the mean sea level (MSL) is below the pier cap indicating that the top
298 portion of the pier and pier cap experiences severe wet-dry exposure to seawater. After about
299 14 years of service, although M35 concrete was used, significant corrosion of rebars was
300 observed in the piers at the splash zone (see Figure 7(a)). In 2005, the jetty structure was
301 visually investigated, and chloride tests were conducted (as per ASTM C1152) on the
302 cylindrical concrete core samples extracted from the structure. An average chloride
303 concentration in concrete at the rebar level was found to be greater than 0.6% by weight of the
304 binder, which is significantly higher than the chloride threshold of the uncoated steel rebar in

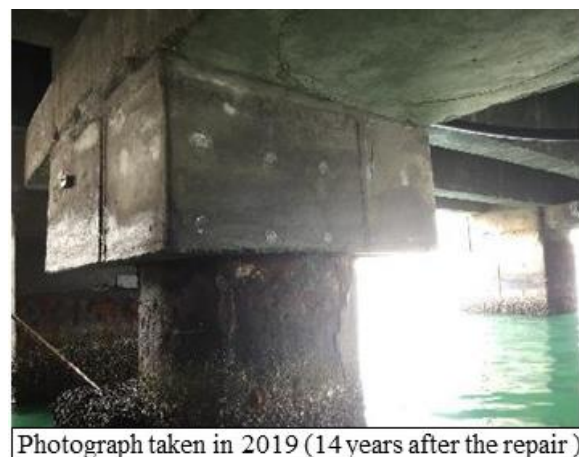
(b) CP protected pier after 14 years

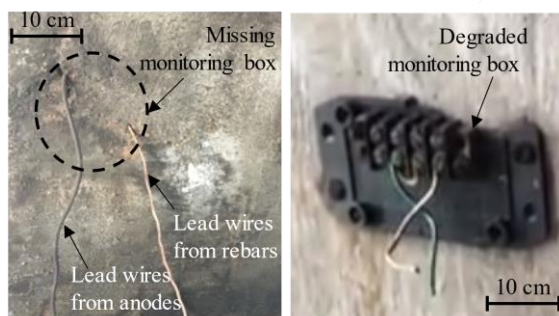
(a) Missing, naturally degraded/damaged monitoring boxes

351 During the 2019 visit, it was found that all the monitoring boxes and lead wires were
 352 naturally damaged/degraded (see Figure 9(a) for a typical scenario). Also, many of the
 353 monitoring boxes and lead wires were missing (say, degraded/damaged and fallen into the
 354 seawater below). Hence, E_{24h} could not be measured and only the I_{output} was obtained from
 355 Piers 1 to 8 (see Figure 9(b)). The I_{output} from a galvanic anode in Piers 1 and 5 were 0.25 and
 356 0.42 μA , respectively, which are significantly higher than the I_{output} from galvanic anodes in

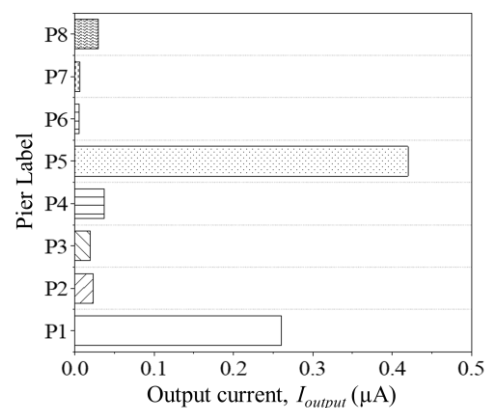
(b) Output current data collected in 2019

367 I_{output} , the anodes in P1 and P5 have shorter residual life than in other piers and may have to be
 368 replaced soon. Frequent monitoring (say, once in every 2 years) of I_{output} from the Piers 1 to 8
 369 can help in developing a preventive maintenance strategy and protecting the steel inside the
 370 piers for as long as desired – with minimal life cycle cost implications.

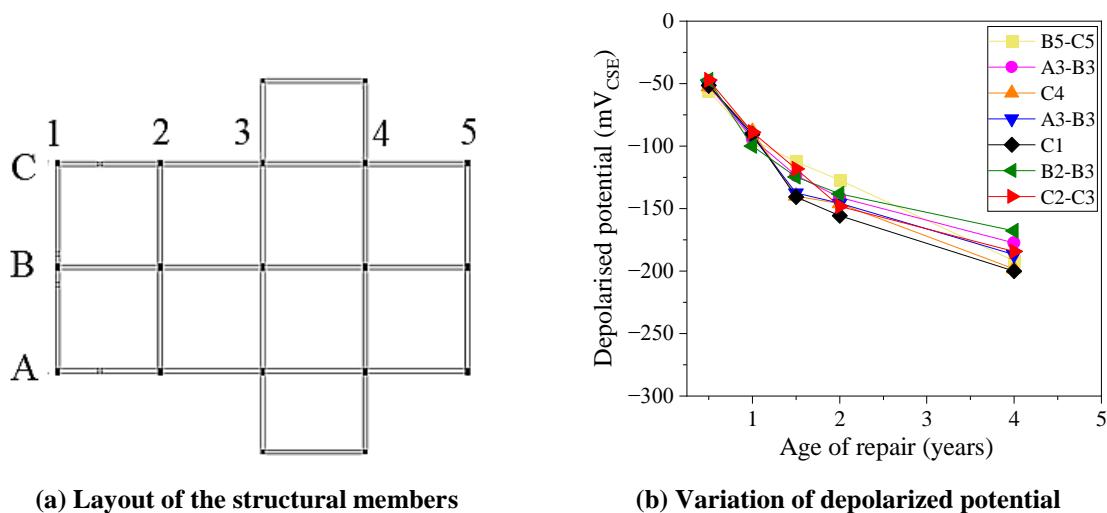
402 **Figure 11: Depolarized potential (E_{24h}) obtained from the industrial building elements.**

392 to about $-200 \text{ mV}_{\text{CSE}}$, which indicate that the steel rebars were still in passive state. Due to
 393 contractual agreements and other constraints, regular monitoring was possible only for 4 years
 394 after installing anodes. However, to check the long-term performance of galvanic anodes, a
 395 visual inspection of the industrial building was conducted at the end of 10 years after repair. It
 396 was observed that the structural elements did not exhibit any corrosion-induced cracking.
 397 However, in 2018, the salt processing procedure was changed, and the building was
 398 demolished. But this is a very good case study showing that galvanic anodes can protect the
 399 steel rebars from corrosion for more than 10 years, even in chloride-rich environments.
 400 However, clients are hesitant to adopt repairs using galvanic anodes due to the myth of the high
 401 cost of anodes instead of considering the effect of galvanic anodes on the LCC of the structure.

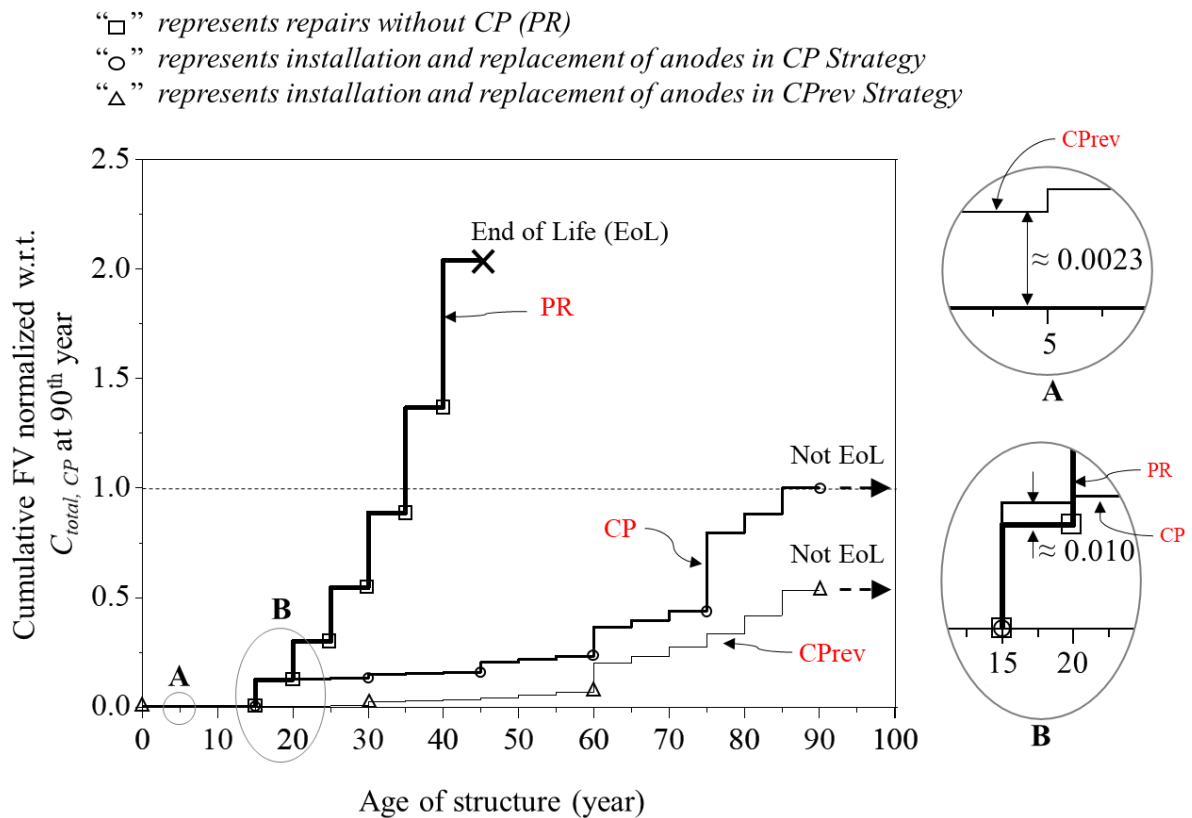
540
 541 **Figure 15: Life-cycle cost of PR, CP, and CPrev strategies for the repair of Jetty in**
 542 **Chennai, India.**

538 on LCC shows that the adoption of either CP or CPrev can lead to huge savings in term of
 539 LCC, see Figure 15. Further examples of such huge savings in LCC are shown next.

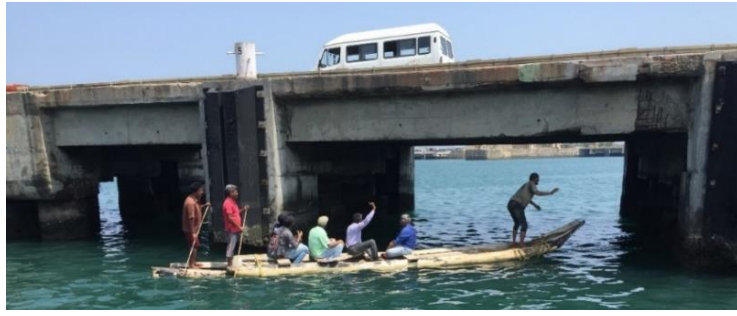
(a) Repaired piers of finger jetty (Photograph taken in 2019)

295 Figure 6 shows the photograph, schematic, and layout of finger jetty constructed in 1992 and
296 located at Chennai city in the East Coast of India. As shown in Figure 6(b), the typical tidal
297 variation is 0.7 m and the mean sea level (MSL) is below the pier cap indicating that the top
298 portion of the pier and pier cap experiences severe wet-dry exposure to seawater. After about
299 14 years of service, although M35 concrete was used, significant corrosion of rebars was
300 observed in the piers at the splash zone (see Figure 7(a)). In 2005, the jetty structure was
301 visually investigated, and chloride tests were conducted (as per ASTM C1152) on the
302 cylindrical concrete core samples extracted from the structure. An average chloride
303 concentration in concrete at the rebar level was found to be greater than 0.6% by weight of the
304 binder, which is significantly higher than the chloride threshold of the uncoated steel rebar in

305 concrete [54]. Based on the visual inspection and chloride concentrations determined, it was
306 decided to repair and strengthen the piers and pier caps immediately.

Figure 6: Repaired finger jetty in Chennai, India

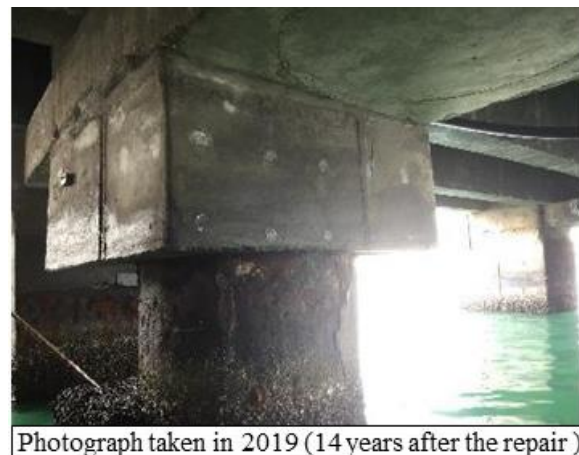
(b) CP protected pier after 14 years

340 of corrosion. After six months of repair, E_{24h} were more positive than $-100 \text{ mV}_{\text{CSE}}$, which
 341 indicate re-passivation of rebars within about six months of installation of galvanic anodes.
 342 E_{24h} were monitored for about four years and were found to be more positive than $-270 \text{ mV}_{\text{CSE}}$.
 343 This indicates that the probability of corrosion was less than 10% (as per ASTM C876 2015(as
 344 per ASTM C876 2015)). Due to contractual agreements and other constraints, regular
 345 monitoring was possible only until 4 years after the installation of anodes. Later, after 14 years
 346 of first repair, a visual inspection was conducted, and no significant corrosion-induced cracks
 347 were observed on the concrete surfaces. Figure 8(b) shows a photograph of one of the pier
 348 caps with cracks 14 years after the repair - indicating good protection of embedded steel for

349 more than 14 years.

Figure 8: 14-year long performance of repair using galvanic anodes in Finger Jetty.

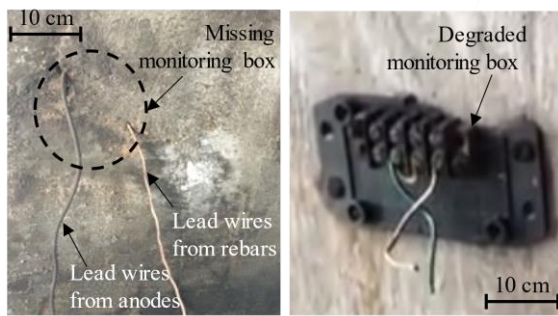
(a) Missing, naturally degraded/damaged monitoring boxes

351 During the 2019 visit, it was found that all the monitoring boxes and lead wires were
 352 naturally damaged/degraded (see Figure 9(a) for a typical scenario). Also, many of the
 353 monitoring boxes and lead wires were missing (say, degraded/damaged and fallen into the
 354 seawater below). Hence, E_{24h} could not be measured and only the I_{output} was obtained from
 355 Piers 1 to 8 (see Figure 9(b)). The I_{output} from a galvanic anode in Piers 1 and 5 were 0.25 and
 356 0.42 μA , respectively, which are significantly higher than the I_{output} from galvanic anodes in

Figure 9: Condition of monitoring boxes and the output current of anodes, at the end of 14 years after repair.

357 other piers. Piers 1 and 5 are located in the outer wing of the finger jetty and experience the
 358 incoming tides to higher level than the internal piers. Also, the outer piers have been
 359 experiencing higher temperature (during summer) and more severe splashing, whereas the
 360 inner piers always experienced lower temperature (under shade) and less severe splashing.
 361 Therefore, the I_{output} required for the outer piers could be higher than that for the inner piers.
 362 Figure 8(a) shows that the rebars are passivated within the first six months after the installation
 363 of anodes; also, the I_{output} would be less for the anodes connected to the passivated steel, which
 364 is the case for Piers other than P1 and P5. In case of P1 and P5, the I_{output} required to protect
 365 the steel is high, the same is provided by the anodes, and no corrosion-induced cracks were
 366 visible – hence, it can be concluded that the steel is protected from corrosion. Due to the high

367 I_{output} , the anodes in P1 and P5 have shorter residual life than in other piers and may have to be
 368 replaced soon. Frequent monitoring (say, once in every 2 years) of I_{output} from the Piers 1 to 8
 369 can help in developing a preventive maintenance strategy and protecting the steel inside the
 370 piers for as long as desired – with minimal life cycle cost implications.
