# Chemical and electrochemical repair methods for the anchorage regions of grouted, post-tensioned concrete systems

Karthikeyan Manickam<sup>a,\*</sup>, Radhakrishna G. Pillai<sup>b</sup>

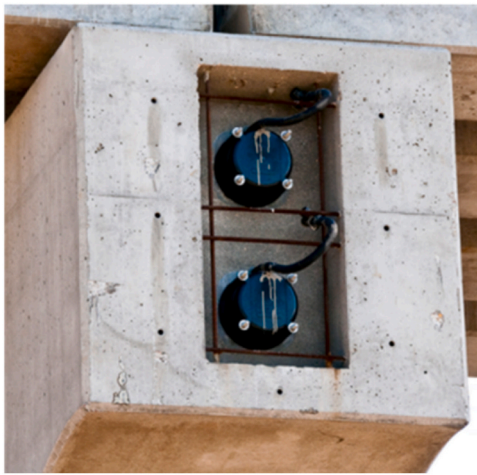
Fig. 1. Photo of a girder with permanent non-metallic anchorage caps [6].

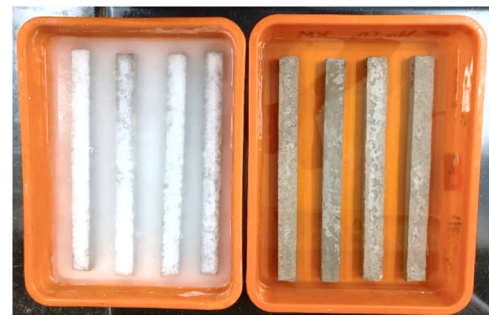
Fig. 5. Photos showing partially carbonated grout specimens immersed in  $1 \text{ M Ca(OH)}_2$  (shown on the left) and  $1 \text{ M Na}_2\text{CO}_3$  (shown on the right) solutions.

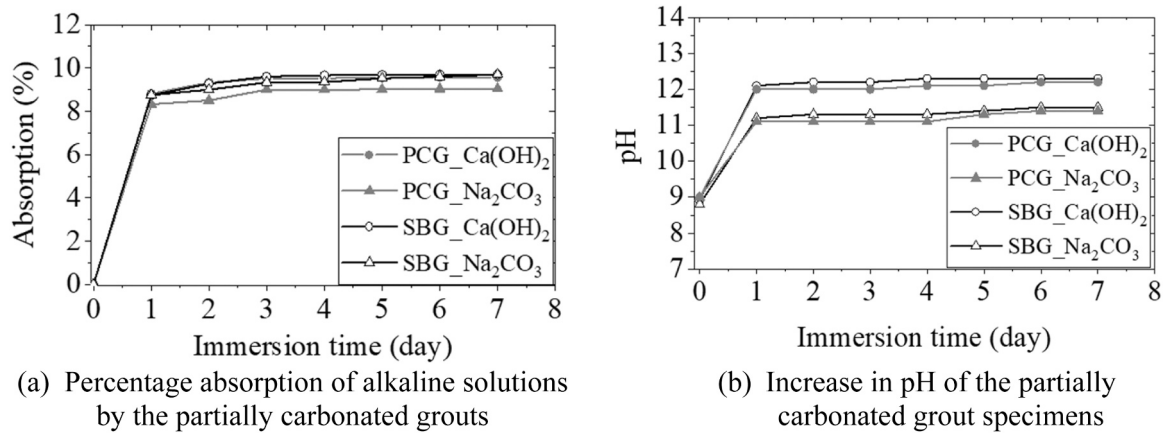
Fig. 7. Percentage absorption of alkaline solutions and the increase in pH after re-alkalization.

Fig. 7 shows the percentage absorption of the alkaline solution by the partially carbonated grout specimens. The percentage absorption was calculated by measuring the difference in the mass of the specimen before and after immersion and dividing it by the initial mass. It was observed that after one day of immersion, there was a sudden increase in the mass of the specimens (for both PCG and SBG). The increase in mass is due to the absorption of the solution into the specimen. Then, the specimens were immersed again into the alkaline solutions, and the measurement was repeated every day for about one week. The results indicate that the percentage increase in absorption was not significant after one day. It can be inferred that the solution could saturate the specimens completely within one day of immersion.
