Article in *Acı Materials Journal* · March 2005

# Surface Condition Effects on Critical Chloride Threshold of Steel Reinforcement

by Radhakrishna G. Pillai and David Trejo

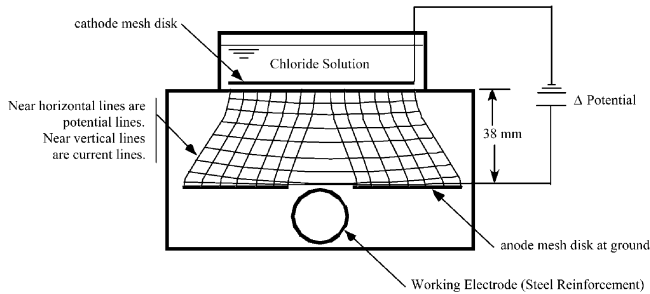
Fig. 1—Potential and current lines in accelerated chloride threshold sample (Trejo and Pillai 2003).

Figure 1 shows the anode-cathode system. Note that the anode is separate from the steel reinforcement (the working electrode). This prevents the steel reinforcement from being directly polarized from the applied potential gradient. Excessive polarization of the reinforcement can change the surface characteristics and result in inaccurate corrosion rate measurements (Tait 1994). A potential gradient was applied between the anode and cathode for 6 h followed by a 42-h rest period. Near the end of the rest period, the  $R_p$  of the steel reinforcement was evaluated. The scan rate was 0.0667 mV/s, and the scan typically started  $-20$  mV from the open circuit potential. The  $R_p$  is inversely proportional to the corrosion rate  $i_{corr}$  as follows

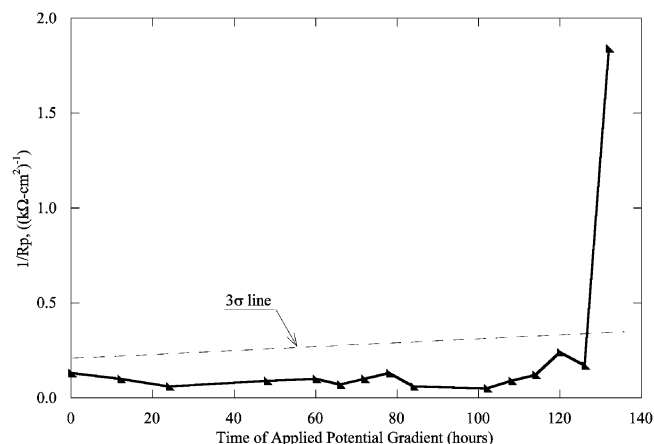
Fig. 2—Typical plot of inverse polarization resistance versus time of applied voltage for accelerated chloride threshold testing.

Once determined, the inverse  $R_p$  was plotted as a function of applied time of potential gradient  $T_p$ . After a minimum of four  $R_p$  values were obtained from the ACT samples, a statistical analysis procedure was implemented to determine if the change in the inverse  $R_p$  value was significantly different from a predicted inverse  $R_p$  value estimated from the previous inverse  $R_p$  values as follows

where  $\sigma$  is the standard error of all previous inverse  $R_p$  values,  $n$  is the sample size, and  $\bar{T}_p$  is the mean value of all previous  $T_p$  values. A typical inverse  $R_p$  versus  $T_p$  plot showing corrosion initiation after 132 h of applied voltage is shown in Fig. 2. For this work, the change in the inverse  $R_p$  value was significantly different if the  $t$ -score was greater than 3.

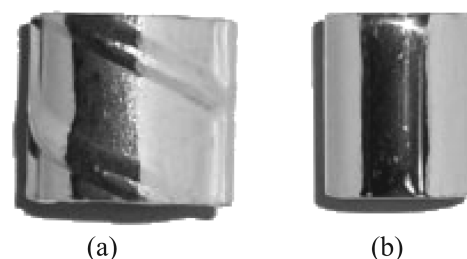
Fig. 3—Typical surface conditions of tested reinforcing bars: (a) “as-received” condition; and (b) “polished” condition.

included the removal of surface layers using the lathe until the diameter of the remaining steel was 15 mm (0.6 in.), followed by polishing of the surface. Polishing consisted of using a 600 grit paper to remove any surface imperfections followed by further polishing on a cotton buffing wheel. The polished samples were then ultrasonically cleaned in acetone, followed by ultrasonic cleaning in ethyl alcohol. The polished samples had all macro surface irregularities removed. After polishing and cleaning, the samples were coated with a low-viscosity epoxy. An area of 150 mm<sup>2</sup> (0.23 in.<sup>2</sup>) was left uncoated to evaluate the corrosion activity of the sample.

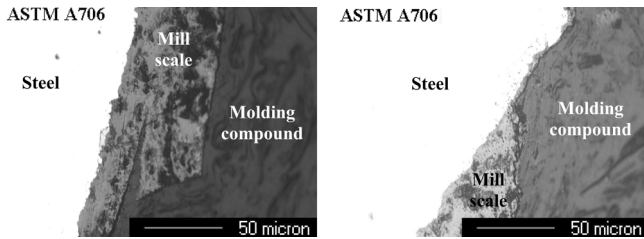
Fig. 4—Typical micrographs of ASTM A 706 steel reinforcement surface.

Figure 4 indicates that the ASTM A 706 exhibits crevices in the mill scale and has a generally discontinuous mill scale. The discontinuous mill scale can lead to the formation of microgalvanic cells that can decrease the critical chloride threshold of the steel. The crevices can also result in a decreased critical chloride threshold level. Figure 5 shows the surface of the ASTM A 615 reinforcement. Although some discontinuities were observed in this mill scale, in general, this reinforcement type exhibited a fairly uniform, continuous mill scale. Although some discontinuities were observed in the mill scale, these discontinuities were in general less frequent than that observed on the ASTM A 706 reinforcement.

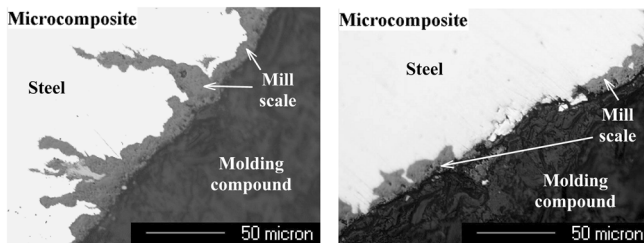
Fig. 6—Typical micrographs of microcomposite steel reinforcement surface.

Figure 6 shows the surface of the microcomposite steel reinforcement. The microcomposite reinforcement exhibited a fairly nonuniform surface, with discontinuous mill scale and a significant amount of mill scale (iron-oxide) rolled into the base steel. Some crevices were identified on the mill scale and steel surface. The nonuniform surface with the presence of crevices could lead to lower critical chloride threshold values when compared with more uniform surfaces.

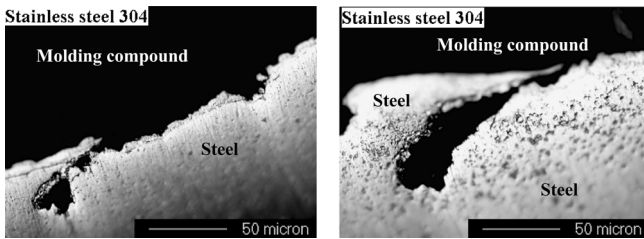
Fig. 7—Typical micrographs of SS304 steel reinforcement surface.

The surface conditions of the SS304 are shown in Fig. 7. This reinforcement type is distributed from the manufacturer with the mill scale removed. No mill scale was observed in the micrographs for this reinforcement type. The SS304 reinforcement did exhibit crevices in the surface. The micrographs

seem to indicate that the mill scale was initially rolled into the base steel and then later removed during the mill scale removal process. Only a limited number of sites on the surface showed remaining mill scale (iron oxides) in these crevices. Because no mill scale was observed, no detrimental effects due to the formation of microgalvanic cells between the areas covered with mill scale and the areas free of mill scale would be expected, although the crevices could be detrimental to the corrosion resistance.

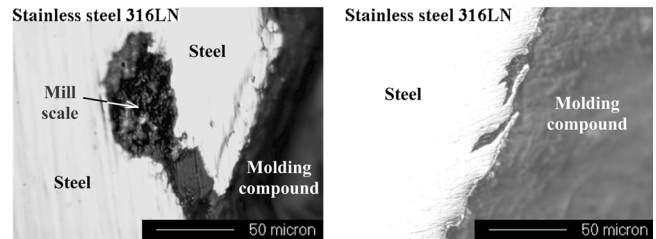
Fig. 8—Typical micrographs of SS316LN steel reinforcement surface.

Figure 8 shows the surface condition of SS316LN steel reinforcement. As shown, the crevices on the surface of this reinforcement type seemed to be smaller than the crevices on the SS304. In addition, it was observed during the microscopy work that many of these crevices tended to contain iron oxides. Although these oxides could result in the formation of microgalvanic cells, these oxides tended to completely fill the crevices, possibly reducing the chance of crevice corrosion.

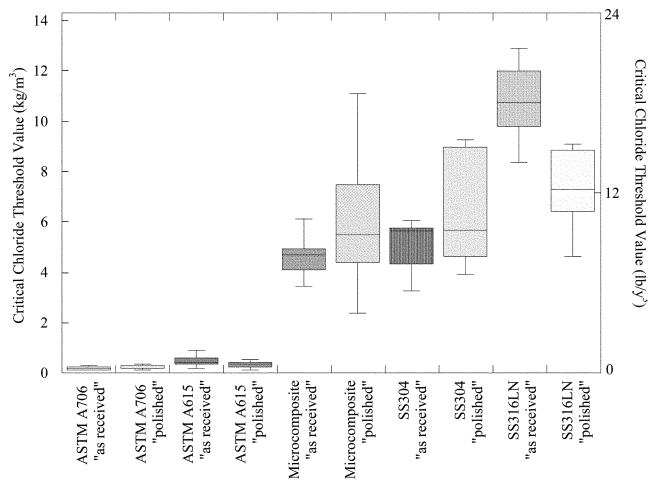
Fig. 9—Critical chloride threshold values for different reinforcement types evaluated in test program

The critical chloride threshold values obtained from the ACT testing for the five reinforcement types with the different surface conditions embedded in mortar are shown in Table 4 through 8. They are also shown graphically in Fig. 9.
